LARGE COMPONENT DEFORMATION STUDIES USING VIDEOGRAMMETRY

*John A. Greenwood, LS
Alignment & Metrology Group, Fermilab, Batavia, IL 60510*

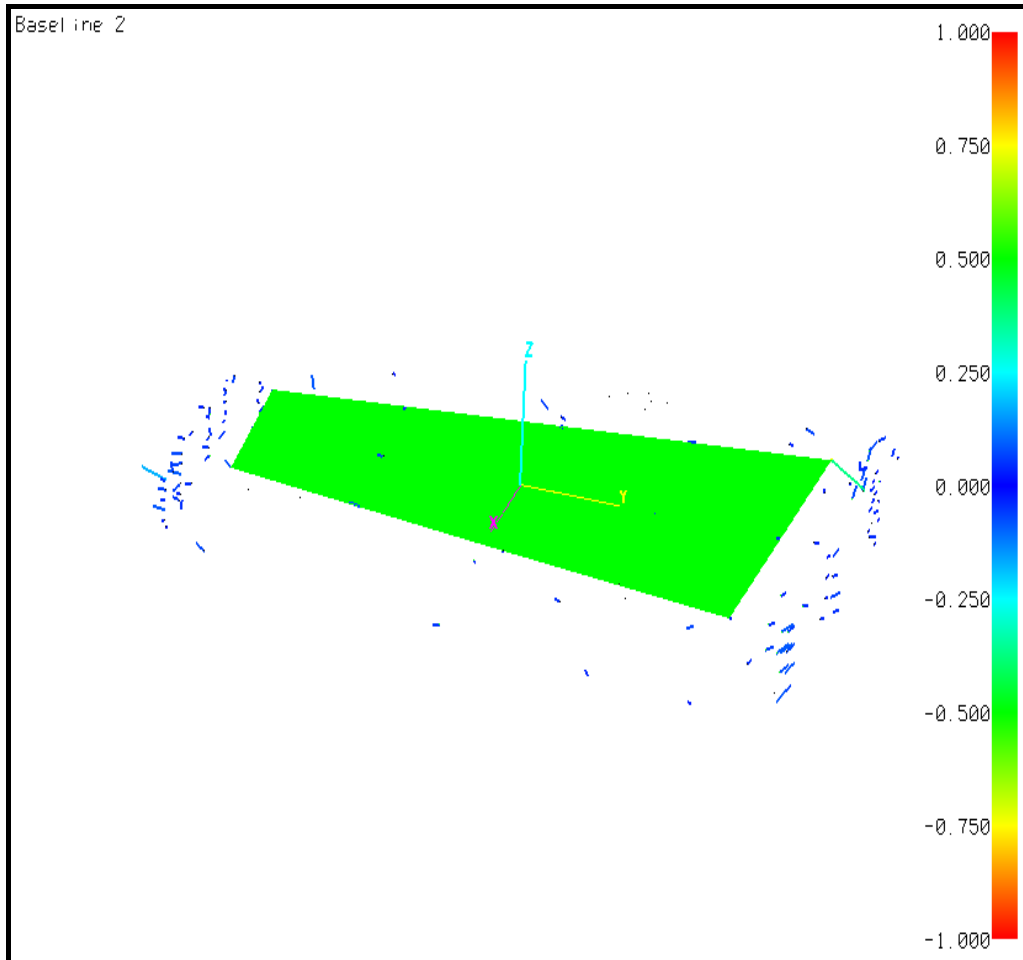
Figure 6 - Baseline 2 with Tolerance Bar in mm

The fifteen targets on the top surface of the panel defined the part reference frame. Each subsequent epoch was best-fit to these points. Figures 6 thru 14 show the residual vectors of each successive epoch, relative to Baseline 1. Figure 6 shows that the initial confirmation observations, with respect to Baseline 1, indicate a consistency better than 0.2mm. Indeed, an examination of the vector components would lead one to believe a small thermal expansion of the part took place; a reasonable conclusion since Baseline 1 was measured on the afternoon of Day 1, while Baseline 2 was measured early the following morning.

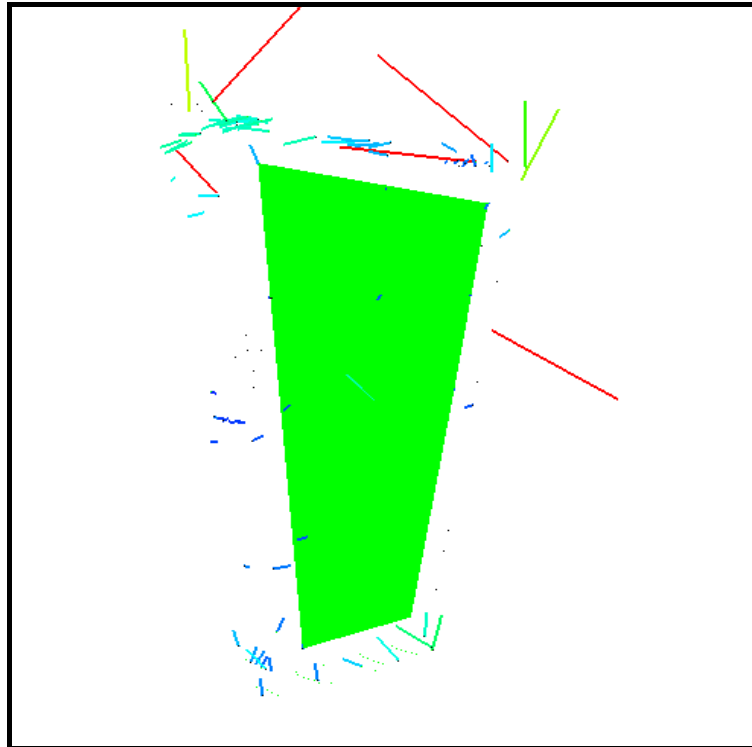
Figure 7 - 12 o'clock epoch

The chamber was then transported by truck to an area with adequate vertical clearance in order to suspend the chamber in the desired orientations using an overhead crane. Figure 7 shows a distortion near the lifting points, which may be seen in Figure 3, near each edge of the chamber's large end. From Figures 7 thru 13, it is clear that one corner of the large end of the chamber was distorted, probably when it was taken in or out of the truck, or during the first lift. The two additional "flyers" are caused by poor geometry due to obstructions limiting the visibility of those points.

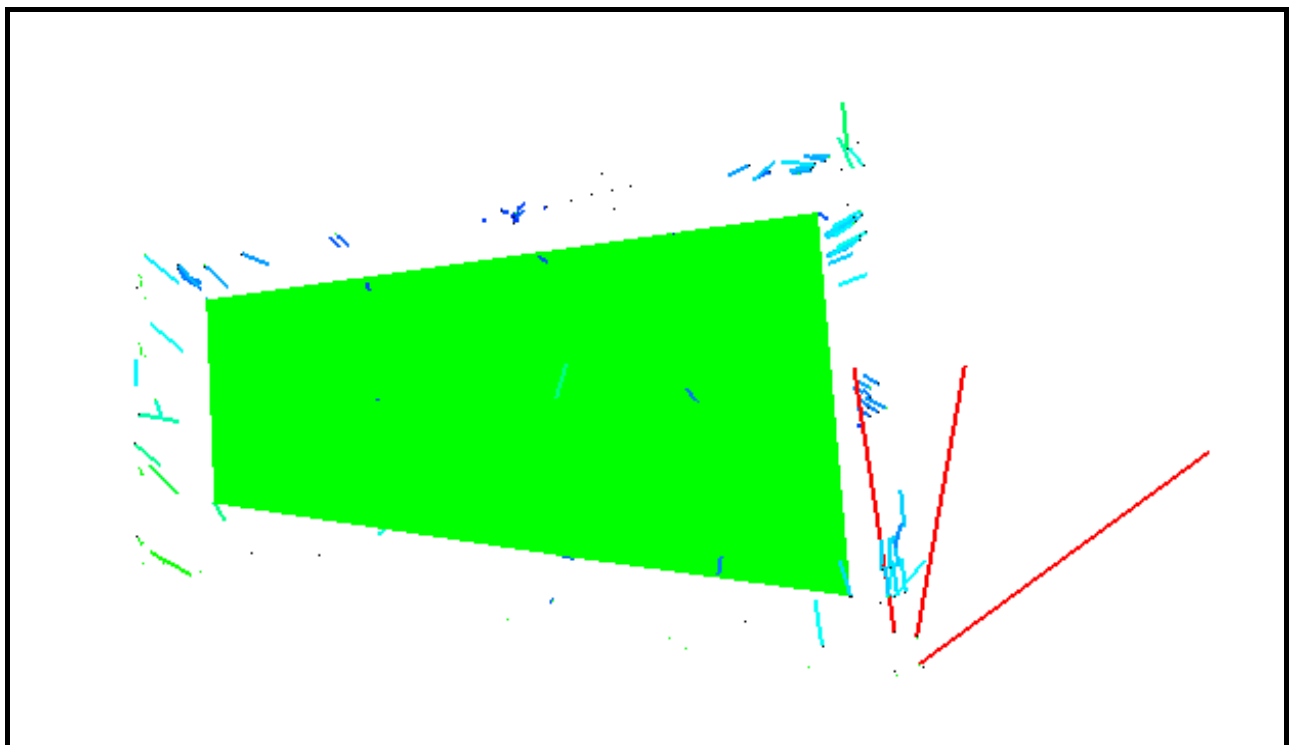
Figure 8 - 3 o'clock epoch

In Figure 8, the chamber was suspended using the near lifting point seen in Figure 3, and the lifting point seen at the center of the small end in Figure 4. Interestingly, this is the first evidence of the inelastic distortion mentioned above. In Figure 9, the chamber was suspended by the single lifting point at the small end.

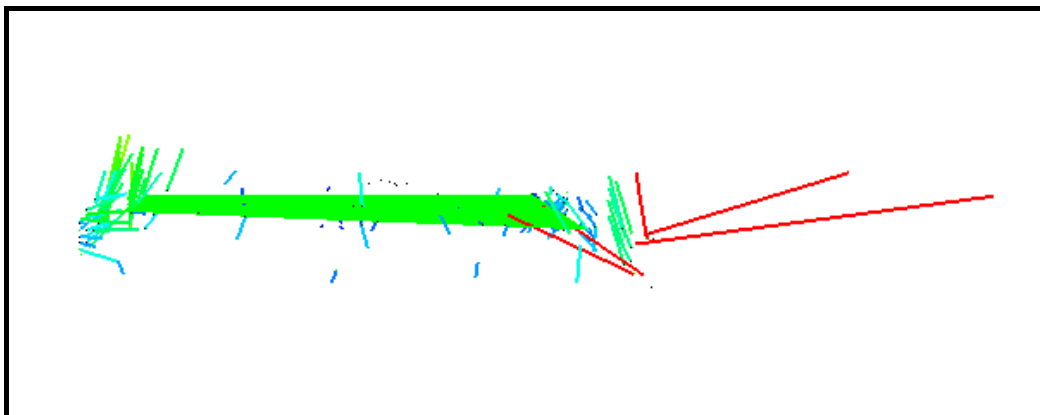
Figure 10 - 0° epoch

Figures 10 and 11 show the chamber when it is suspended in the service fixture. The fixture allows the chamber to be rotated about its long axis, supported by pins attached to the ends. The vectors in Figure 10 indicate the external framework does not hold the panels rigidly, thereby allowing the reference frame to droop relative to the attachment points.

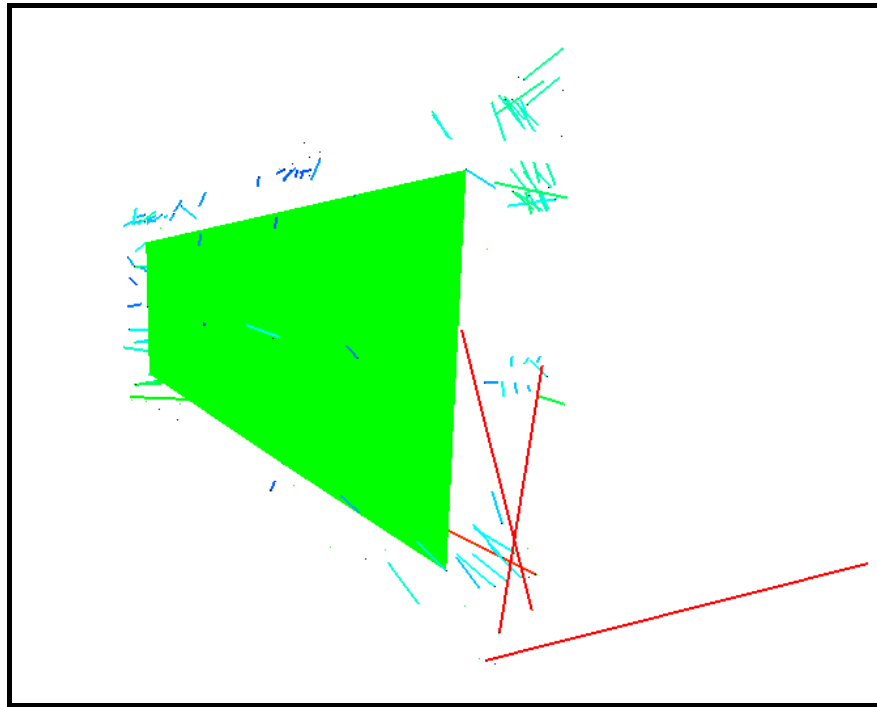
Figure 11 - 90° epoch

Figure 11 reveals the same problem but in the vertical direction.

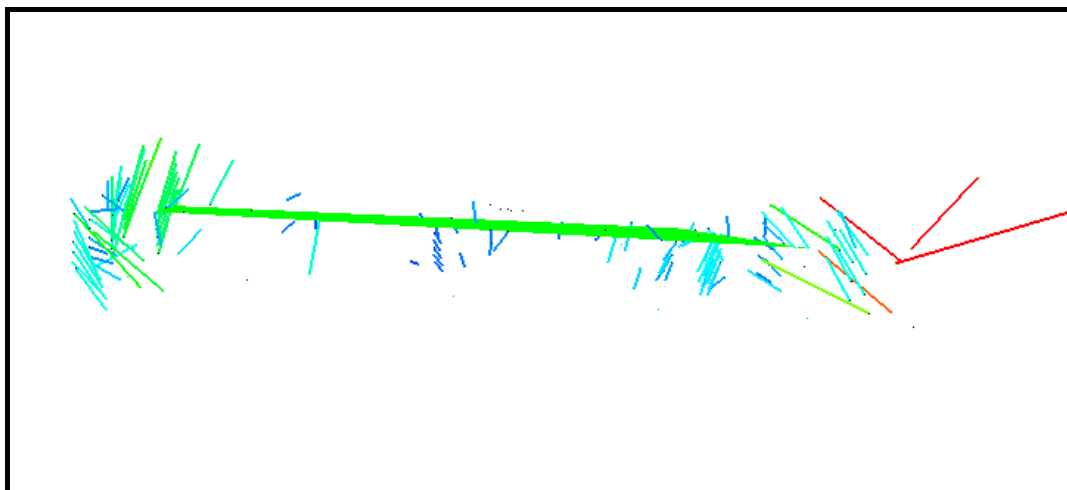
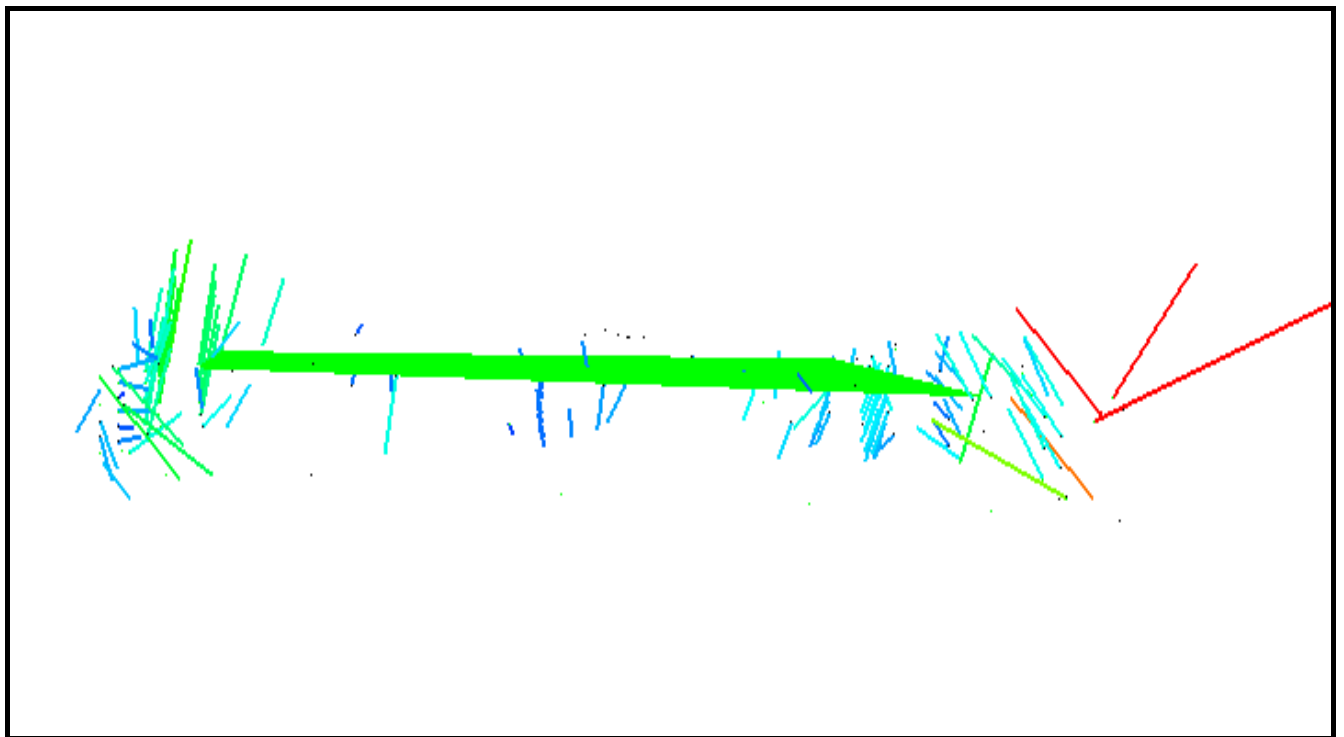
The post run measurements, Figures 12 and 13, were made on a surface table at the second facility. The work area was quite cramped, which gave a slightly poorer Plan Quality Factor. The Plan Quality Factor is a measure of the appropriateness of the number of exposure and the position and orientation of the camera stations. The effects of this can be seen in Figure 14, when compared to Figure 6. The distortion at the lifting point at the large end is still apparent, as is the likelihood that the small end external framework has not been replaced in the same location.
