Notes on Scanning Electron Microscope Analysis of 25-Cell W-Band Structure Iris Diffusion Bond Joint

E. Colby 8/14/98

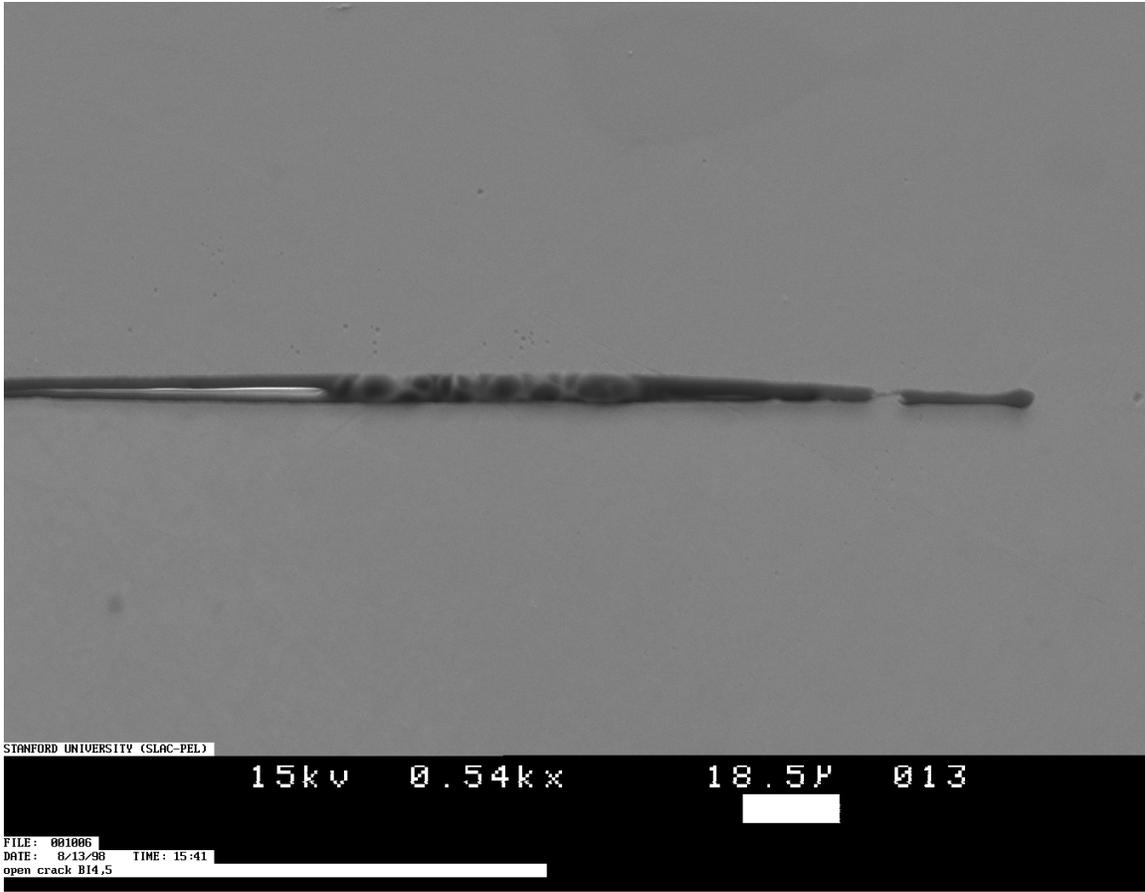
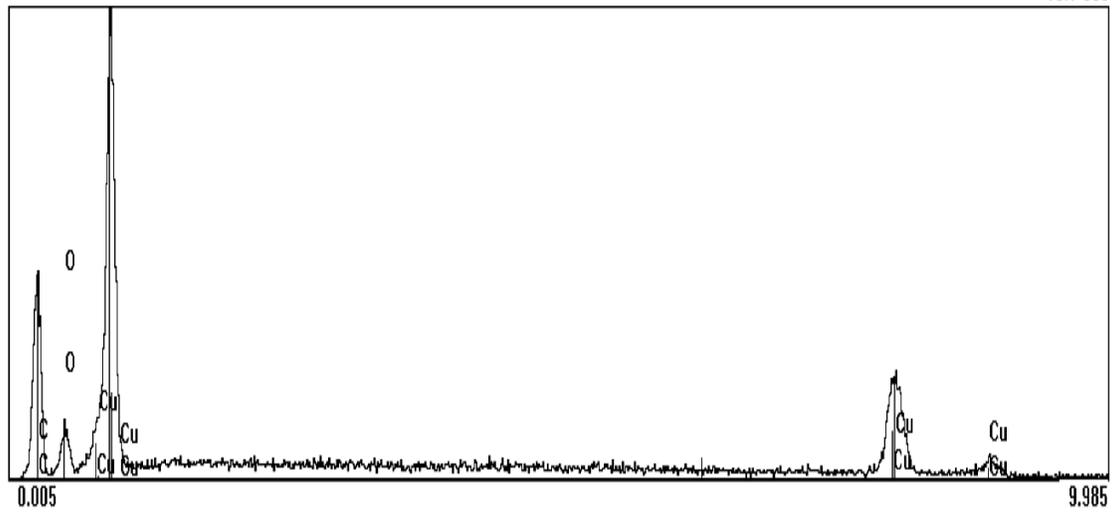
<u>File Name</u>	<u>Description</u>
001006B.gif	Largest crack in bond joint at 540X, fluorescent insulator is source of spectrum
001006.gif	Pit adjacent bond crack at 1630X, spectrum from site inside crack
001007.gif	Surface porosity on surface away from crack at 3000X
001008.gif	Pit along "good" bond joint segment at 8800X
001009.gif	Overview of "good" bond region at 500X
001010.gif	Grain boundary/bond joint intersection with two pits at 2000X
001011.gif	Double pit in "good" bond region at 2670X with spectrum of pit contents

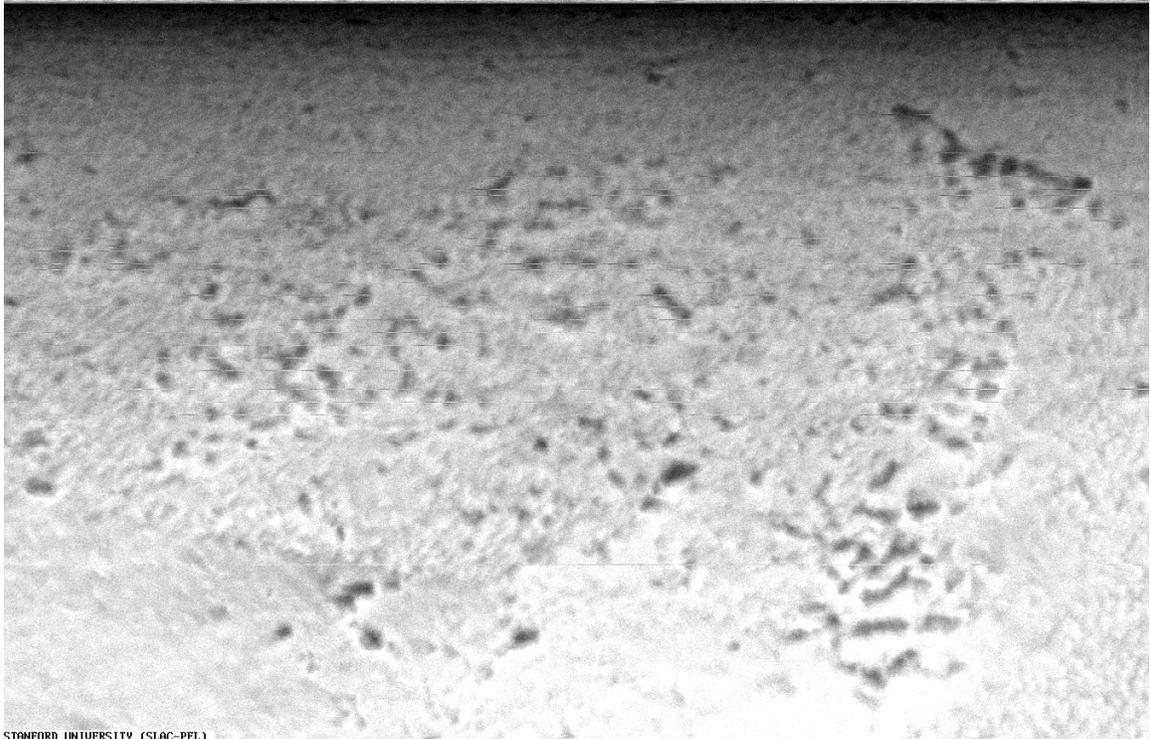
The pits appearing in image 001007 could well arise during the acid etch step. Since similar lapping and etch treatment is used prior to diffusion bonding it is reasonable to expect the diffusion bond surfaces so prepared to be pitted, giving rise the voids seen in images 001006, 001008, 001009, and 001011. The size of the surface pits and the bond crack pits are comparable, $\sim 1 \mu$. Relative dislocation of the copper grains is also evident from the shadows cast in image 001010. Such changes in surface flatness could account for the smaller crack seen in 001006.

FILE: 001007
DATE: 8/13/98 TIME: 16:35
copper porosity away from bond

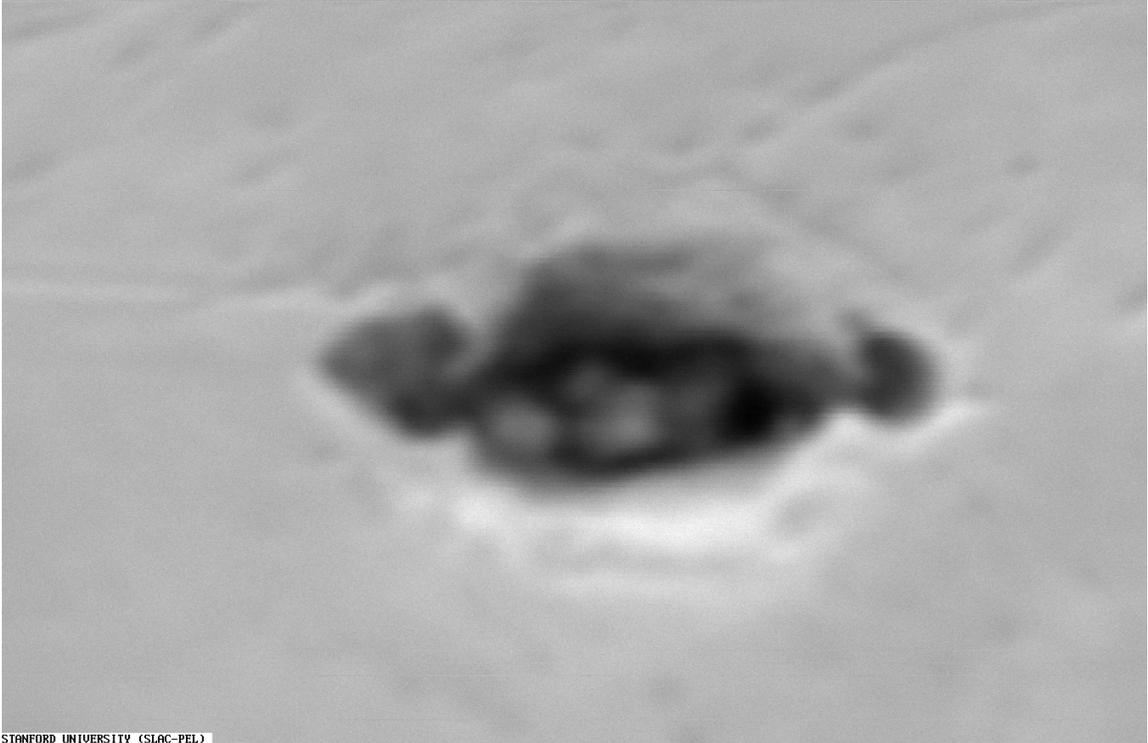
FILE: 001000
DATE: 8/13/98 TIME: 16:50
good region, hole in bond

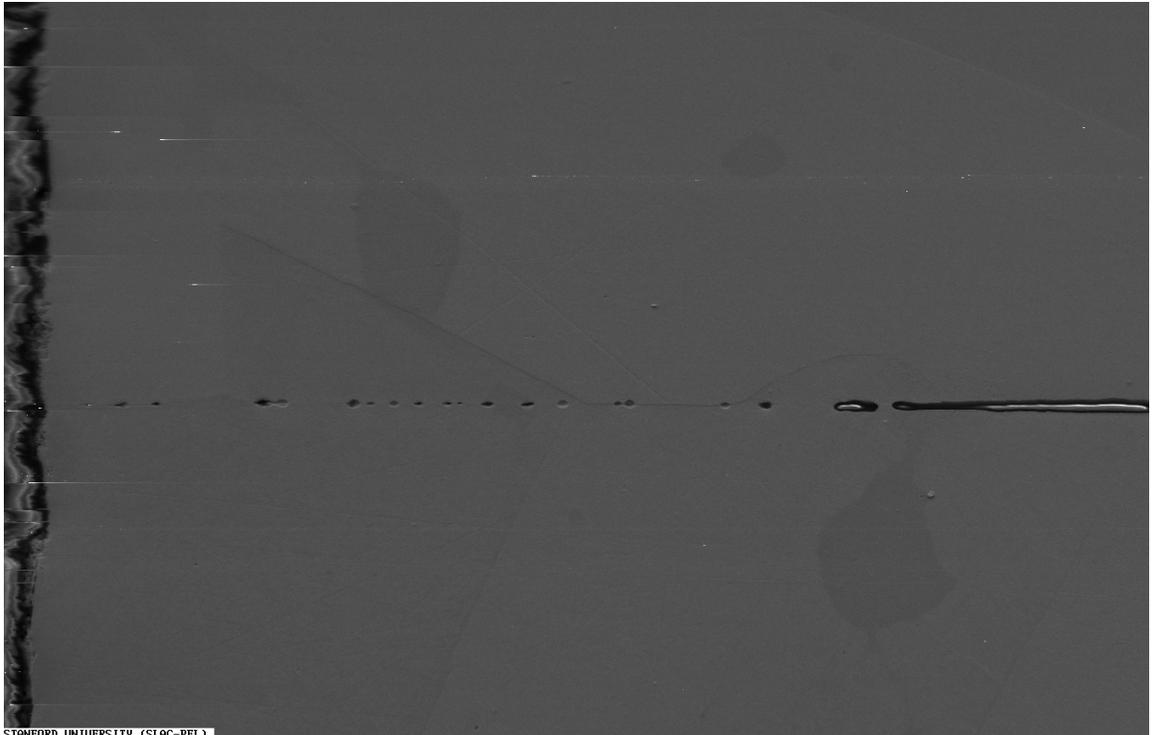
FILE: 001009
DATE: 8/14/98 TIME: 9:04
distance view of good bond

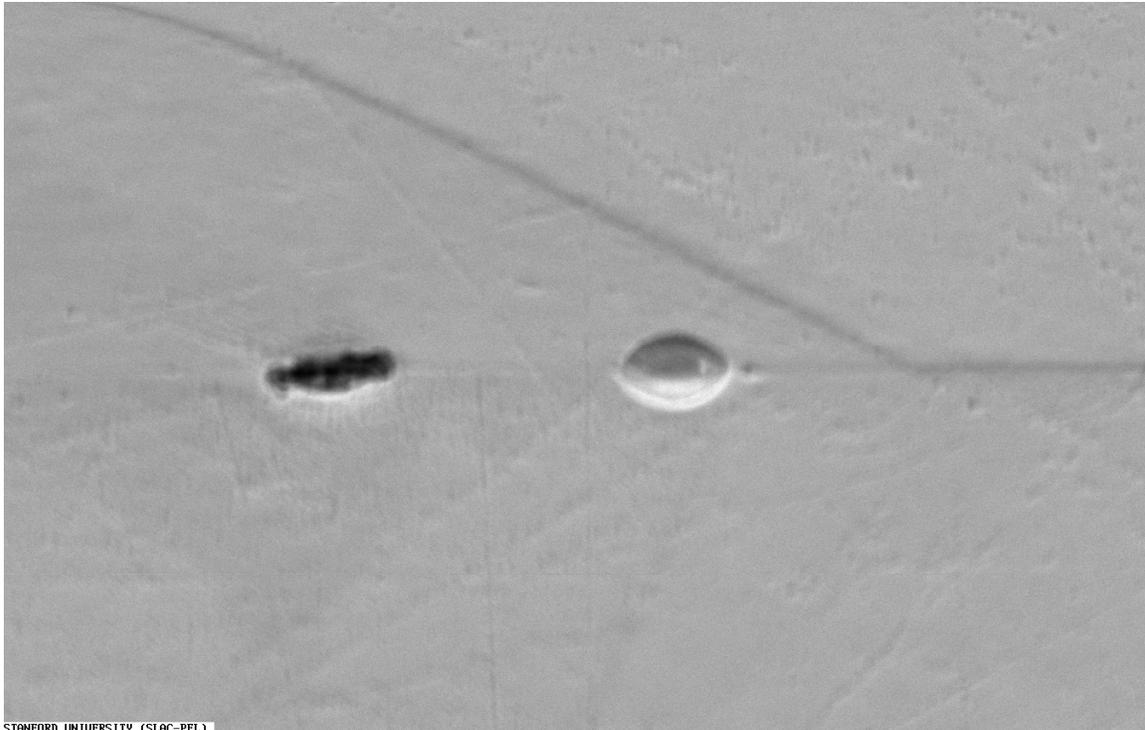
FILE: 001010
DATE: 8/14/98 TIME: 9:18
grain tip view at bond

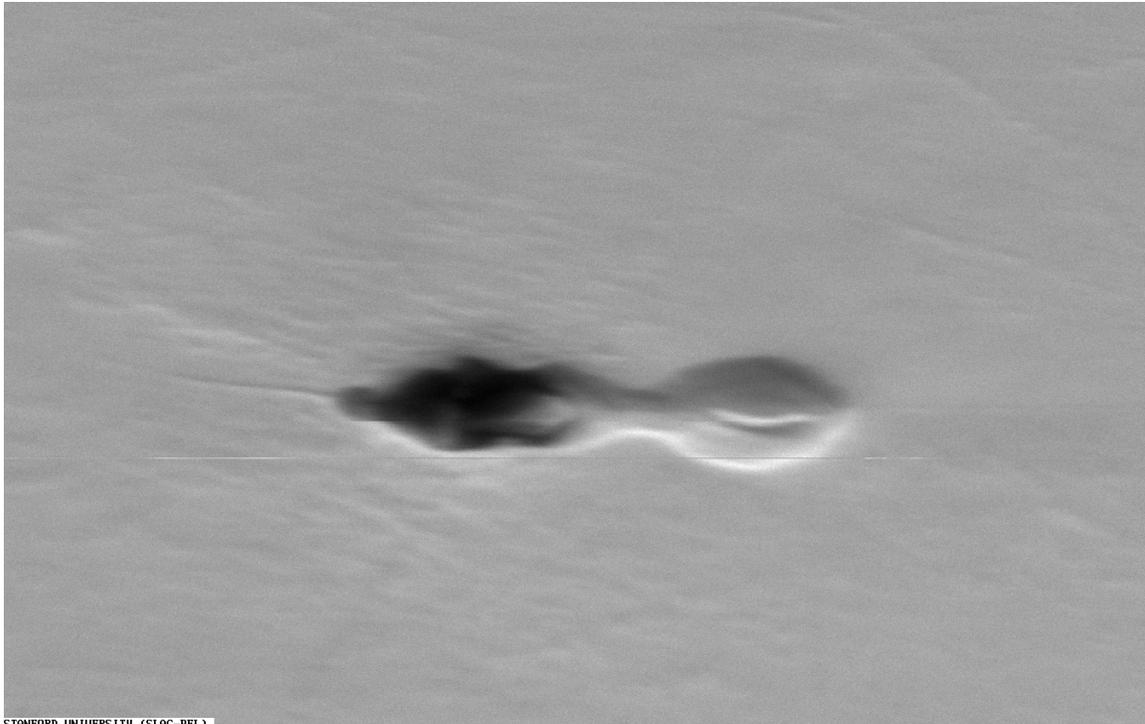
FILE: 001011
DATE: 8/14/98 TIME: 9:33
island at bottom of bond pit
