Materials Characterization

Job ID **965**

Material: Copper GTF and Orion cathode plates with friction-welded Mg plugs.

Purpose of: Characterize surface condition.
Analysis

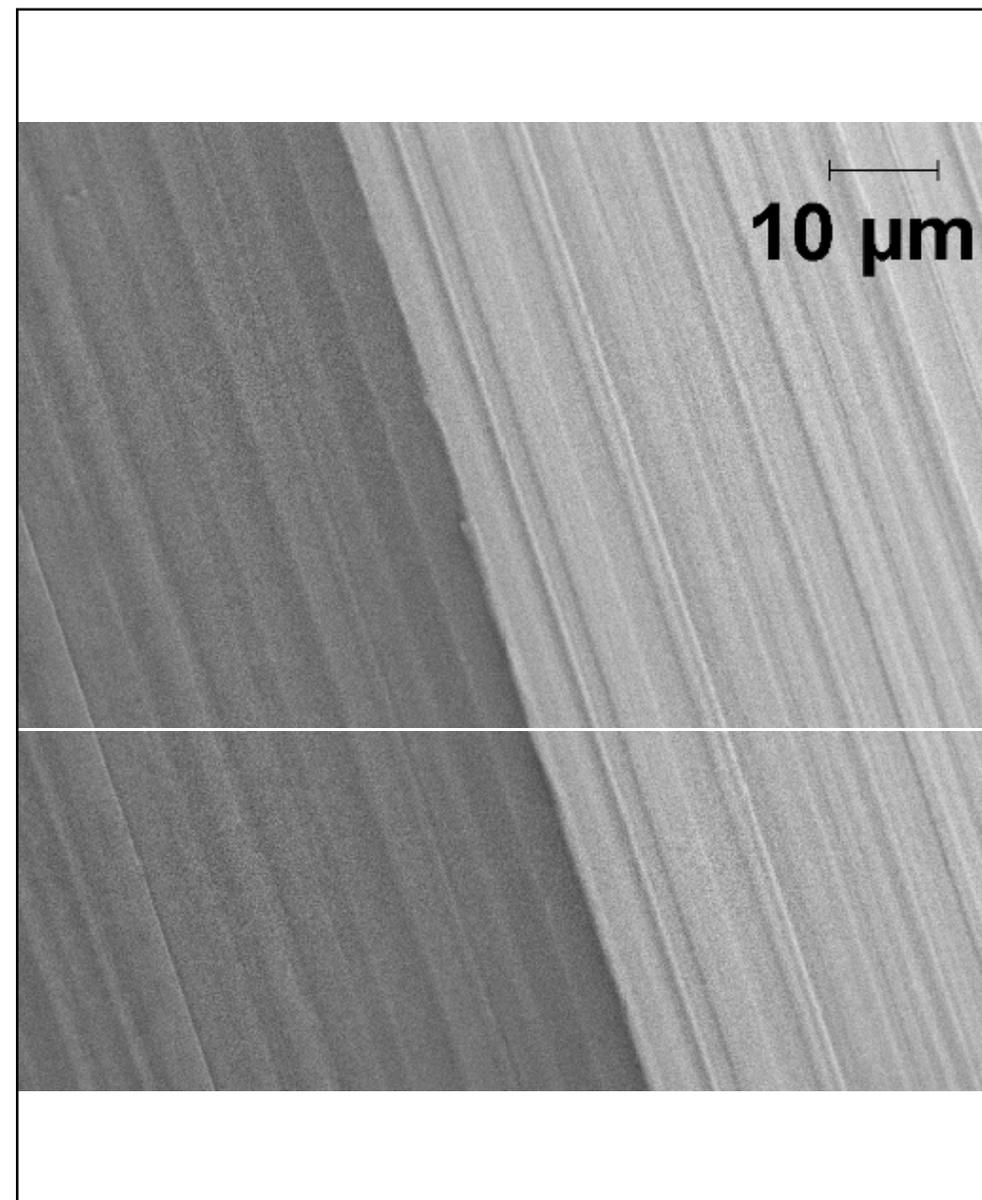
Figure 1: Orion cathode, as-machined. Mg (left)/ Cu (right) boundary. The weld-line is tight around the full 360 degrees.

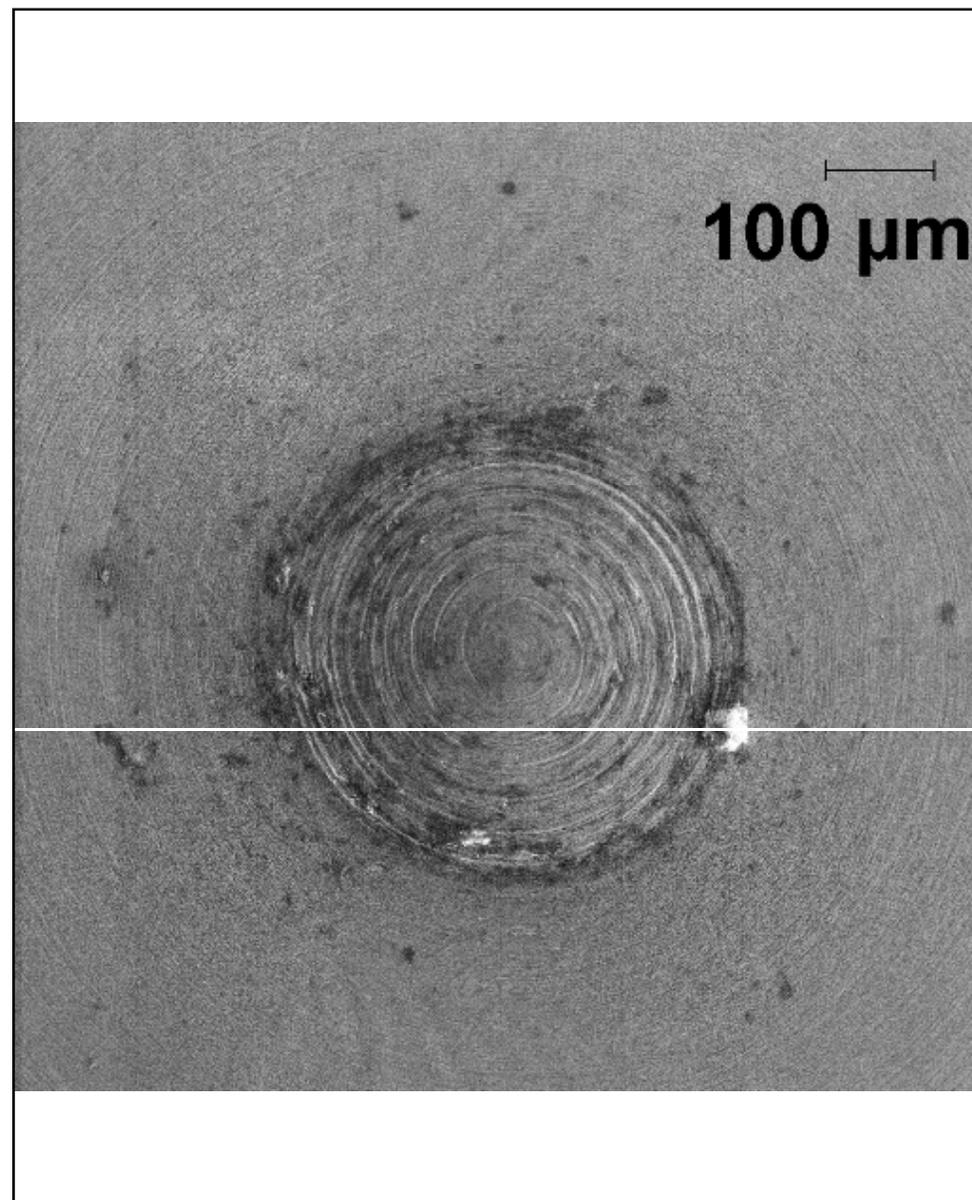
Figure 2: Orion cathode, as-machined. Machining tit, located at center of circular cathode plate. The particle debris is Mg.

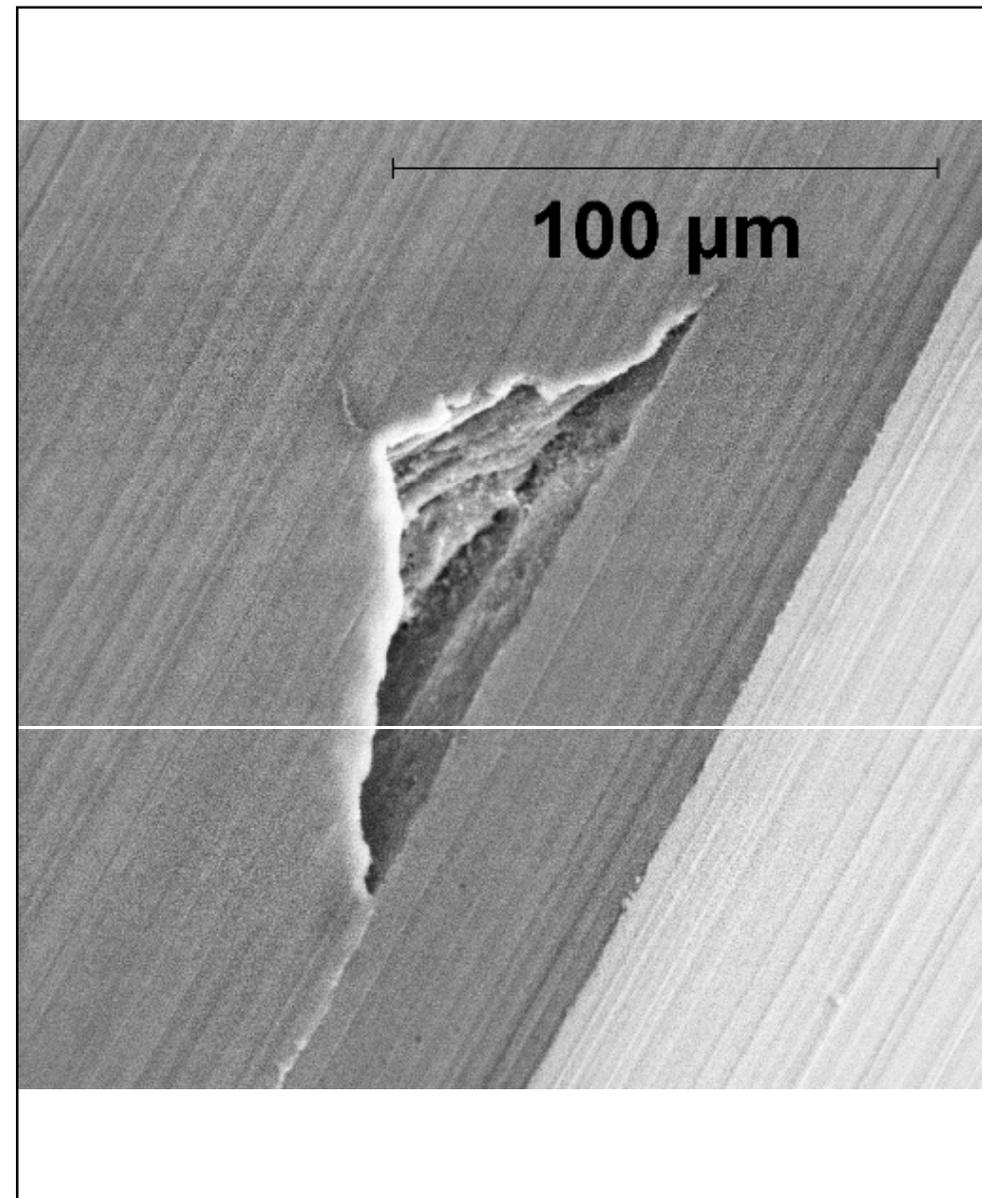
- 2) The boundary of the Mg and Cu weld always looks tight, but the stress of the weld near the boundary area is relieved by breakouts of the Mg material nearby;

Figure 3: Orion cathode, as-machined. The Mg cavity is caused by material fallout. Such features are common as a way of relieving the stress from the nearby Mg/Cu weld boundary.

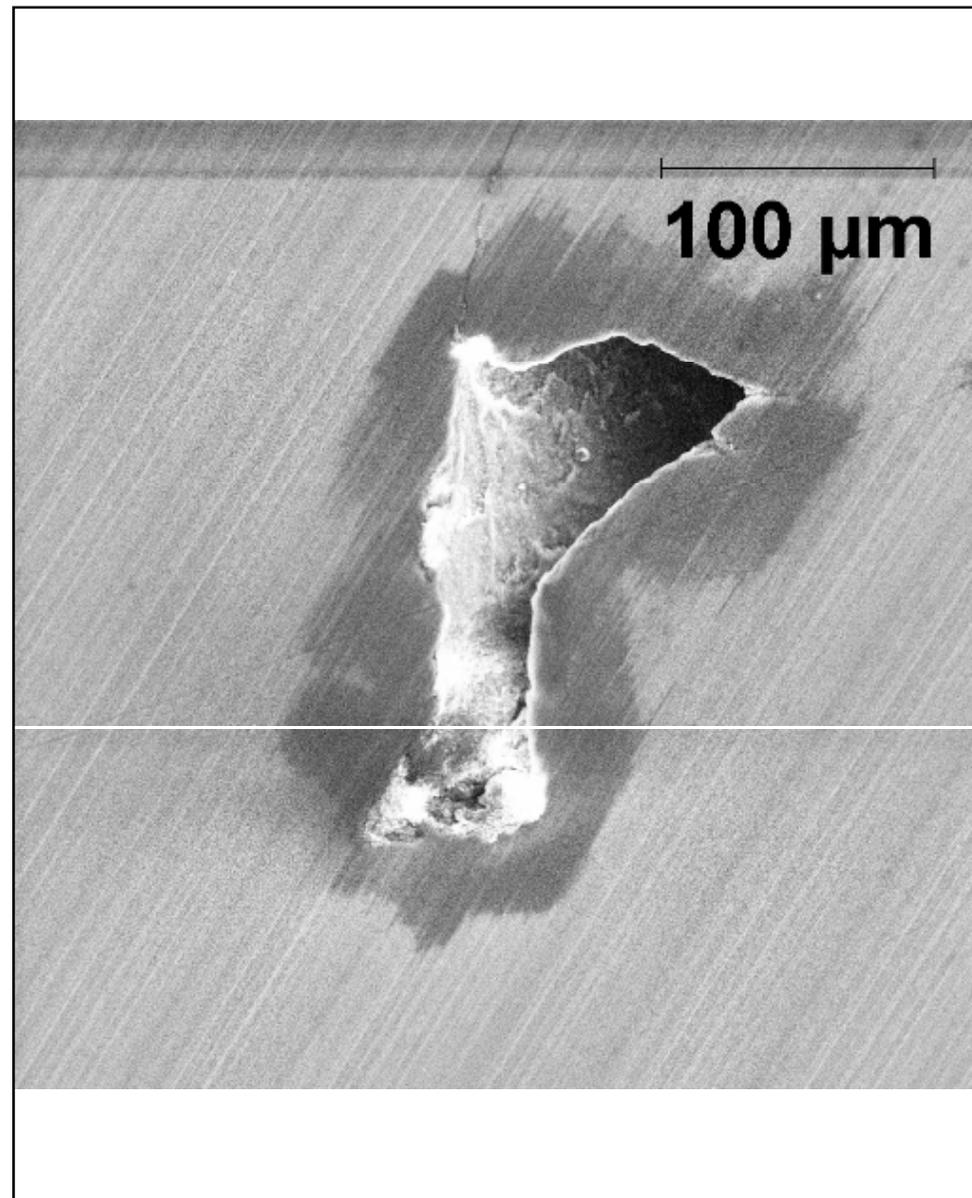
- 1) The Mg plugs are apparently made by powder metallurgy, with cavities strewn throughout their bulk. Almost always, a few of these are exposed by the machining;

Figure 4: Orion cathode, as-machined. This cavity was revealed on the Mg surface, well away from the weld boundary. The cause of the darkening is possibly due to wicking out of alcohol and contaminants from the cavity interior onto the surrounding surface during drying, giving a low secondary electron yield at the rim

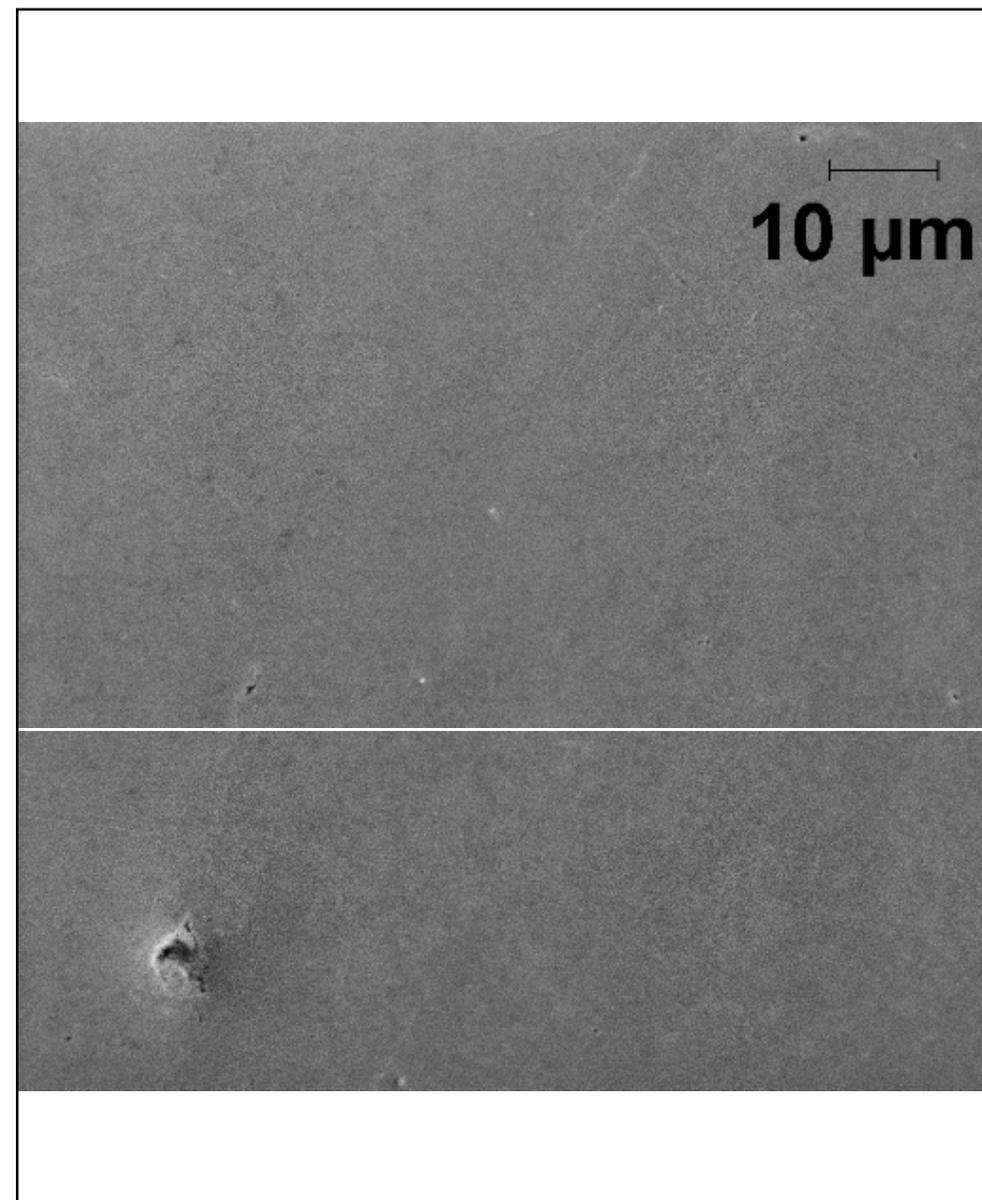
Figure 5: Orion cathode of Figures 1-4, after polishing with one micron MgO and DI water. Surface finish on Cu.

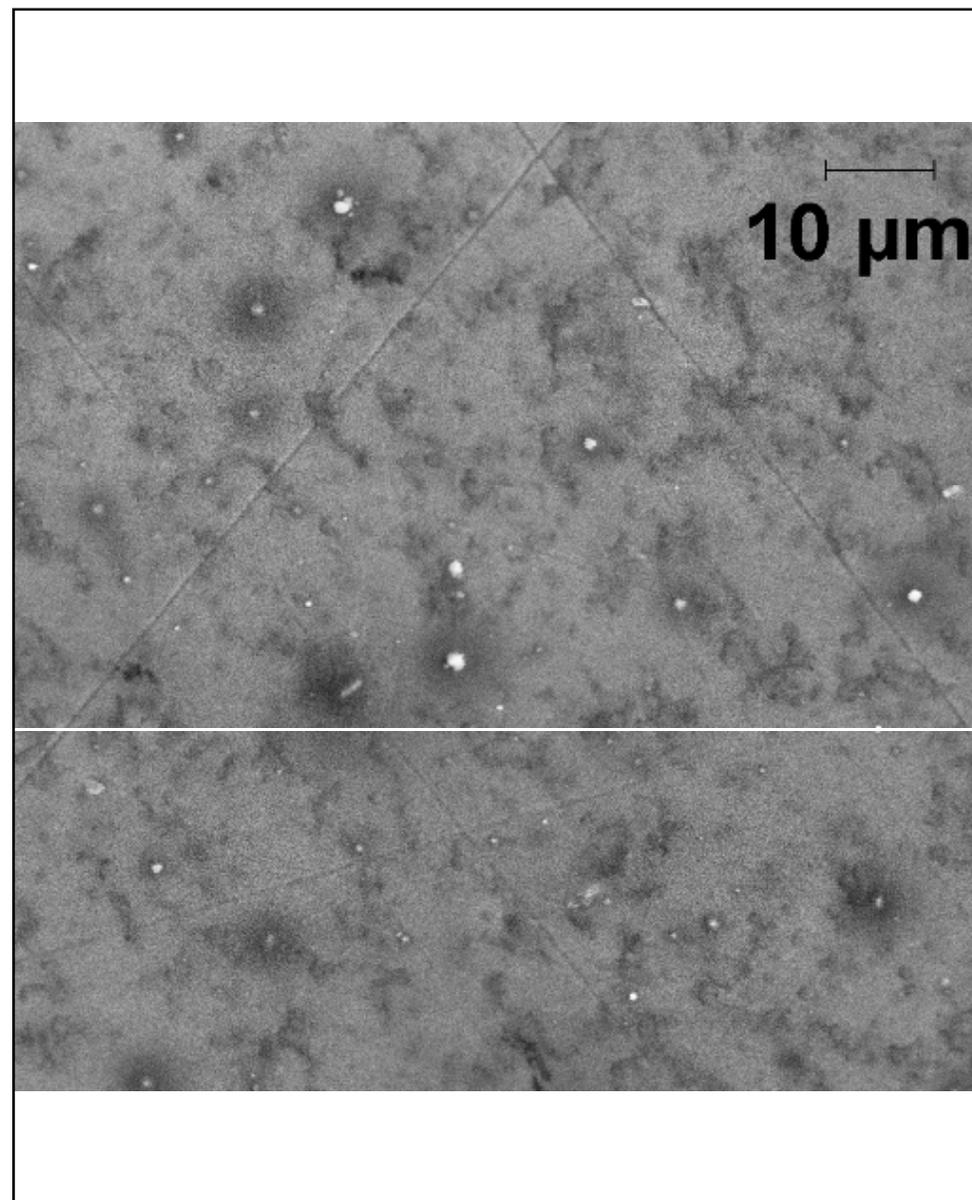
Figure 6: Orion cathode of Figures 1-4, after polishing with one micron MgO and DI water. Surface finish on Mg. White particles are MgO.

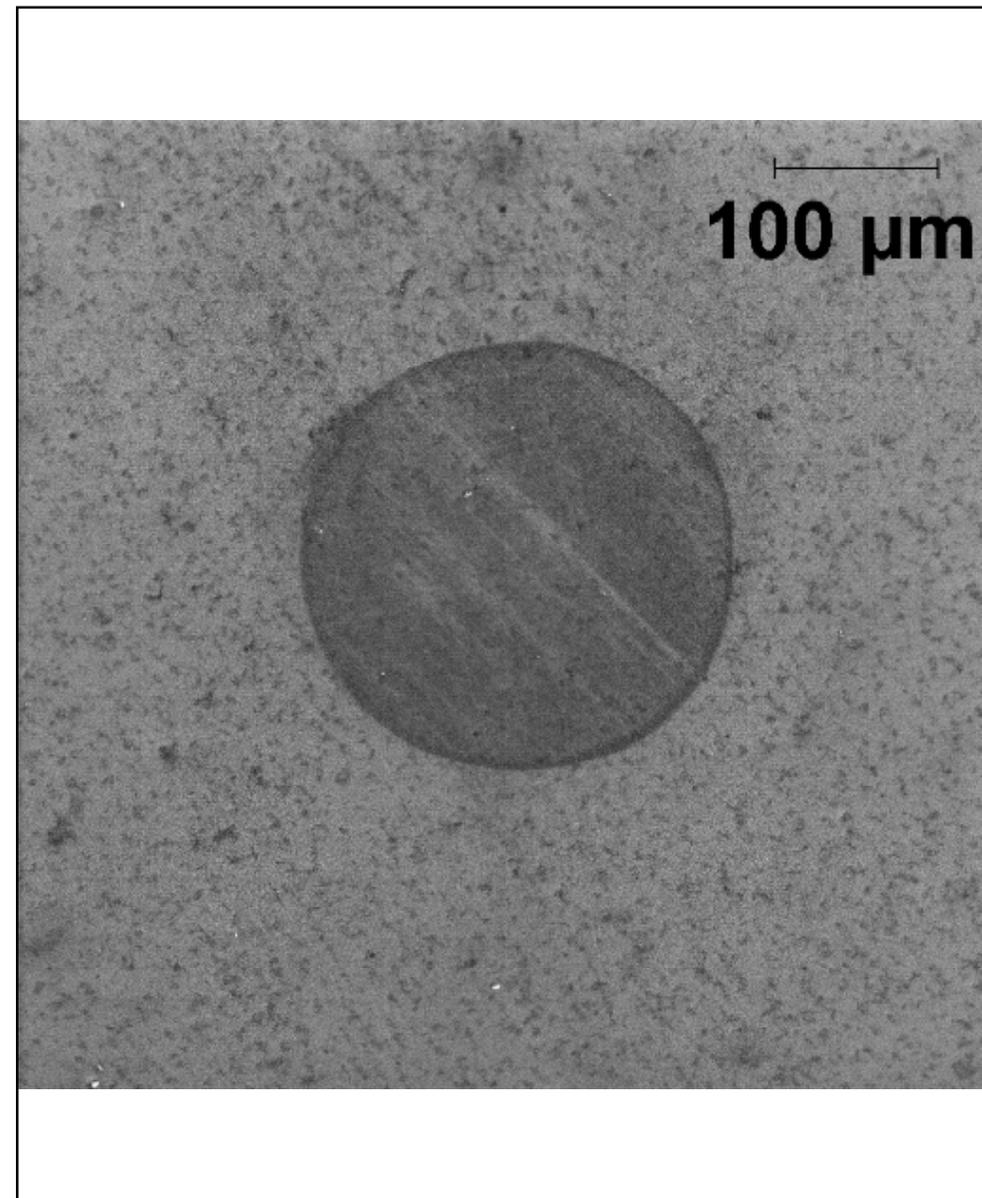
Figure 7: Orion cathode of Figures 1-4, after polishing with one micron MgO and DI water. Shown are the remains of the center machining "tit".

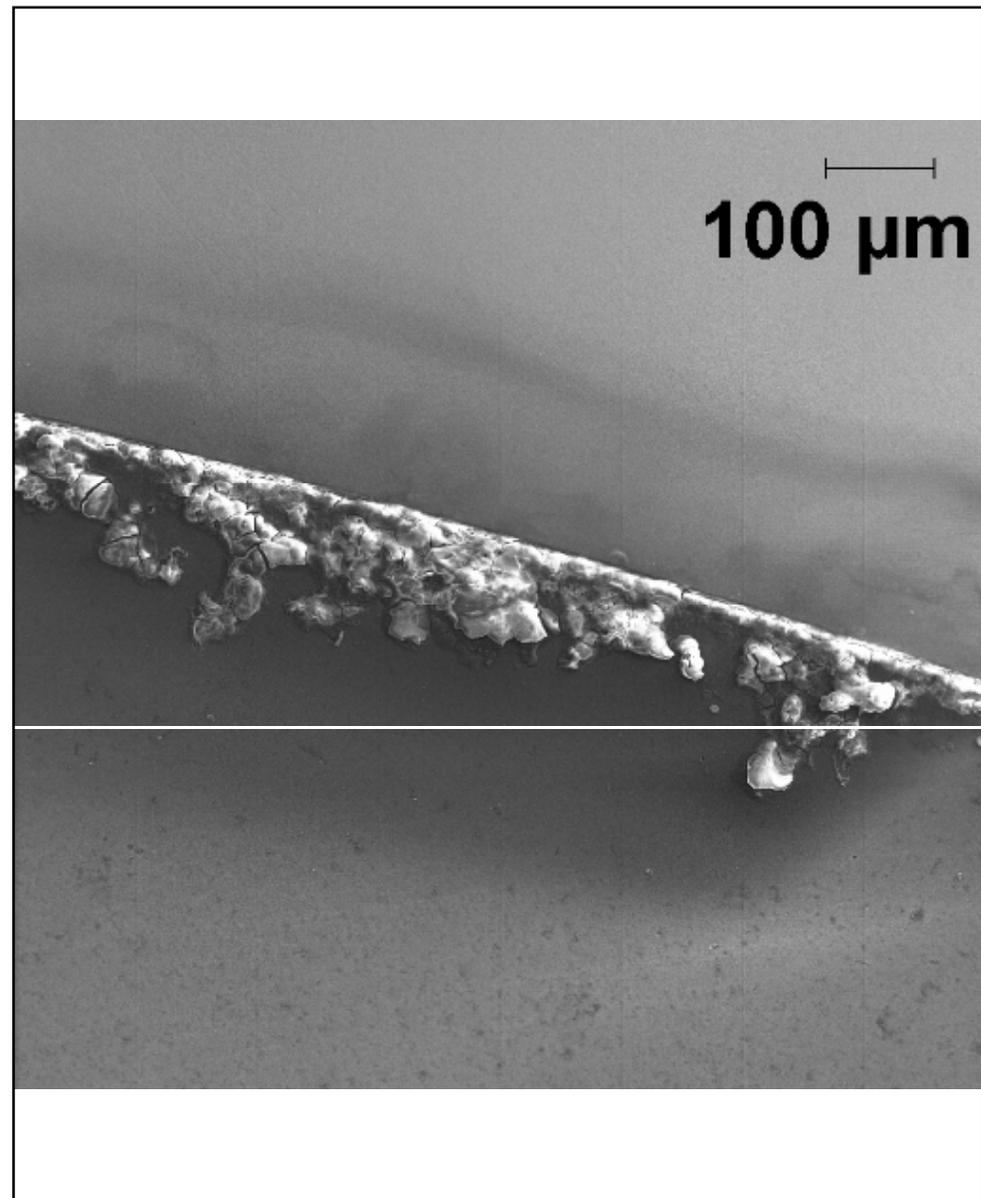
Figure 8: Orion cathode of Figures 1-4, after polishing with one micron MgO and DI water. Polishing debris accumulates at the inside corner of the Mg/Cu weld boundary (Mg plug is lower half of the image).

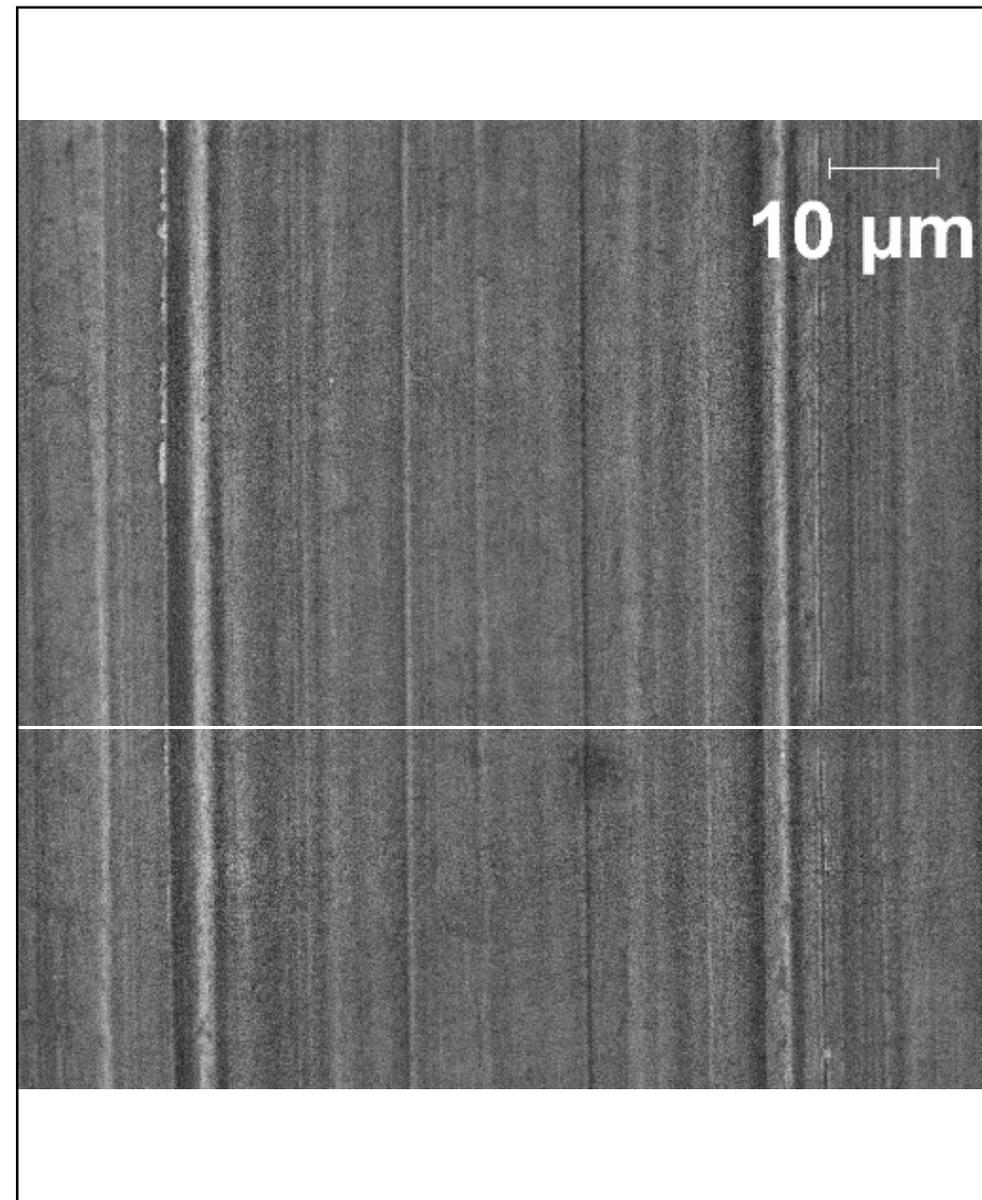
- 4) The surface finish produced by the machining depends on cutting tool quality, feedrates, workpiece resonances, and lathe-gearing clearance asymmetries.

Figure 9: GTF cathode center, after first re-machining off-axis. Shown are prominent tool/lathe cutting marks (two vertical ridges).

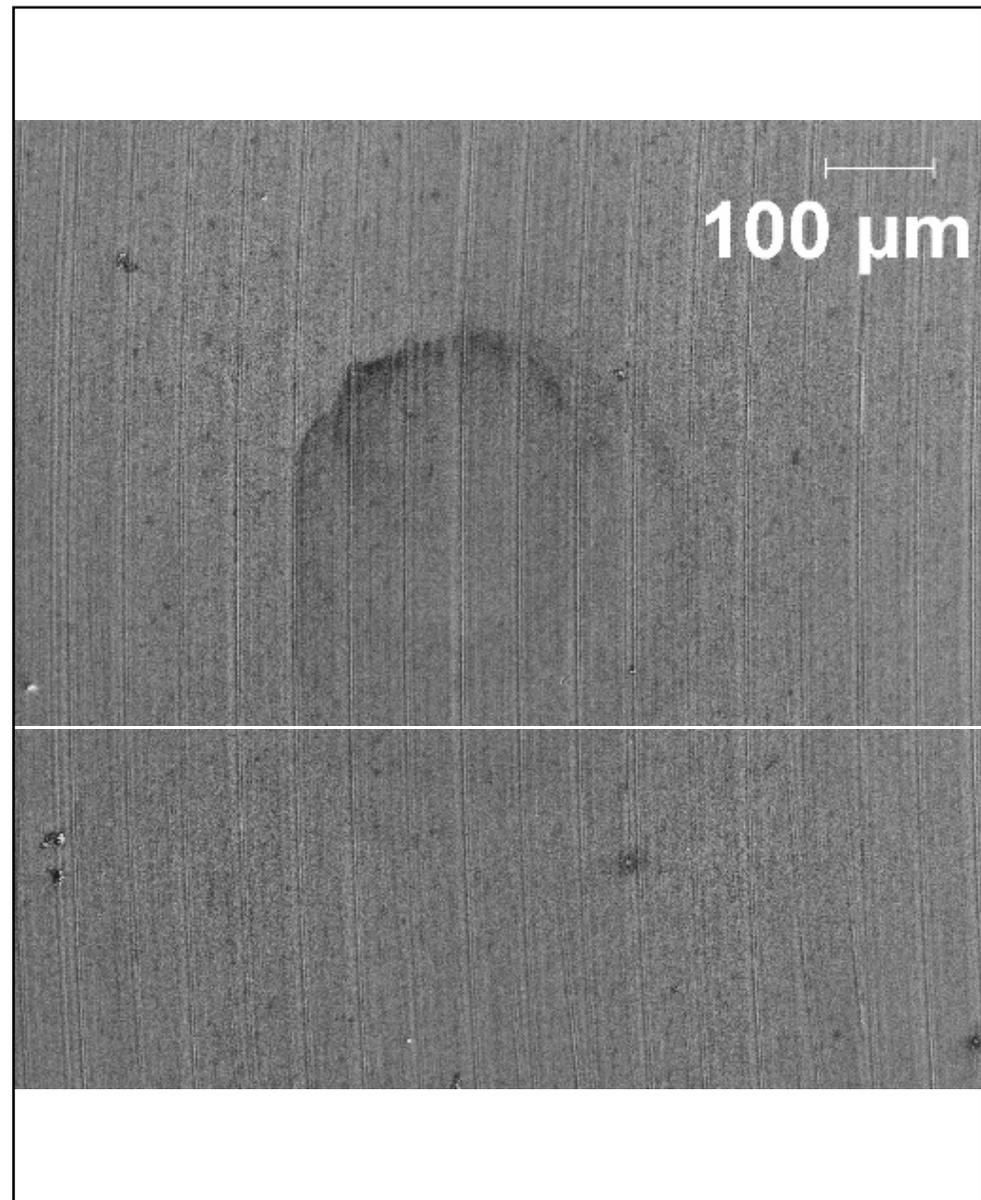
Figure 10: GTF cathode center, after first re-machining off-axis. The "stain" is the remains of the original on-axis machining tit.

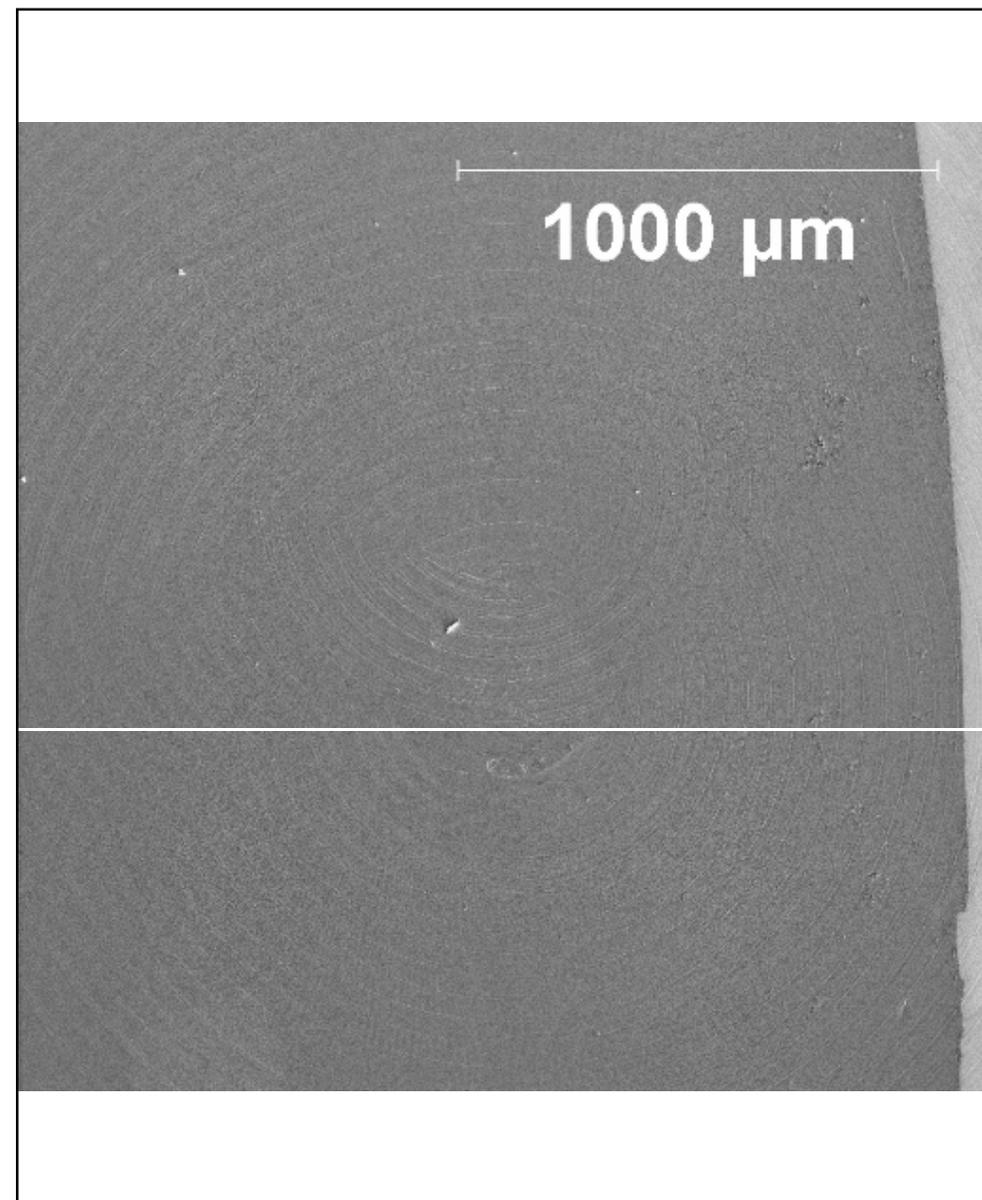
Figure 11: GTF cathode, after first re-machining off-axis. Shown are the off-axis machining "centers".

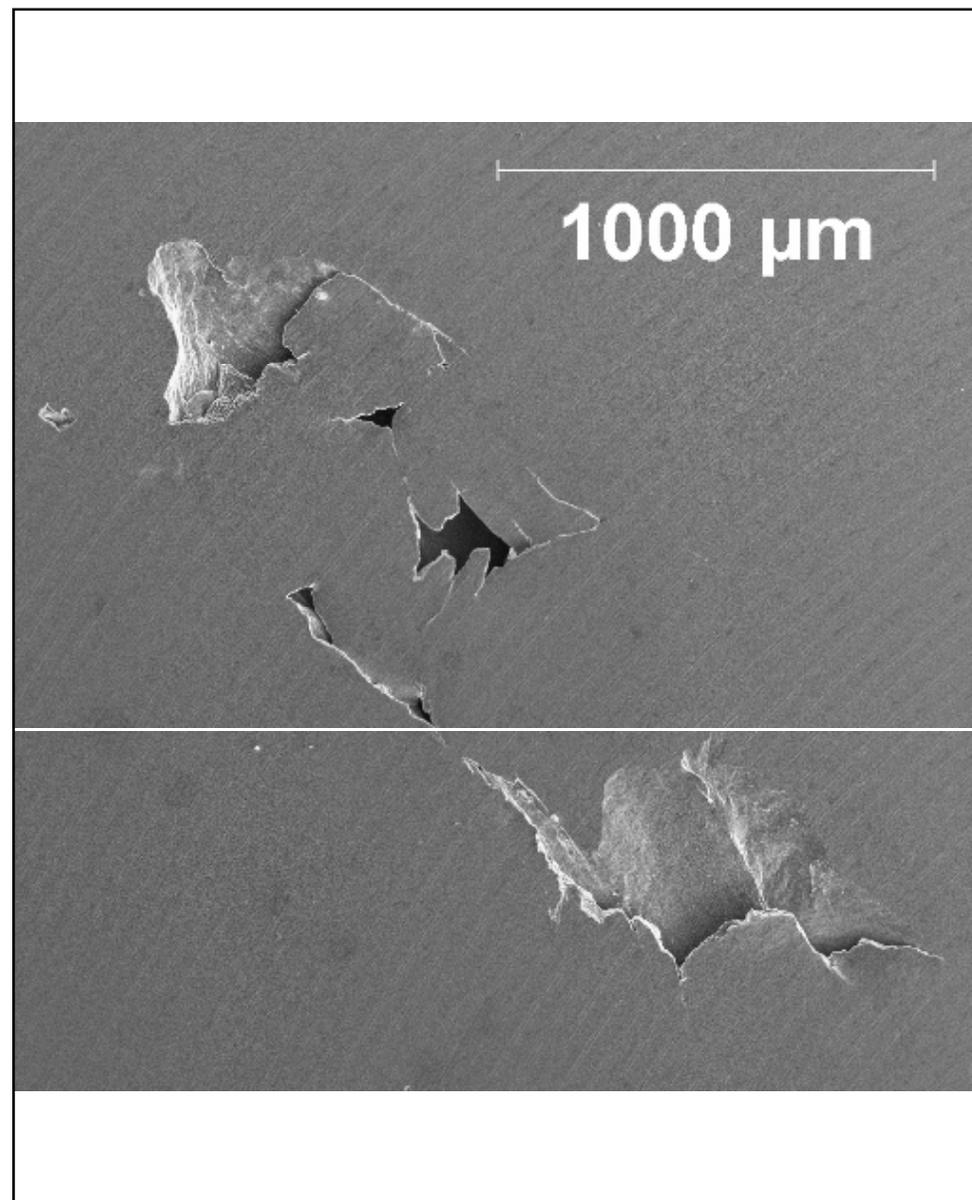
Figure 12: GTF cathode, after first re-machining off-axis. Large cavity on the Mg plug.

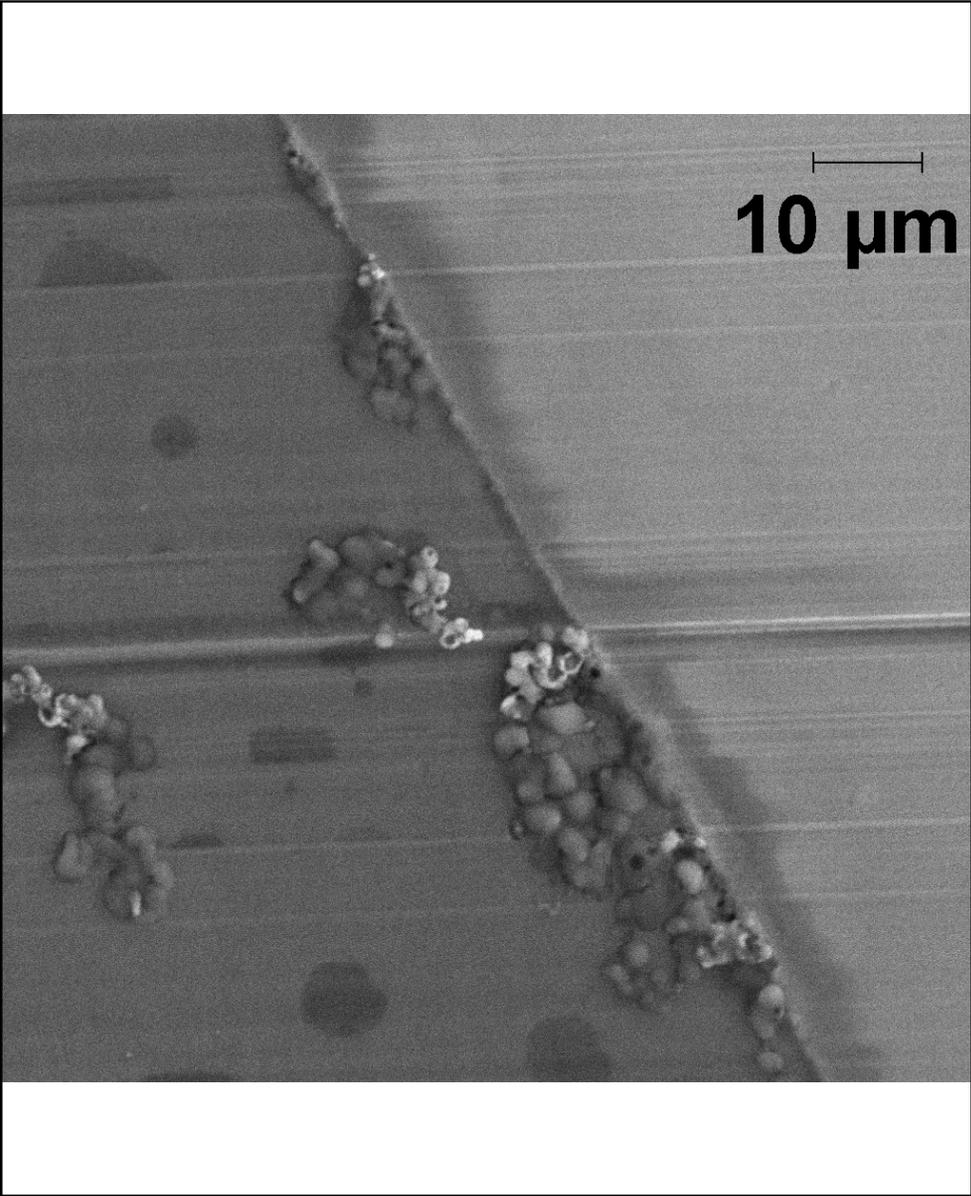
Figure 13: GTF cathode, after first re-machining off-axis. Mg (left)/ Cu (right) boundary, showing accumulation of machining debris at boundary. The surface was allowed to dry prior to final cleaning and this debris (Mg) was not removed in final cleaning, even with low-power ultra-sonic agitation.

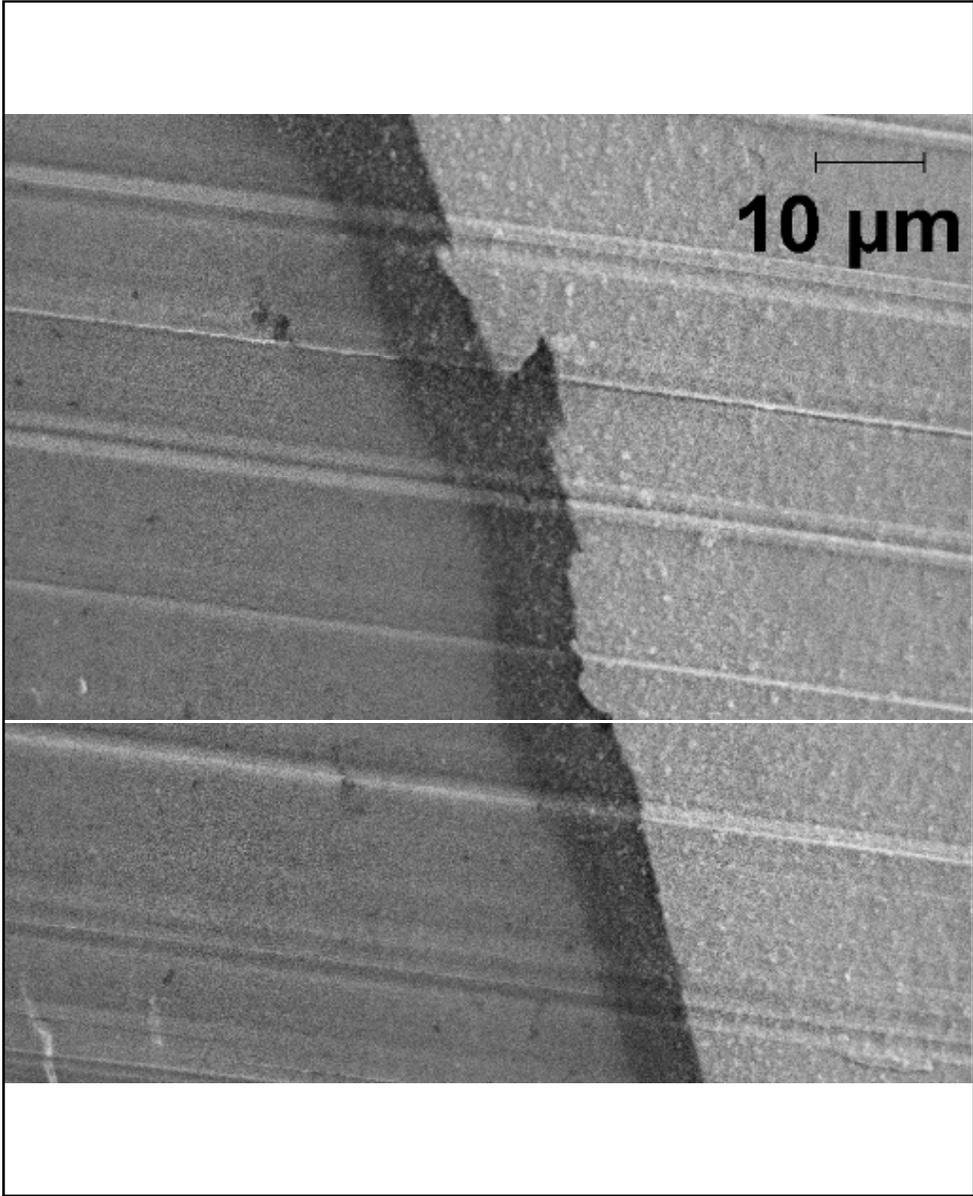
- 3) The Mg surface, after machining, is several microns below that of the Cu surface. The cutting tool pressure will be different on the two metals, according to C. Pearson. He thinks the Cu, which is softer (more elastic) actually rebounds after tool passage. The practical result is that there is a rather abrupt inside corner on the Mg, which traps cutting and polishing debris. It is important therefore to not let the surface dry of ethanol at any stage, so that debris is "glued" down by drying.

Figure 14: GTF cathode, after second re-machining off-axis. Mg (left)/ Cu (right) boundary shows a vertical displacement of several microns, present on all Mg/Cu plates, and possibly due to elastic rebound of Cu after tool passage.

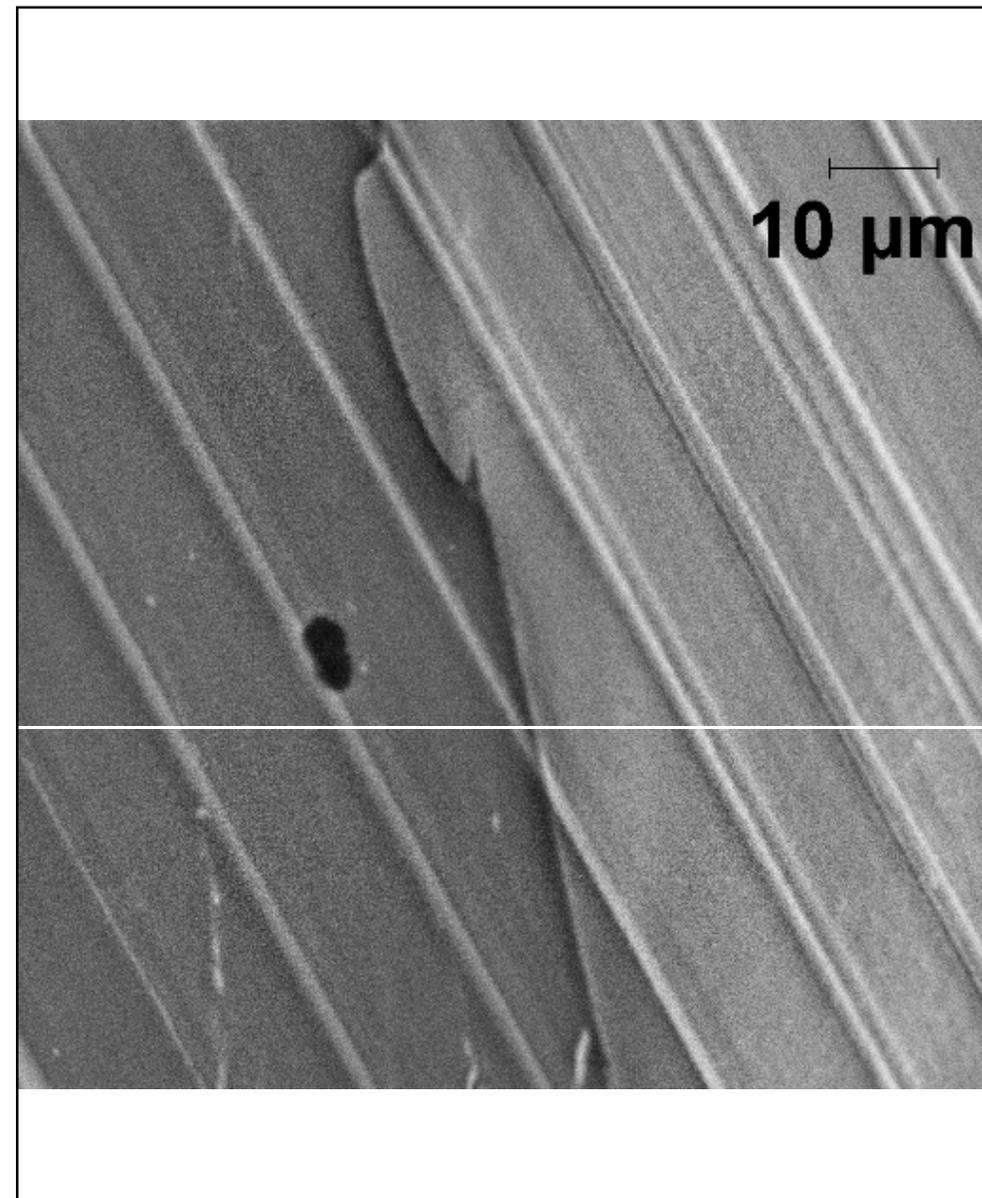
Figure 15: GTF cathode , after second re-machining off-axis. Change of cutting angle to weld boundary appears to affect the vertical offset.

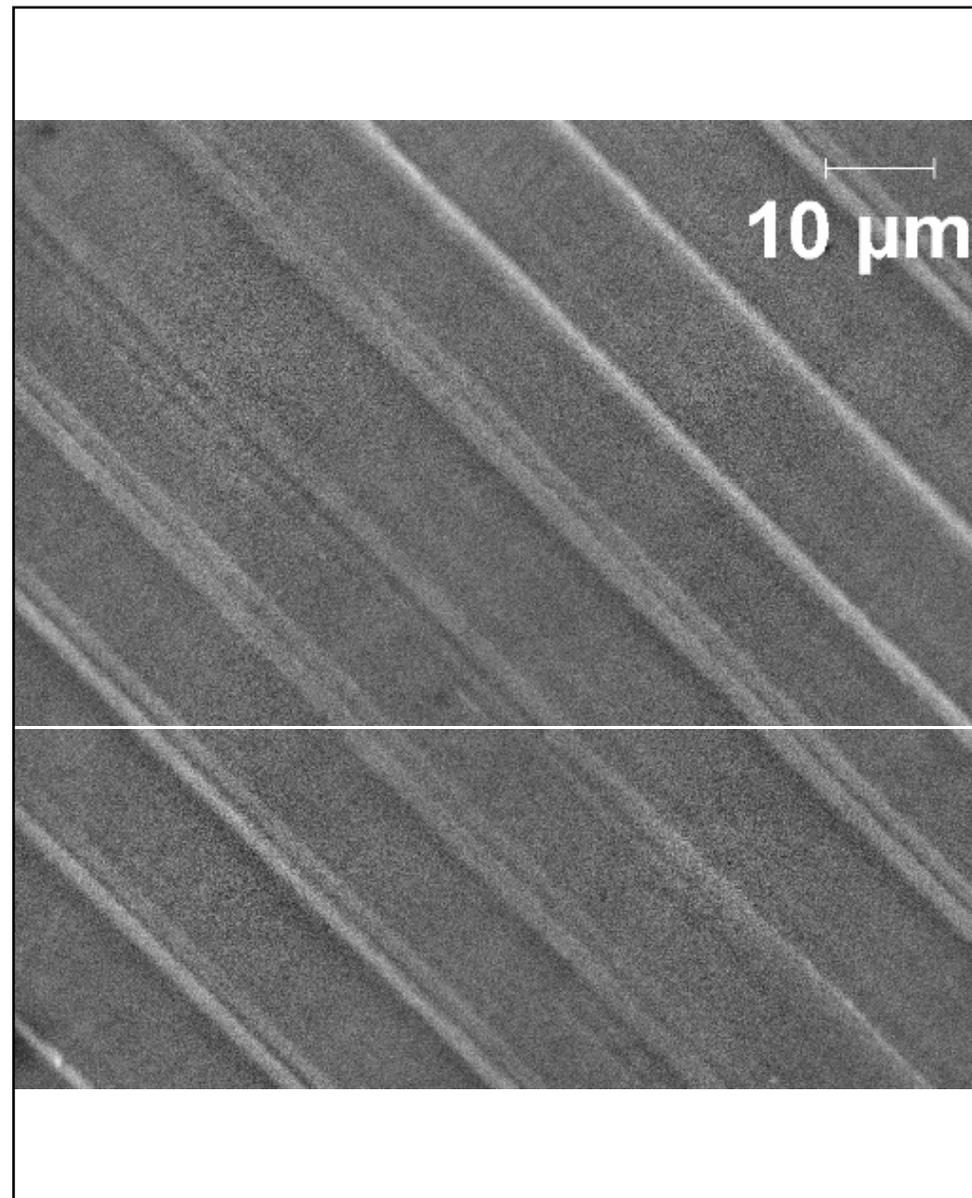
Figure 16: GTF cathode center, after second re-machining off-axis. Machining ridges are now more uniform. The surface was kept flooded with ethanol during and after machining, then rinsed with filtered ethanol and blown dry with filtered dry nitrogen, just prior to insertion into the SEM.

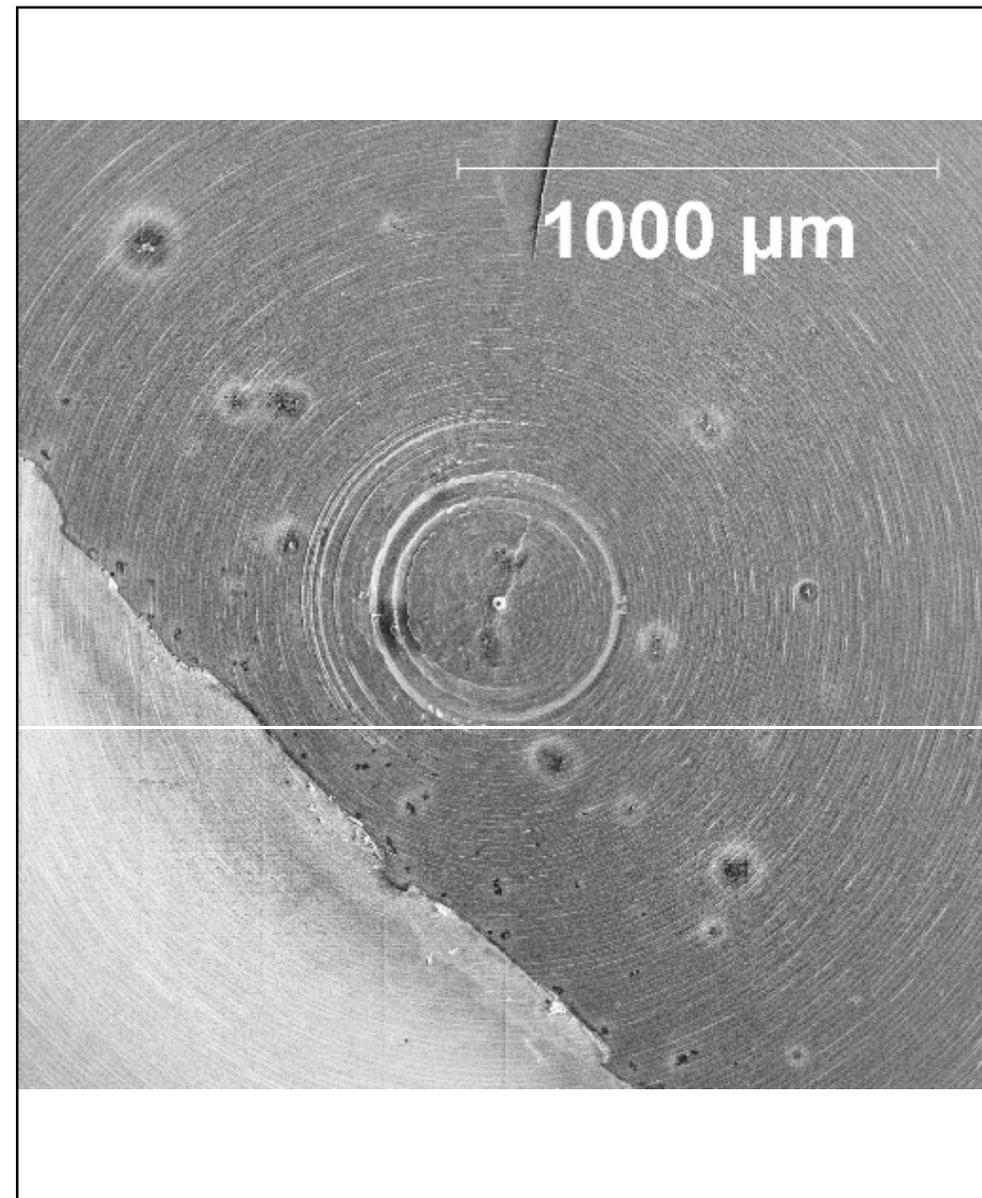
Figure 17: GTF cathode, after second re-machining off-axis. Imaged is the off-axis machining center, on the Mg, near the Cu boundary.

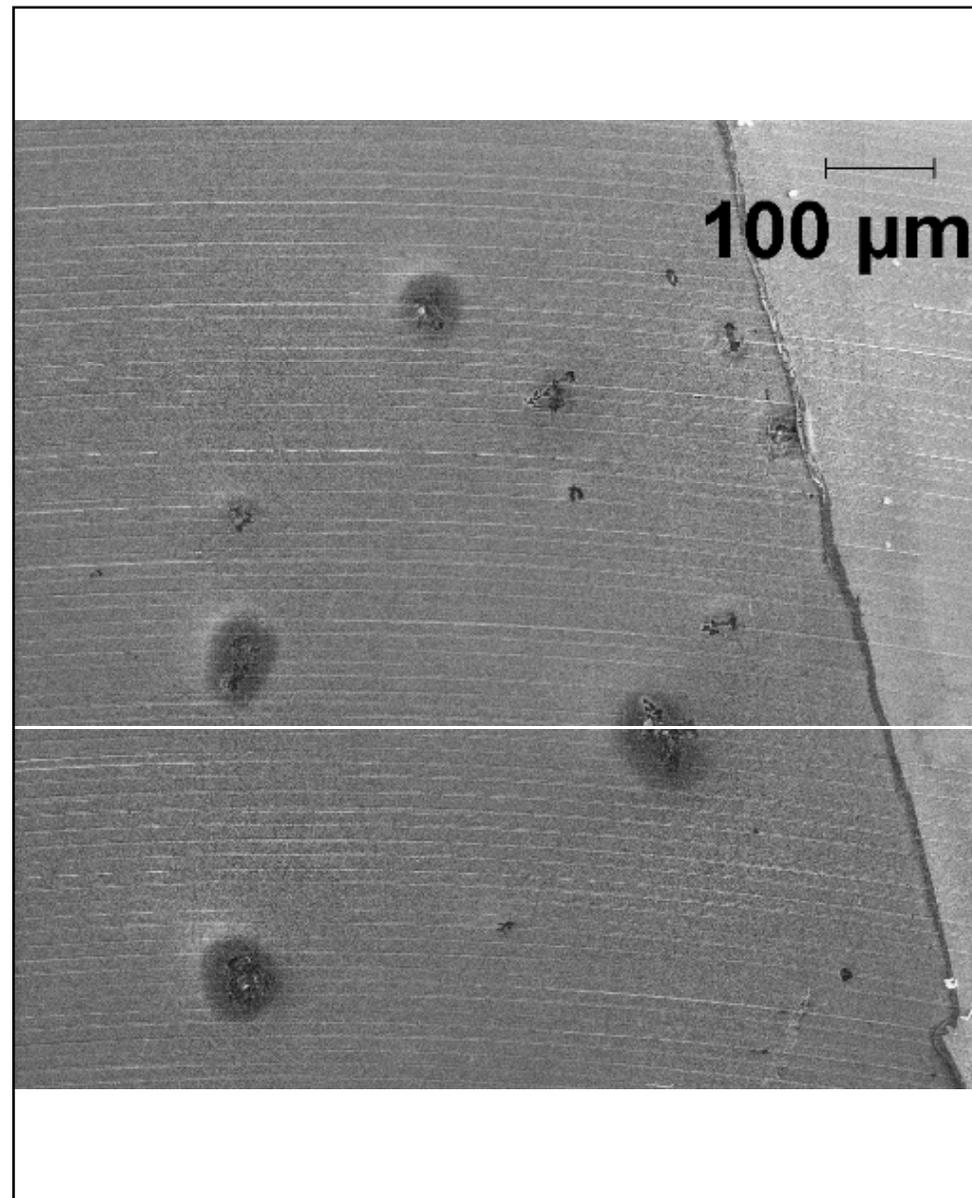
Figure 18: GTF cathode, after second re-machining off-axis. A few of these small voids were found on the Mg, near the Cu boundary. They are at or below surface level and appear to be stress-relief features.
