ANOMALOUS HIGH RADIATION BEAM ABORTS IN THE PEP-II B-FACTORY*

Abstract

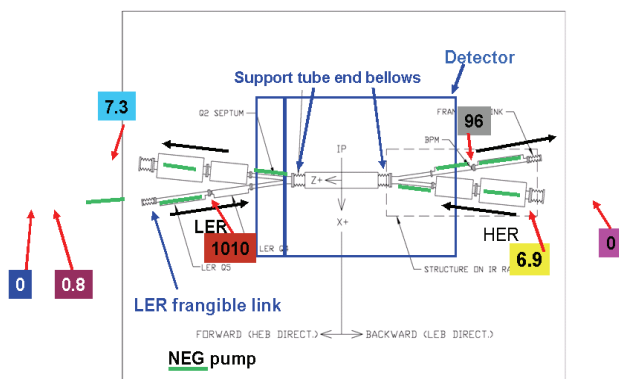
Figure 1. Layout of the Interaction Region. The numbers are typical peak pressure readings in nTorr for one of these fast pressure spike events. The green bars indicate the location of NEG pumps in this area. The layout is pictorial. The total z length of this region is about ± 10 m.

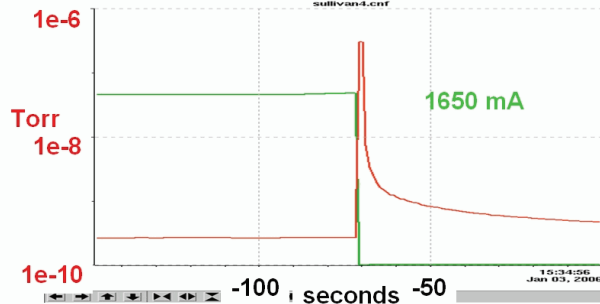
Figure 2. Time plot of a fast pressure spike and radiation abort event. The green curve is the LER beam current. The current was about 1.6 A when the spike occurred. No activity is seen before the spike. The red curve is the pressure seen from the vacuum gauge with the highest signal--about 5 m from the IP in the upstream LER beam pipe. The peak pressure for this event was about 300 nTorr. The pressure at this gauge returned to below 1 nTorr in less than 20 sec.

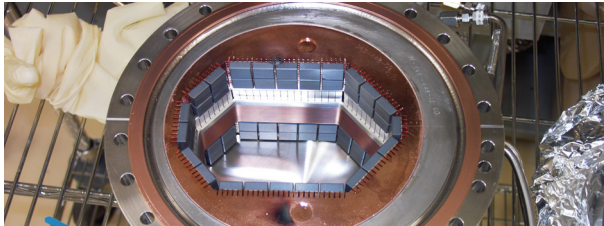
The pictures tell the story. Fig. 3 is a picture of the bellows section. A close look shows a small discoloration on the edge of the top row of tiles. Fig. 4 is a close-up of the damaged tile. The breakdown appears to start at the corner of the tile and then travel along the surface of the tile to the copper underneath the tile. Fig 5 is the RF seal that was next to the tile and figure 6 shows the new RF seal.

Figure 3. The entire bellows section. The LER beam is on the left side and the HER beam is on the right side. The damaged tile is a little closer to the LER than to the HER.

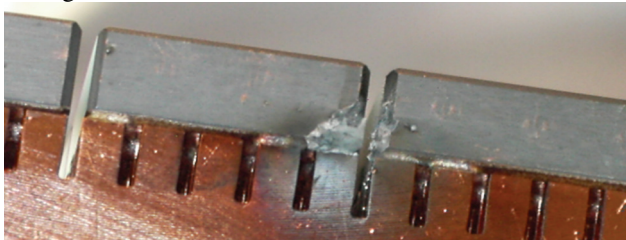
At about this time it became clear that there was a design flaw in how the RF seal works near the HOM tiles. The seal is supposed to electrically connect two vacuum pieces at flange joints so that the image current can easily flow along the inside surface of the chamber. The RF seals for the bellows section, however, were touching the HOM tiles instead of metal. The HOM tiles are essentially insulators, consisting of 60-40 composites of AlN and SiC. A damaged tile might be able to emit nitrogen gas. After designing and building a new set of RF seals we were ready to remove the bellows section.

Figure 4. A close-up of the damaged tile.

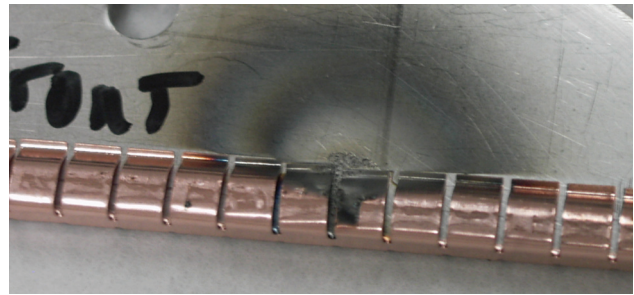
Figure 5. The RF seal that mated with the damaged tile. All of the discoloration was hidden behind the RF seal. We do not completely understand why the breakdown occurred at this location. There is a small dark spot on the third RF finger to the left of the discoloration that matches a small pit on the tile in Figure 4.

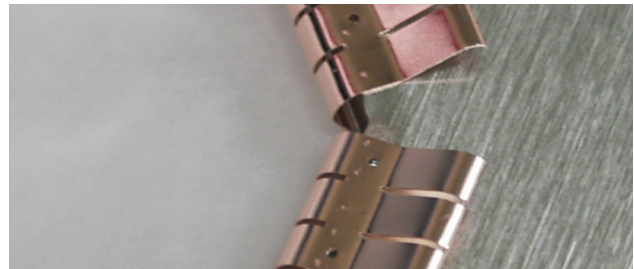
Figure 6. Picture of the replacement seal. Note how the contact point is much lower and will engage the copper underneath the tiles.
