SLAC-PUB-12050
August 2006

RF Breakdown Studies in Tungsten and Copper Structures

Presented at the 12th Advanced Accelerator Concepts Workshop
Lake Geneva, Wisconsin
July 10-15, 2006

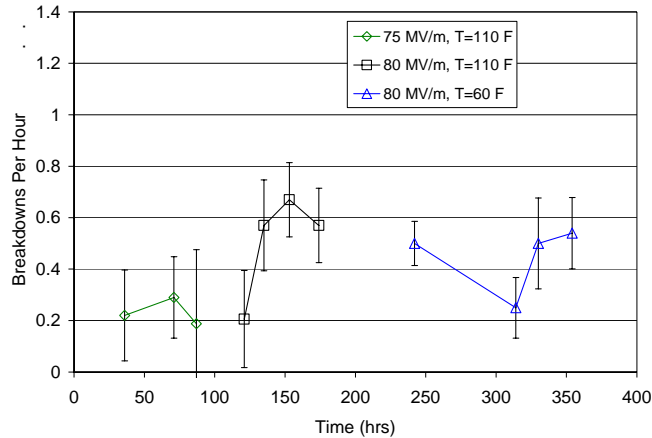
60 hours of operation. The water temperature was then reduced to 60°F, which is the lower limit of the available cooling equipment. The structure temperature is about 10 degrees higher than the water temperature in both cases. To maintain the same phase advance per cell, the drive frequency was offset by 5.4 MHz. The structure ran at 80 MV/m for almost 200 hours (triangle markers) resulting in a breakdown rate close to that during operation at 110°F.

FIGURE 1. Breakdown rate over time at different gradients and water cooling temperatures.

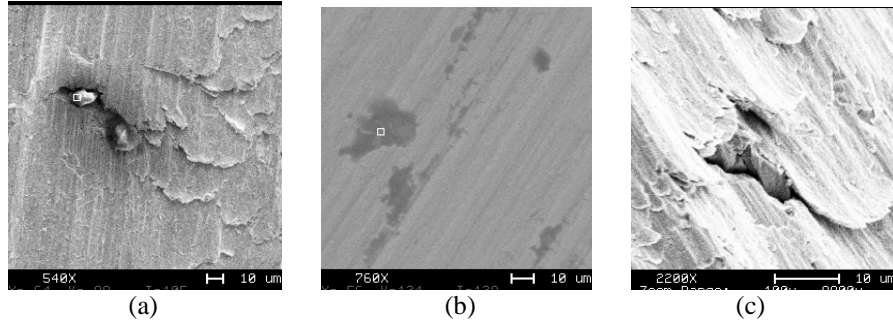
SEM analysis was conducted on a sample tungsten iris insert which was subjected to the same fabrication process as the inserts inside the accelerator. The sample insert has never been rf processed. Four main features were observed on the sample (Fig. 3) and are common problems when working with tungsten. Embedded carbon particles (Fig. 3a) and dark patchy areas (Fig. 3b) of carbon (having the appearance of liquid droplets) were frequently observed. The source of carbon in the dark patchy areas remains unknown; however, the embedded carbon particles probably come from the cutting tool during machining. It is also common to find tearing, fractures (Fig. 3c), and sharp edges on machined tungsten surfaces.

FIGURE 3. SEM photos of a tungsten iris insert sample not exposed to rf. Numerous (a) embedded carbon particles, (b) dark patchy areas of carbon, surface tears and (c) fractures were observed.

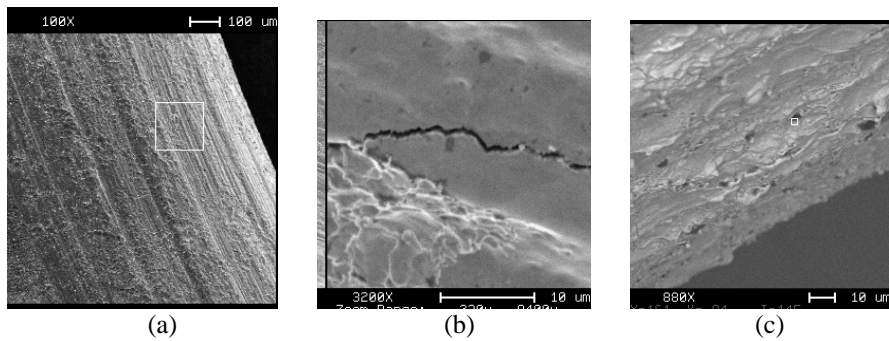
After rf testing, the accelerator was unclamped and three of the tungsten iris inserts were removed, photographed, and SEM analyzed. SEM images of Iris 1, Iris 2, and Iris 15 are shown in Fig. 4 and Fig. 5. Iris 2 sustained substantially more breakdown damage (Fig. 5a,b) than the other two irises as would be expected. Iris 1 (Fig. 4) is the input coupler iris and has a larger iris diameter and consequently a lower surface field gradient. Iris 15, which is located near the center of the structure, shows breakdown damage similar to that on the input coupler iris. The accelerator is a constant impedance structure so the field gradient decreases as power flows down the structure. At high magnification, the areas that appear untouched by breakdown on both Iris 1 and 15 do not have the same surface texture as observed on the tungsten sample. Although machining lines remain evident, surface heating and melting has occurred at

these locations and the sharp edges seen on the sample (Fig. 3) are not apparent on the irises that have been rf processed. Surface fractures and carbon spots were observed on all three of the irises that were inspected. It is especially interesting to see carbon spots clearly visible on top of many layers of breakdown as shown in Fig. 4c. The source of carbon is currently being investigated as part of a tungsten material study that is discussed in the following section. The SEM image of Iris 15 (Fig. 5c) shows a damaged area that probably occurred from the cutting tool during machining.

FIGURE 4. SEM images of Iris 1 at (a) 100x magnifications and at higher magnifications (b and c).

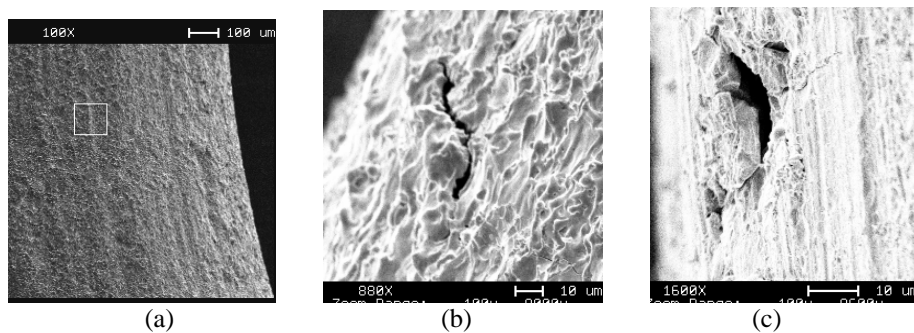
FIGURE 5. SEM images of Iris 2 (a, b) and Iris 15 (c).

Surface tearing is not uncommon when working with brittle materials such as tungsten. The fractures and tears may be responsible for trapping gas and would explain why the structure was gassy and required reprocessing after brief shutdowns. Since the structure was clamped together instead of brazed, it is possible that this might also be responsible for some of the gas problems; however, this would not

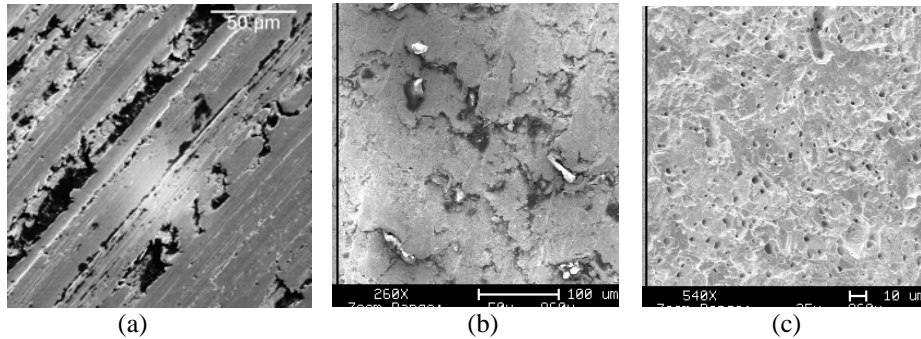
In an effort to improve the surface finish, a variety of machining, etching, and polishing techniques were explored using tungsten rods. During the machining phase, different cutting speeds, feed rates, cutting tools and cutting fluids were used. Initial attempts at machining showed that the cutting tool had a tendency to tear the surface (Fig. 7a). All of the cutting tools used at SLAC left tungsten and/or carbon particles embedded in the surface (Fig. 7b). To remove the embedded debris picked up during machining, electropolishing was used, however, this resulted in numerous etch pits on the surface (Fig. 7c).

FIGURE 7. Typical features observed after machining tungsten were (a) surface tearing and (b) and embedded particles. After electropolishing for 2-minutes, etch pits (c) were observed over the entire surface.

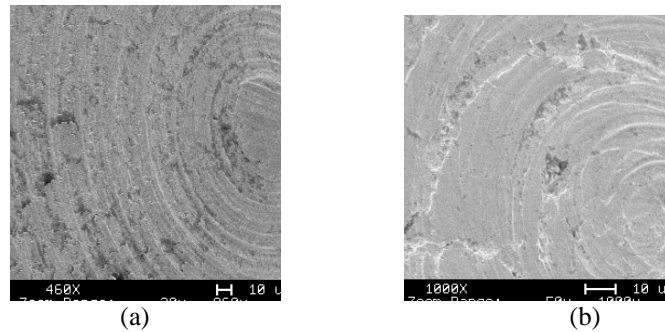
is shown in Fig. 8b. On the polished sample there were large gashes on the surface containing a significant amount of aluminum. The aluminum presumably came from the polishing agent that was used. On the sample that was not polished (Fig. 8a), carbon, fractures, and tears were observed on the surface similar to the accelerator inserts discussed above. The sample that was not polished was later hand polished at SLAC to a mirror finish using a diamond polishing paste (Fig. 9a). SEM analysis after hand polishing revealed a surprisingly smooth surface (Fig. 9b). High magnifications were required to locate surface features necessary for focusing. There were no fractures or tears observed on the surface; however, at very high magnification, dark patchy areas of carbon were detected. An example of one of these areas is shown in Fig. 9c, which was taken after electropolishing the part for 5 seconds.

FIGURE 8. A tungsten sample machined (a) and polished (b) by an outside company.

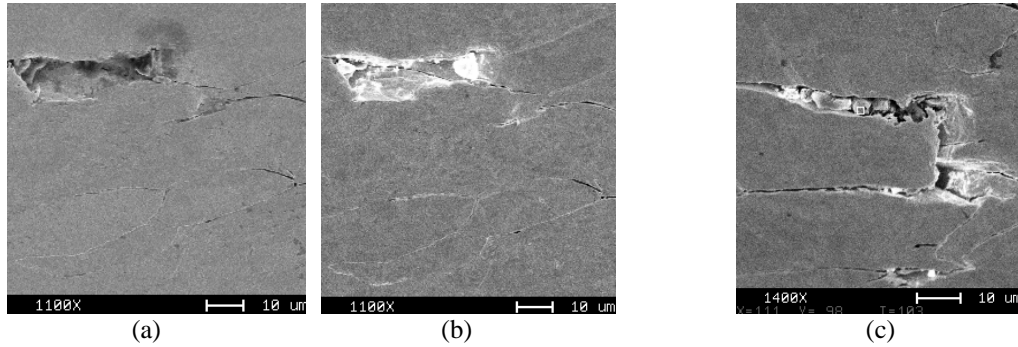
FIGURE 10. SEM images of a tungsten surface before (a) and after (b, c) wet hydrogen firing at 1000°C for 2 hours.

In an effort to identify the source of carbon, a tungsten rod was forcibly cracked apart, avoiding contamination from cutting tools. SEM and chemical analysis revealed no signs of carbon located in the bulk of the tungsten rod. Wet hydrogen firing was used on several tungsten rods in hopes of removing the carbon from the surface. An SEM image taken prior to hydrogen firing is shown in Fig. 10a. The same location was imaged again after hydrogen firing for two hours at 1000°C (Fig. 10b). At elevated temperatures, it appears that particle migration occurs on the surface and that the particles lodge inside cracks and fissures. In both of the images taken after hydrogen firing (Fig. 10b,c), the white areas and the embedded particles are all carbon. There were no significant changes in the size or appearance of compression boundaries or fractures after the wet hydrogen firing process.

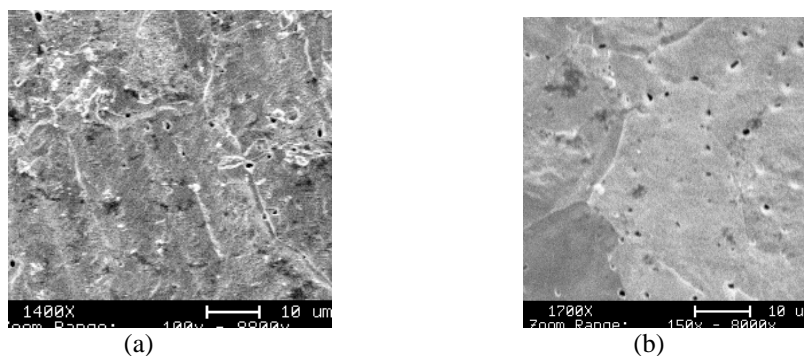
A combination of hand polishing and electropolishing has thus far provided the best tungsten surface finish. An example of two tungsten rods that were hand polished and then electropolished is shown in Fig. 11. The electropolishing was done with both a 2 V (Fig. 11a) and 4 V (Fig. 11b) source, while the remaining parameters (e.g. time and temperature) were kept the same. The tungsten rod that was electropolished at 4 V has a smoother surface compared to the electropolished sample at 2 V. However, the surface has a large number of etch pits. Further experiments are being conducted to determine the optimum parameters.

FIGURE 11. Tungsten samples electropolished using (a) 2 V and (b) 4 V.
