SLAC-PUB-1095
(ACC)
August 1972

BRAZING WITH COPPER AND COPPER-BASE ALLOYS*

G. P. Fritzke

Stanford Linear Accelerator Center
Stanford University, Stanford, California 94305

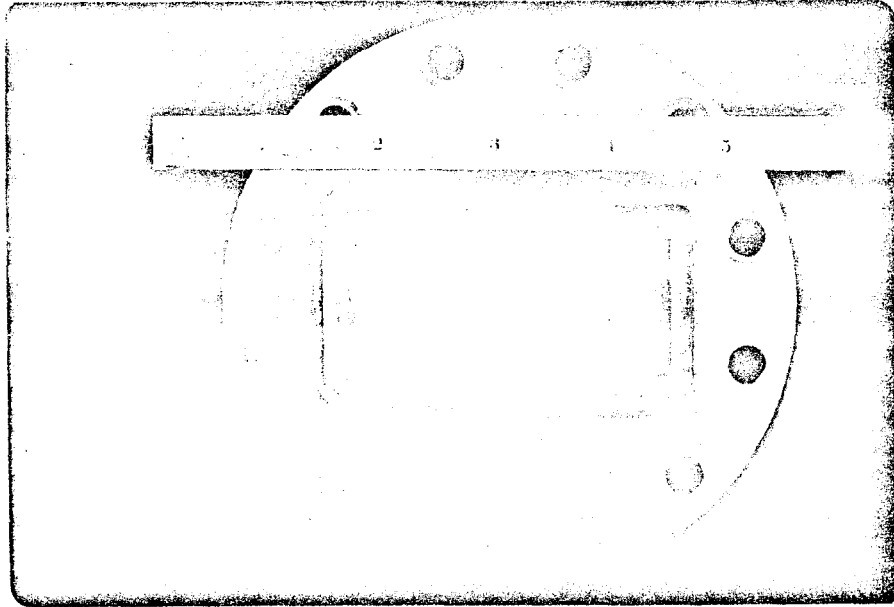
The type of "ordering" referred to does not mean a purchasing procedure with a brazing vendor. As shown in Figure 5 low-temperature reactions called "ordered" reactions may occur between copper and gold if the time and temperatures are suitable. While not common, such reactions may provide headaches to facilities where high-production operations are necessary. During cleaning of the stainless-steel flange which was mentioned in the above section, the normal operations used to prepare stainless steel for hydrogen brazing did not remove the copper-gold braze material from the flange. Figure 6 shows the rejected stainless steel flange — the rectangular cutout is surrounded by a rim of braze alloy left behind by an unsuccessful repair braze. Metallography showed the residual braze alloy to be enclosed by an envelope of 90 to 95% pure gold. Figure 7 is a metallographic cross section of some of the residual braze alloy — the light-colored zone on the surface of this section is the high-gold content envelope that would not dissolve in our normal cleaning solutions.

FIG. 6--Stainless steel flange reject -- undersolvable braze.

Other flanges, afflicted with similar "undesolvable" braze residues, were saved from the scrap bin by sanding the surface to expose the copper-rich alloy which easily dissolved during routine cleaning.

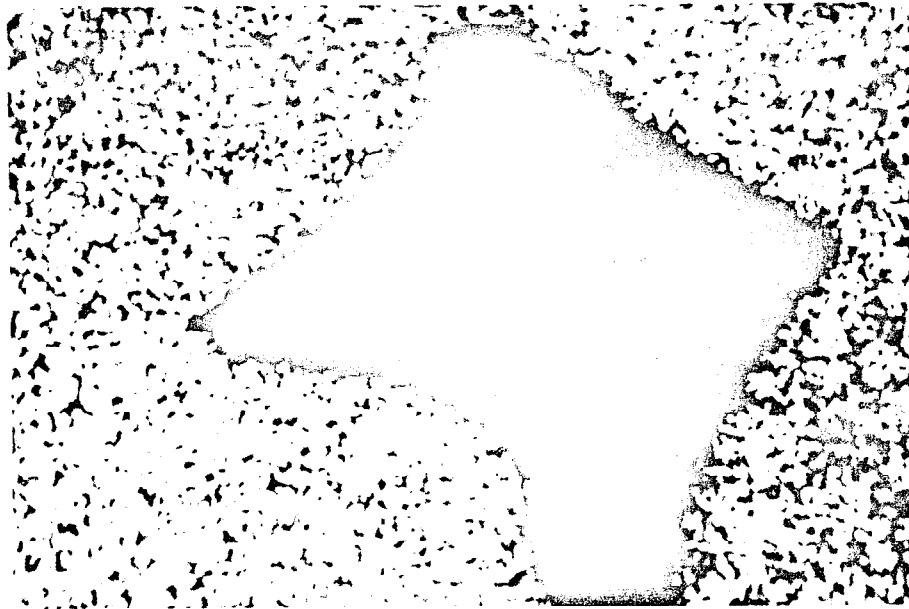
Microprobe analyses were performed to determine the ratio of gold and copper in some of the particles. For example, Figure 8 shows the etched sample and Figures 9 and 10 show the same area where microprobe scan pictures were taken which were sensitive to gold-rich (Figure 9) and copper-rich (Figure 10) areas. Thus, small islands of gold-rich particles were caused to separate from the matrix during the ordering reaction that took place during furnace cooldown.

FIG. 10--Microprobe scan showing copper-rich background.
Magnification: 750X.

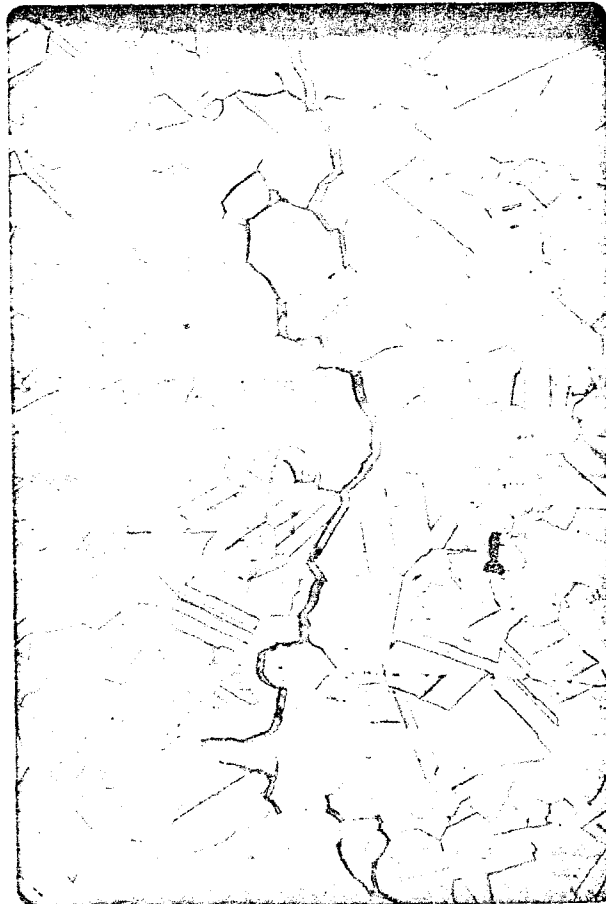
As shown in Figure 11, the short sides of the stainless steel target were set into milled slots cut into the inside surfaces of the longer top and bottom pieces. Tack welds were used to jig the plates. Copious quantities of copper powder were spread along the joint with a brazing cement. The part was inserted into an Inconel retort which was purged with nitrogen and hydrogen and lowered into a large furnace at a temperature of 1100°C. Every joint cracked, as shown in Figure 12. Metallographically, the joint area showed numerous copper-filled cracks similar to Figure 13.

FIG. 13--Stress crack in stainless steel target. Magnification: 50X.

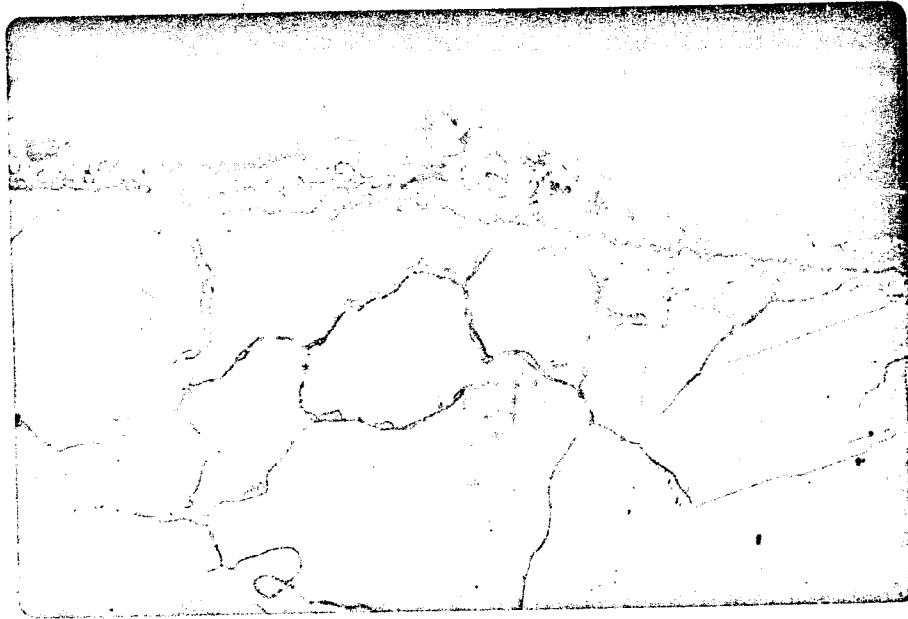
Interestingly, the etched sample revealed not only grain boundary penetration by the copper but also considerable interaction by the copper with grain-boundary materials associated with 304 stainless steel. Figure 14 illustrates this grain-boundary interaction as a broadening of the grain boundaries. Also of interest was the moderate dissociation of the stainless steel at the surface where excess amounts of copper braze alloy resided. Figure 15 shows many islands of "stainless steel" as they float away from the parent material. Additional grain-boundary interaction of copper and stainless steel may also be seen in this figure.

FIG. 14--Grain-boundary attack by copper braze. Magnification: 200X.

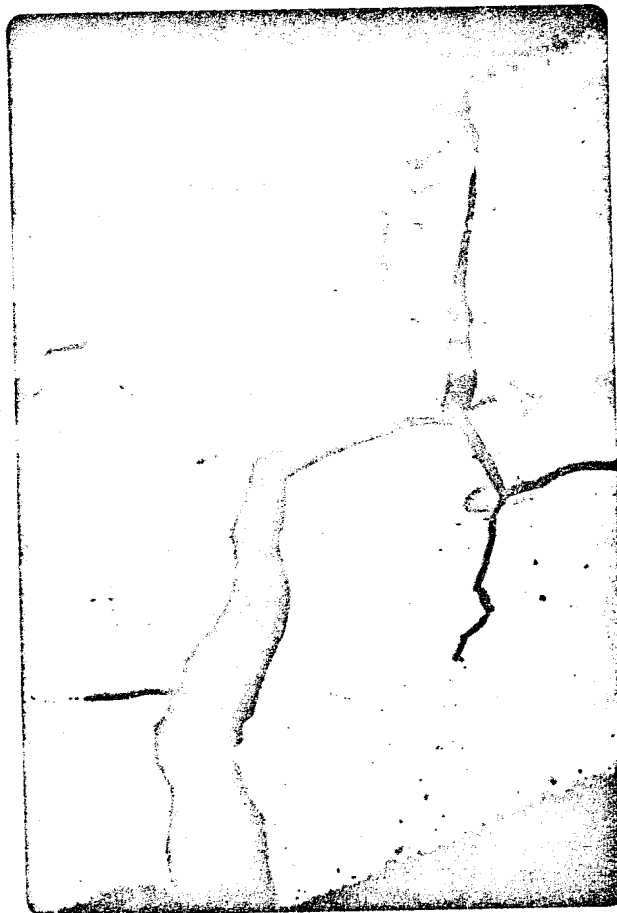
Within a week after the above hydrogen-target assembly cracks had occurred, a failure occurred in the large (2 feet in diameter by 13 foot long) Inconel retort that contained the hydrogen atmosphere used for brazing. Many brittle cracks, such as shown in a section of the retort wall (Figure 16) transected the retort near the bottom flange in several areas. Metallographically (Figure 17), the cracks again had the brittle, intergranular appearance of stress cracking.

FIG. 17--Brittle crack pattern through inconel retort shell.
Magnification: 50X.
