Surface Analysis of OFE-Copper X-Band Accelerating Structures and Possible Correlation to RF Breakdown Events

S.E. Harvey*, F. Le Pimpec, R.E. Kirby, F. Marcelja, K. Adamson, E.L. Garwin
SLAC, 2575 Sand Hill Rd, Menlo Park, CA, 94025

26th November 2003

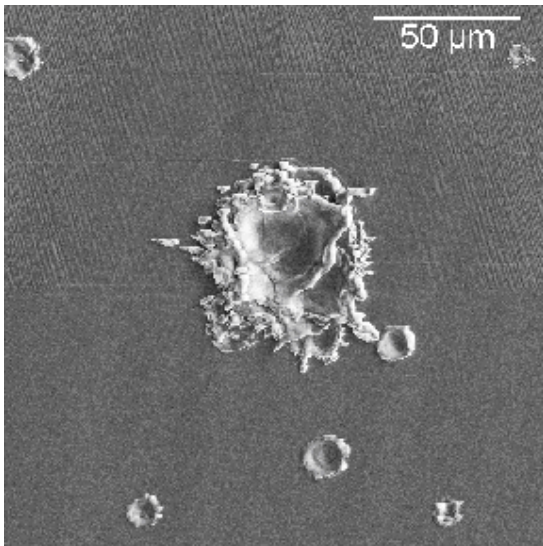
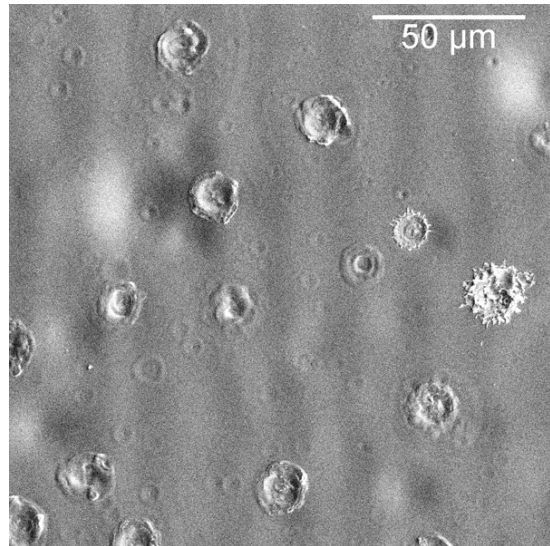
distinct groups: irregular edges and softened edges. Fig.1(a) shows a crater with irregular edges; in Fig.1(b) a second type of crater is observed where there are few sharp edges and repeated melting appears to have taken place. The softened-edge craters often appear in close proximity with one another; irregularly edged craters are frequently spaced further apart. This suggests that the softened-edged craters may have started out irregularly edged, but have changed morphology due to repeated melting or plasma-ion bombardment; even possibly by evaporated and ionized copper which has a higher sputtering yield than gases [10].

Figure 1: (a) sharp-edged craters (left); (b) smoothed-edged craters (right)

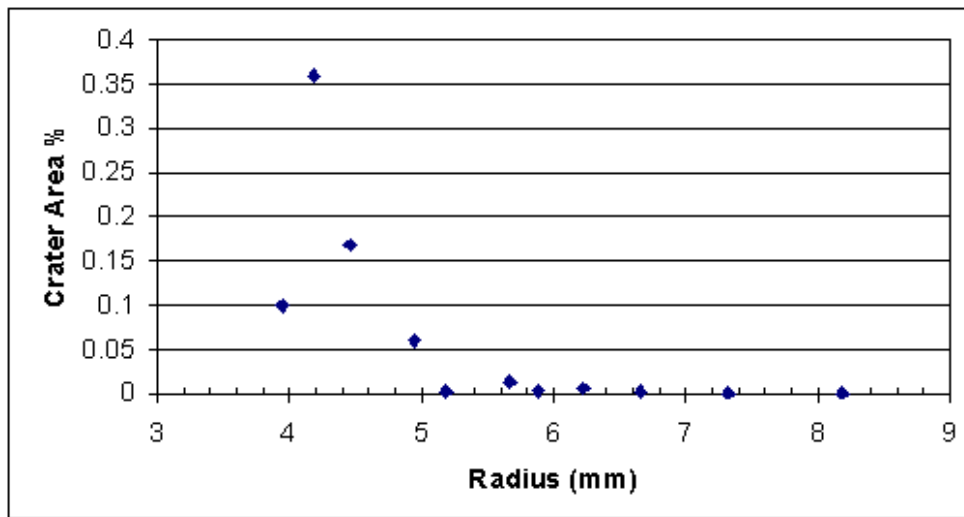
In general the density of craters increases along the cell radially toward the center, where electric fields (\mathbf{E}) are highest, Fig.2. It is important to note that not every grain near the aperture exhibited craters and that the crater density varied substantially from grain to grain.

Figure 2: Average percentage area damaged by craters versus radial distance from center of aperture (30thCell T53VG3RA)

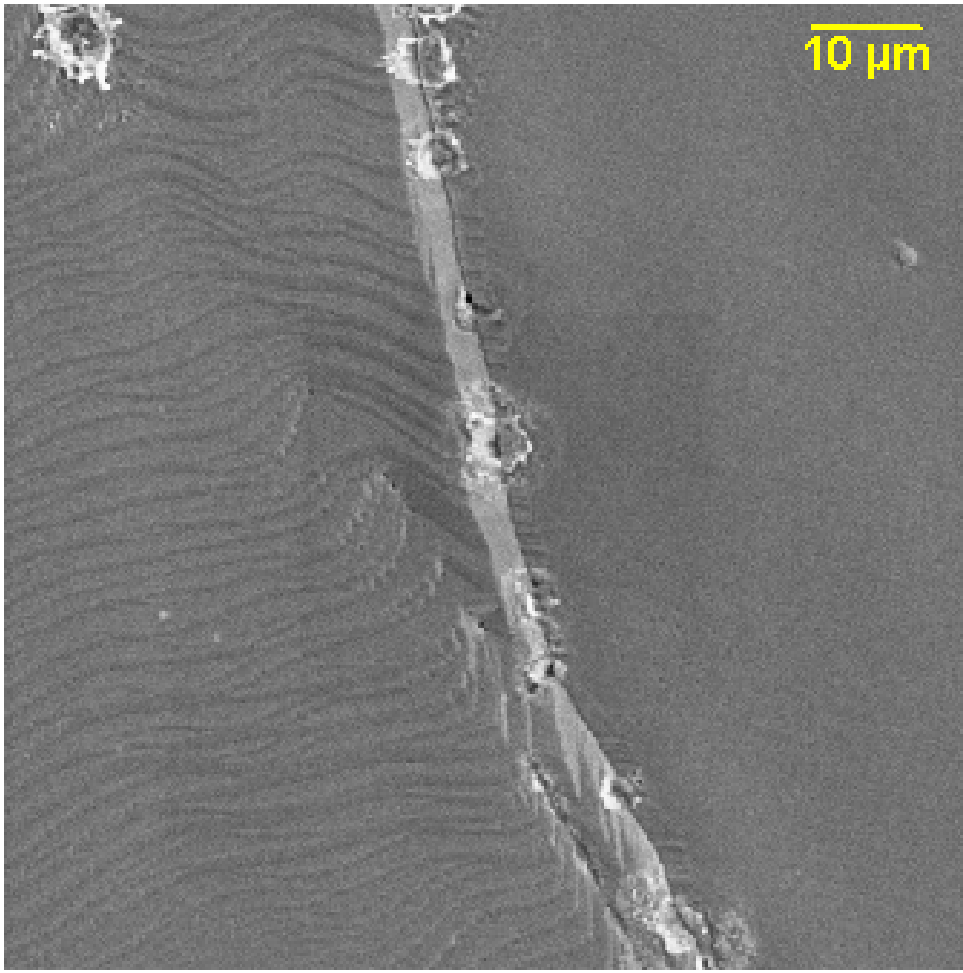
Craters were also seen at grain boundaries and at inclusions, Fig.4. Grain boundaries and inclusions are logical field emitters considering a Fowler-Nordheim model [11], equation.1. Both of these defect types have irregular geometries that increase the value of β (geometrical field-enhancement factor). These defects indicate an area of high stress within the material, which could decrease the work function Φ [12], increasing the field emission current:

material from one electrode to another due to the strong \mathbf{E} field has been observed [4]. Fig.4 does present mass movement inside a grain, indicated by slip lines in the left grain, and a crater with no traces of contaminant. However, we have not correlated systematic mass movement in a grain with breakdown events. Mass movement in a grain is dependent on its orientation to the stress on the system. Mapping the grain orientation to the magnetic field (\mathbf{H}) is planned. Mass movement, in the form of slip lines, has not been observed in witness coupons that accompanied the structures when etched and thermally treated during manufacturing.

Figure 4: Breakdown on Grain Boundary

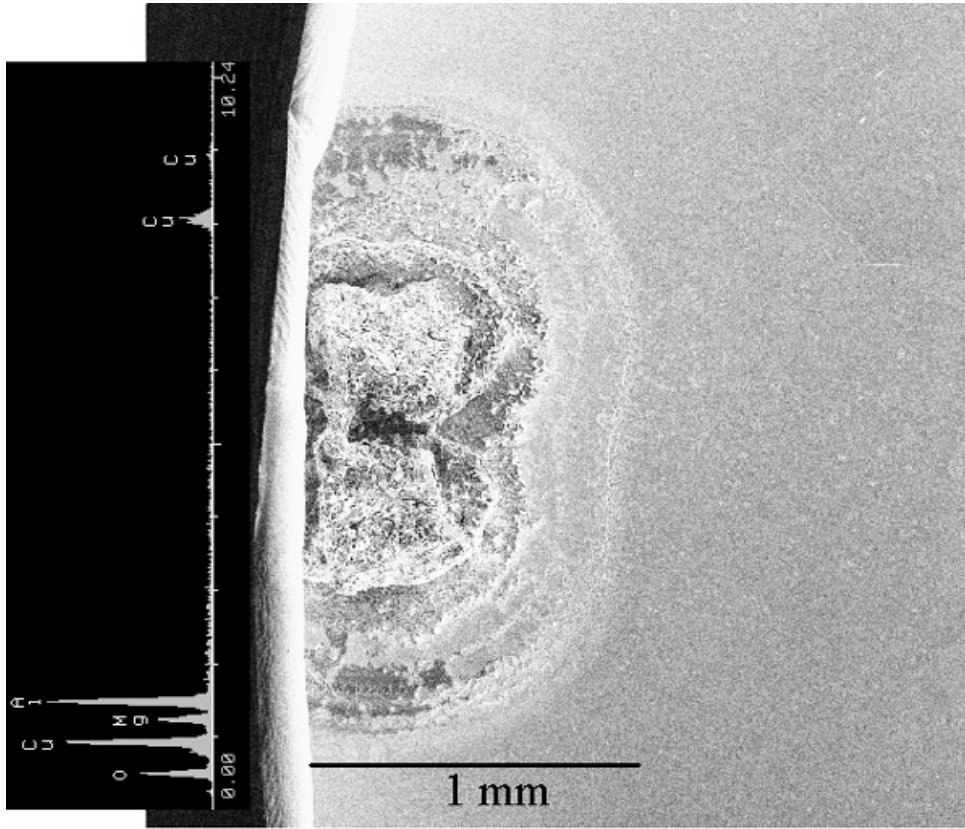
Two processed structures, H90VG5 and H90VG3N, did exhibit high RF breakdown in a localized region within the structure. At the bottom of the cell 13, between iris 12 and iris 13, of H90VG5, an aluminum sliver (mm length) was found, Fig.5. In cell 35-36 of H90VG3N a large (> 100 microns) stainless steel (SS) particle, Fig.6 was found embedded in the sidewall of the cell. A high density of craters was found near the SS particle, Fig.7. The aluminium sliver was likely introduced to the structure during assembly in the NLTCA. The process by which the SS particle was introduced inside the structure is not so clear because the particle is now actually embedded into the copper.

Figure 5: Aluminum particle (melted due to RF breakdown?) found on cell 13 of H90VG5

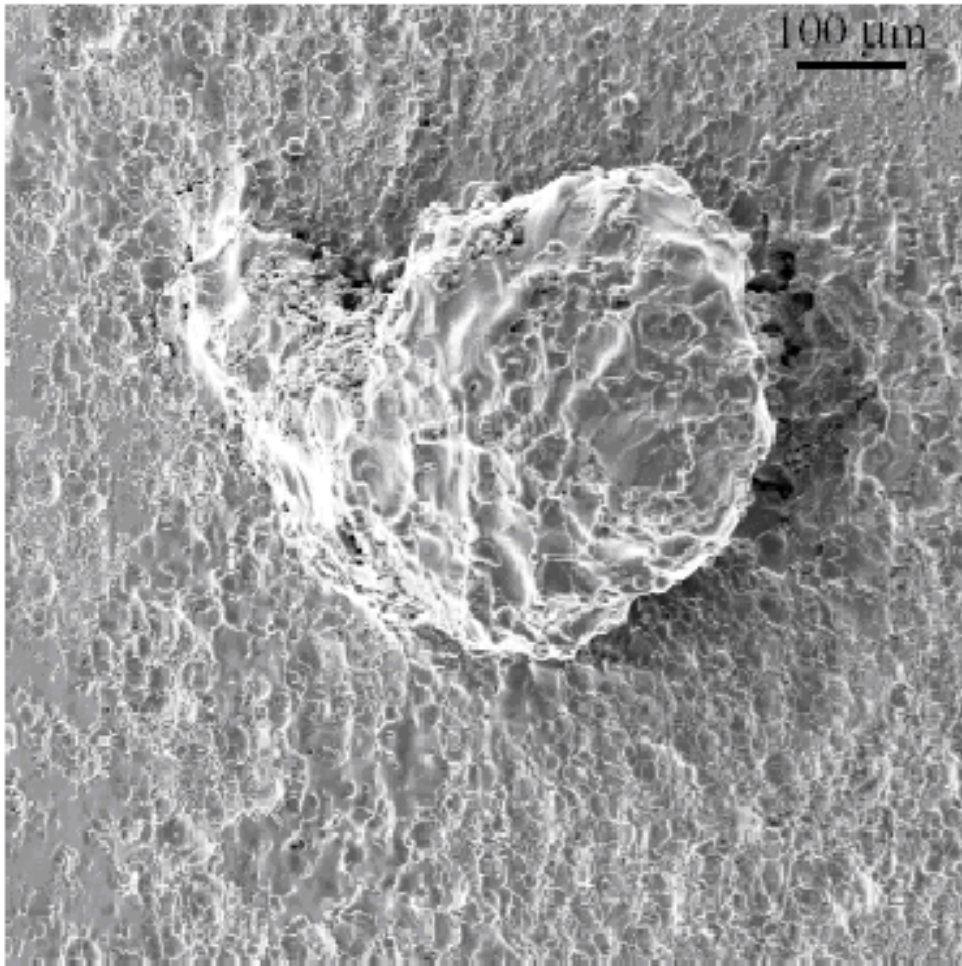
Using RF design simulation software the intensity of the magnetic or electric field inside a structure or a cell can be determined. At the location of the cup side the peak magnetic field associated with the RF wave is 0.3 MA/m , on the iris it can be up to five times less. The surface electric field on the iris is 150 MV/m and is 7 MV/m at the location

of the SS particle. The pattern of the melting at the base of this particle is consistent with a high current induced by \mathbf{H} [17].

Figure 6: Stainless steel particle embedded in wall of H90VG3N

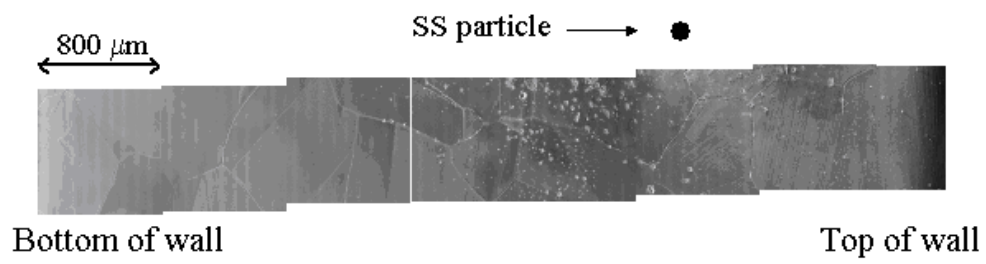
Figure 7: High density of RF breakdown events near stainless steel mushroom
