RESOLUTIONS OF PROBLEMS THAT OCCURRED IN SPEAR3 MAGNET PRODUCTION

Nanyang Li, SLAC, U.S.A. Huamin Qu, Fuhe Huang, IHEP, China

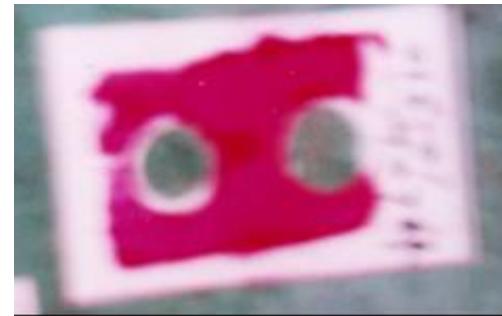
Figure 1: An Acceptable Connection

Good connections between buss and coil lead lugs are vital to prevent overheating and degradation of the contacting surfaces. To verify this connection SLAC suggested using pressure film to test the contact area between the buss and the flag. The film is made of polyester and can be cut. Accuracy is $\pm 10\%$ and temperature range is 41° to 95° F. SLAC selected the film with pressure range 350-1400psi for this purpose. The film was placed between the two connecting surfaces and bolted tightly, under the pressure applied by the bolts the film will turn red if there is contact between the surfaces. The mating surface that achieved 80% contact area was considered acceptable (refer to fig.1); otherwise, the surface should be trimmed. The films that were used for testing had been kept in the travellers of each magnet.

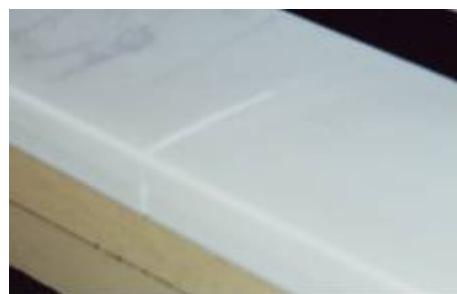
Figure 3: Epoxy Crack

In the early stage of coil fabrication at IHEP, about 80% of potted coils sustained severe epoxy cracks either right after the potting or few days later. Eventually 100% of those potted coils cracked (refer to figure 3). Theoretically, a thin epoxy layer, <0.5mm is desirable to avoid cracking. But in practice, in order to cope with coil winding tolerances and necessary taper of the potting mould, the epoxy thickness is larger in some segments of the coil. Therefore, using G10 filler or reinforced epoxy filler is necessary to avoid epoxy cracking at these places (refer to fig. 4 and fig. 5). The following engineering data shows thermal expansions of four materials:

One can see that non reinforced epoxy, which has high shrinkage coefficient (about 3.18 times higher than copper), should never be used as a filling material as the differential expansion rates between it and copper are great and will eventually cause epoxy cracking in potted coils .

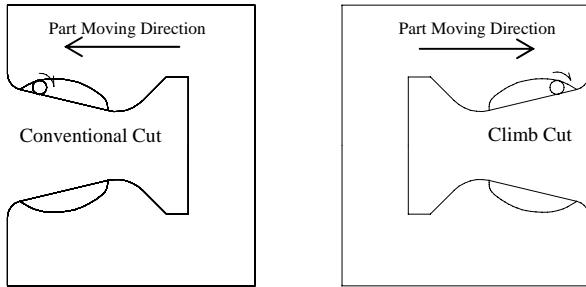
Figure 6: Both Poles Start Chamfering at Open End

The first dipole end pack chamfering was done in a configuration that used a milling machine programmed for a conventional cut on one pole and a climb cut on opposite pole (refer to fig.6). The glued laminations peeled off under the conventional cut method. The technician modified the program making both poles cut under climb cut method which solved the peeling problem (refer to fig. 7).
