ANALYSIS OF BEAM-INDUCED DAMAGE TO THE SLC POSITRON PRODUCTION TARGET*

Vinod K. Bharadwaj, Yuri K. Batygin, John C. Sheppard, David C. Schultz, P.O. Box 4349, SLAC, Stanford, CA 94309, USA

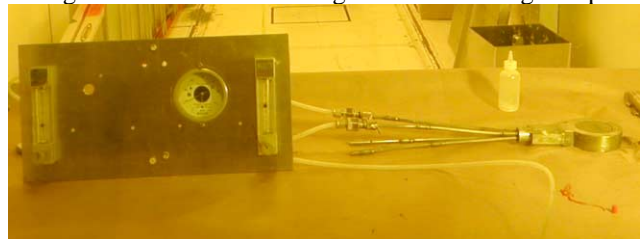
Figure 1: SLC Positron Target Leak Checking Setup

After the target arm was removed from its housing, the target cooling water lines were pressurized with helium to 10 psi (see Fig. 1) and Snoop liquid leak detector fluid was applied to both sides of the target. A small leak was observed on the exit side of the target.

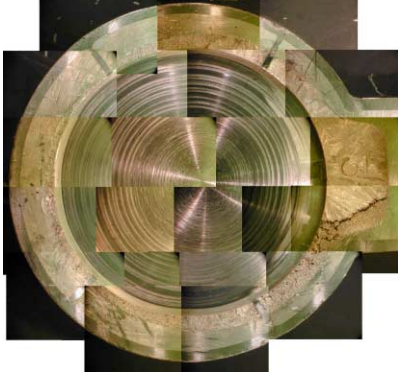
Figure 2a: Target - Beam Entry Face

Next, the target was transferred to a hot cell containing a microscope and photos at magnifications up to 20X were taken. Photos of the beam entry face of the target are shown in Figs. 2a-b and the beam exit face in Figs. 3a-b. The beam entry face showed areas in the silver with a dendritic solidification pattern. This area corresponded to the top of the silver casting after it was machined to size. The beam exit face showed a circular crack where the beam exited through the W-26Re. Additional cracking was present in the silver especially in areas where the beam was closer to the W-26Re/Silver interface.

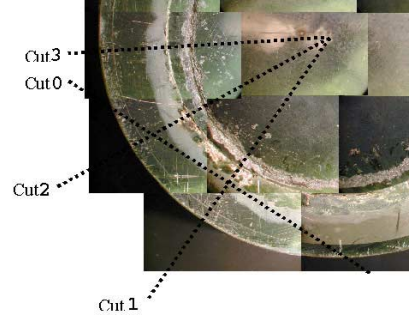
Figure 4: Target Cuts

These optical micrographs were used to determine the locations where the target would be sliced. Fig. 4 shows the exit face of the target and the location where the cuts were made. Cut0 went tangentially through the cooling tubes near where the leak was observed. Cut1 went radially through the location of the leak. Cut3 was chosen to look at an area far away from the location of the leak. Cut2 was chosen to cut the wedge into two pieces for mounting. Each cut was performed with a high speed diamond cutting saw and took approximately 4-6 hours.

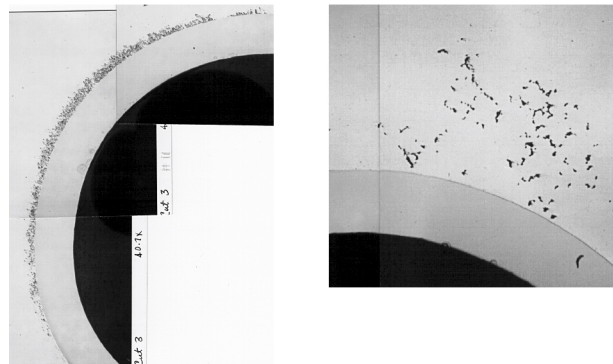
Figure 6: Porosity and evidence of second phase in the silver

Cut3 goes through the stainless steel tubes, the silver matrix and the W-26Re. When viewing this cut using higher magnification, two features are noted in the silver. There is porosity in the silver, which seems to be associated with the dendritic cast structure. Areas in the silver at the stainless steel/silver interface show the presence of fine porosity or a second phase. Cracking was observed in the W-26Re, see Fig. 5 (left), and there is also the presence of a fine second phase on the edge of the silver.

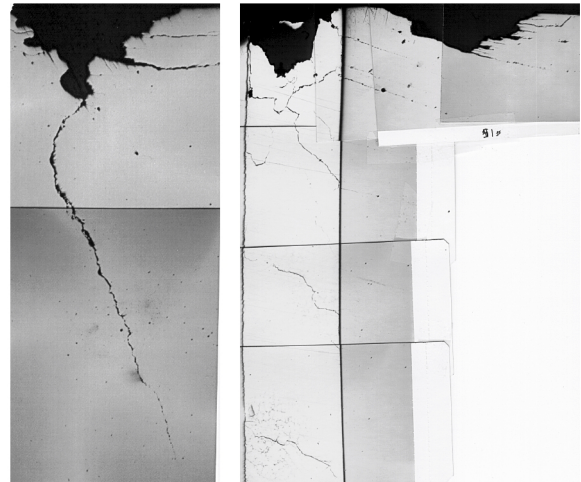
Figure 5: Target Cracking, Cut1 (right), Cut3 (left)

Cut1 went through stainless steel tubes, followed by silver matrix, then through a stainless steel spacer, through the silver matrix again and finally through the W-26Re. Higher magnification pictures of Cut1 show two interesting areas, see Fig. 5 (right). First there are many cracks present in the tungsten-rhenium and in the silver. Second material has spalled off of the tungsten-rhenium and the silver at the edge of the specimen. It should be noted that the analysis showed no irregularities at the stainless steel water cooling tubes.

The W-26Re positron target of the Stanford Linear Accelerator Center linac gave many years of reliable service. When the target is impacted by a high energy electron beam, creating the electromagnetic shower in which the positrons are produced, sudden high temperature increases create high shock and stress in the material. The target was designed to withstand these stresses. The electromagnetic shower will also cause radiation damage to the target material. This damage is evidenced by the changes in the hardness of the W-26Re in the areas where the shower occurred. The damage may have led to degradation in the material's strength, leading ultimately to the observed failure.

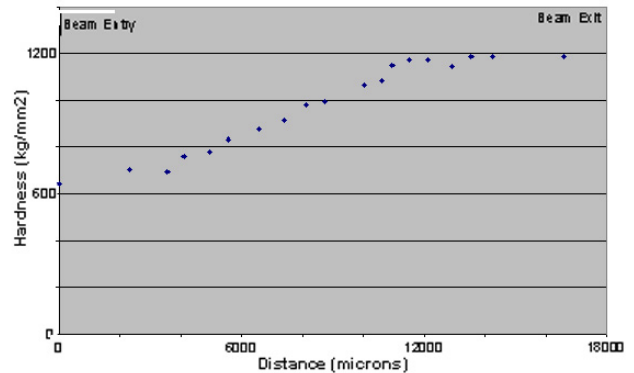
Figure 6: Hardness variation along Cut1

Very little change was observed in the hardness of the stainless steel and the silver matrix due to the effects of irradiation. A significant variation of hardness, however, was measured in the W-26Re where the electron beam irradiated the target. Hardness traces were performed making sure that each hardness indentation was a significant distance (at least five indent diameters) away from the previous indent to avoid interaction with the damage zone associated with the measurement. Figure 6 shows the variation of the hardness measured on Cut1 moving from the beam entry area toward the beam exit area near the center of the beam path. This figure shows that the hardness increases significantly (approximately twice its original unirradiated value) as one moves toward the beam exit face of the specimen (higher radiation dose). Evidence of fresh cracking was observed around an indentation made on the beam exit side of Cut1, indicating that the hardness increase is also accompanied with a decrease in ductility. The hardness also varied as one moved transversely away from the area where the beam went through the tungsten-rhenium. Figure 7 shows this variation measured on Cut1 and Cut3. The hardness was measured in the location where the beam interacted with the tungsten at the height of the center of tube A along a line toward the silver/W-26Re interface.
