Autopsy on an RF-Processed X-band Travelling Wave Structure

F. Le Pimpec, S. Harvey, R.E. Kirby, F. Marcelja
SLAC, 2575 Sand Hill Road, Menlo Park CA 94025 , USA

In an effort to locate the cause(s) of high electric-field breakdown in x-band accelerating structures, we have cleanly-autopsied (no debris added by post-operation structure disassembly) an RF-processed structure. Macroscopic localization provided operationally by RF reflected wave analysis and acoustic sensor pickup was used to connect breakdowns to autopsied crater damage areas. Surprisingly, the microscopic analyses showed breakdown craters in areas of low electric field. High currents induced by the magnetic field on sharp corners of the input coupler appears responsible for the extreme breakdown damage observed.

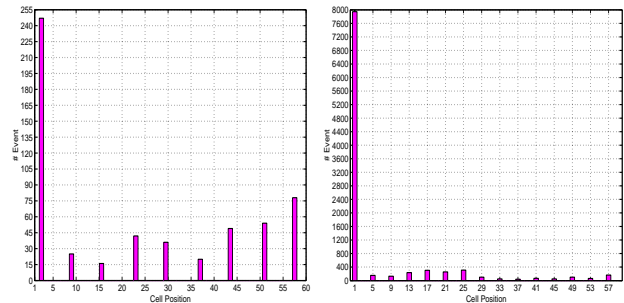
Figure 2: Example of damage localization in T53Vg3R (left) - T53Vg3RA (right) during operation

The breakdown pattern localization Fig.2 reveals that most of the breakdown are occurring in the input coupler (IC) of the TW. In Fig.3 we can see that the input coupler is divided into two parts the waveguide section, left side of the picture and the cell side in the center. The feature separating the waveguide side and the cell side is denominated "horns". The gap between the top and bottom horn is ~ 9 mm.

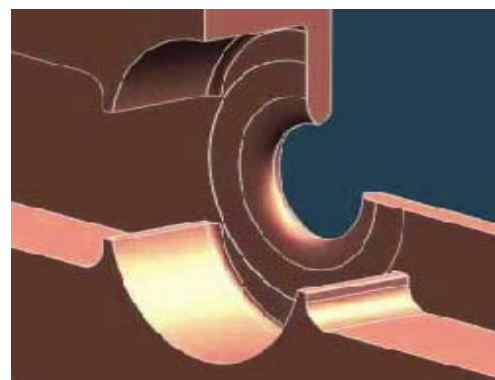
Figure 3: Input coupler design. The center is the cavity side with the first iris

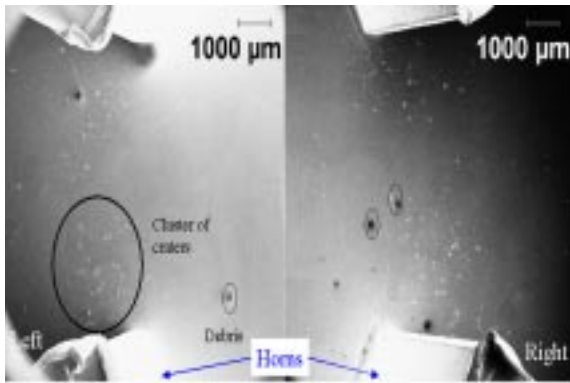
Fig.4, 5 and 6 reveal a very interesting pattern of damage. The craters on the floor of the IC, Fig.4, are mainly located along the imaginary circles connecting the two faces of the horns. Closing up to the horns and focusing on the

Figure 4: Pitting due to RF breakdown on the floor of the Input coupler. The iris is in between the horns.

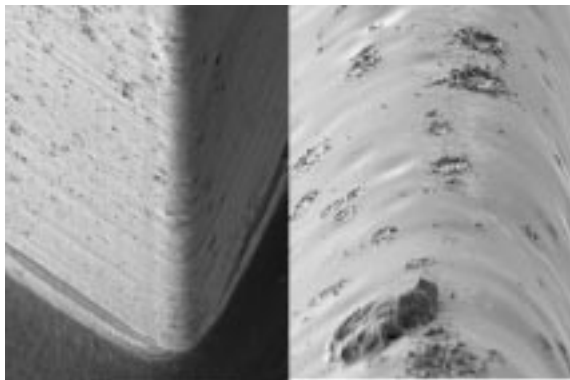
details, one can observe droplets of copper [3]. Craters appears on all the sides of the horns, with a density higher in the face side than the waveguide or cavity side. Looking more closely of the edges of the four horns has revealed that the edge on the waveguide side, Fig.5, shows little damage. In the contrary the edge on the cell side shows a chaos of features, Fig. 6, with sharp and melted objects. The dimension bar in the right picture of Fig.6 is $\sim 10\mu\text{m}$.

Figure 5: Typical damage on the waveguide side of a horn of the IC

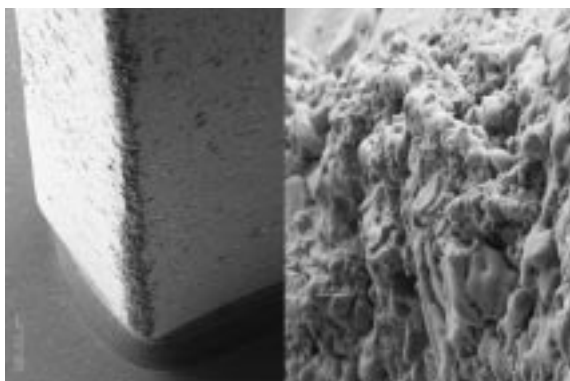
Figure 6: Typical damage on the Cell side of a horn of the IC

be invoked to explain the damages. However, the horns lies in a very low electric field area, and the vacuum is of the order of 3.10^{-9} Torr. It is then not possible to explain how such a low gas density and kinetic energy might start a breakdown leading to the so seen damages. It is also not possible to explain the very localization on the edge of the cavity side of the horns Fig.6. During processing, the RF pulse went from 50 ns to 400 ns carrying up to 100 MW of power. Part of this energy is dumped in the Cu in form of heat or directly or by the induced current due to the high magnetic field 0.7 MA/m at 400 ns pulse length [5]. Along the edge ($76\mu\text{m}$ radius) this RF pulse heating leads to an increase of temperature up to $130\text{ }^\circ\text{C}$. It is clear that this temperature do not cause the observed damage. However, it might induce thermal fatigue in the Cu, inducing formations of cracks, as observed in [6], and leading in roughening of the edge. As the surface becomes rougher, the local resistivity of the Cu increases leading to a higher temperature maybe up to the melting point ($1083\text{ }^\circ\text{C}$). At this temperature, the vapor pressure of the Cu is $\sim 3.10^{-4}$ Torr [7]. This gas can now be ionized by the electrons coming form the surface and back bombard the horns. As a result, raising up the temperature and sputtering the surface. We might, in addition, explain the droplet of Cu seen at the surface of the floor. The patterns of craters on the floor, Fig.4, seems to follow the high magnetic field line. As we move toward the center the density of craters diminish and increase again as the electric field start to be consequent Fig 7.

Following our autopsy many studies and simulation led to the decision of rounding the edge to 3mm instead of 76 μm radius in order to avoid the thermal fatigue roughening mechanism. It is believed that the new design of the IC and OC implementing this rounding will cure our breakdown problem in those couplers. Also, machining a 3mm edge radius should leave the surface extremely smooth. We have shown on an identical input coupler of T53Vg3R, Fig.9, that the 4 edges of the cavity side of the horns present a roughness after machining. Following the etching and thermal processing, that sees the structure, do not removed this roughness. In a contrary, the edge on the waveguide side of the horns are well finished.

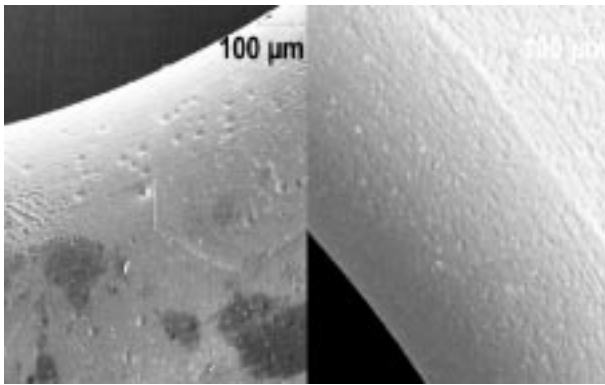
SEM (secondary electron microscopy) Fig. 7 shows the damage on the upstream side and the downstream side of the iris, respectif to the displacement of the NLCTA electron beam. On both sides etch pits can be seen as well as craters. However, the density of craters is much higher in the upstream side. Many craters are also located in the grain boundary. A particle search in and out of the craters shows MnS located in and out of them. Most of this inclusions are located in the grain boundary. The analysis of the contents of the craters shows mainly pure Cu. The black spots on the upstream side is carbon. An Auger analysis of the surface, not including those spots, shows heavy contamination by carbon of this iris [3]. Carbon contamination due to electron bombardement is a well known problem, [8]. There is no such contamination in iris 28 further down the structure [3].

Figure 7: Activity on the 1st iris, Upstream side left picture and downstream side right picture

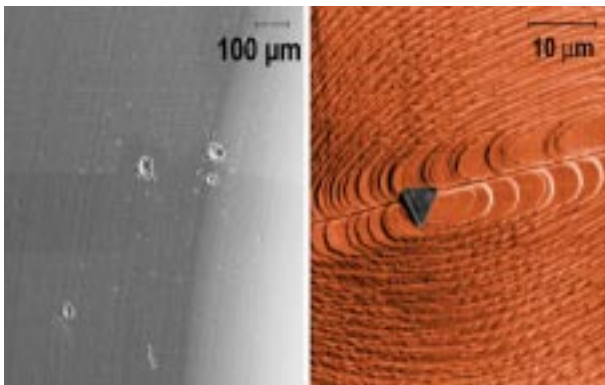
As we move toward the output coupler (OC), the activity on the irises decreases, endoscope (boroscope) monitoring. Fig.8 shows the sparse activity on the 28th iris of the structure. As we looked for particles/inclusions on the surface and at the grain boundary, we did not find MnS. However, some other sulfur compound were found [3], as the atypical one shown in Fig.8.

The cells used to make the structure are bonded and then brazed in a stainless steel (SS) H_2 furnace at $\sim 1020\text{ }^\circ\text{C}$. The Sulfur (S) composition is 0.03 weight % in stainless steel. Other material like Mn, Cr, Ni are also used in the making of SS. The solubility of sulfur in copper is

Figure 8: Activity on the 28th iris, Upstream side. CrS inclusion at a twin boundary, right picture

very high at this temperature and significant at a few hundred °C. Hence, a significant amount of S can get into the copper. After its fabrication, the structure is vacuum baked in a SS pot at 650°C for few days, in order to desorb the H₂. Metals might be present in the atmosphere of the H₂ furnaces and bakeout pot at this given temperature, with vapor pressures of 10⁻⁵ Torr for Mn, 10⁻¹¹ Torr for Cr, 10⁻¹ Torr for Ca and below 10⁻¹¹ Torr for Ni [7]. At 300°C and above the S concentrates at the grain boundaries of the Cu. The S also start migrating to the surface at low temperature 75°C [9]. The Model for sulfur compound formation is that the sulfur getters the metal vapor out of the furnace atmosphere to form crystals/inclusions at/near the grain boundaries. A particle search on the IC reveals that ~80% of the particles are Mn-S. On the very next iris the proportion falls to ~50%. The search in the 28th cell shows no Mn-S but S-compounds are present at ~50%. Finally the search on the last cell in front of the OC shows Mn-S and other S-compounds. Finally in all the cases, other particles are compounds based on C, Al and Si not excluding the presence of Mn or S or other elements. This model might explain the sulfur compound formation, but the understanding of the distribution along the structure of those elements is under investigation.

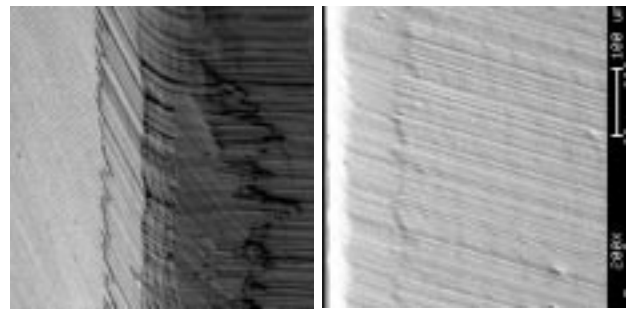
Figure 9: Surface of the edge, cell side, of a horn after machining (left) and after 60" etch and thermal processing
