BEHAVIOR OF THE FIRST SUIT OF SCOTCHLITE IN THE 40" SLAC HYDROGEN
BUBBLE CHAMBER

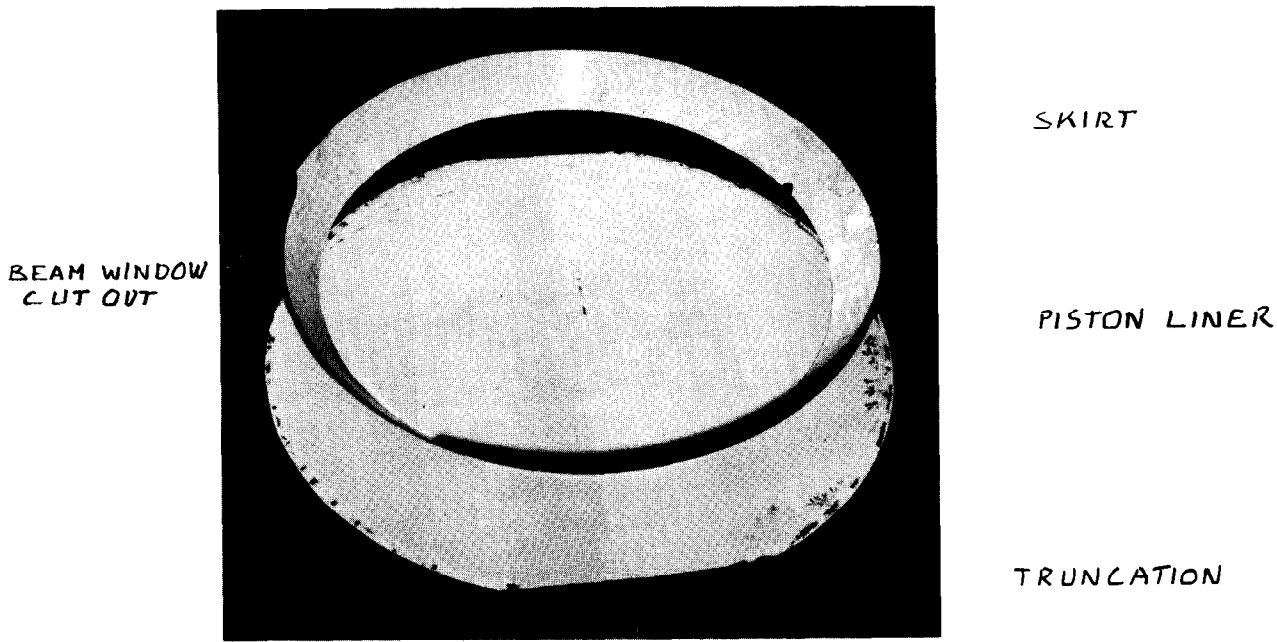
FIG. 2.
SCOTCHLITE RETRODIRECTOR AS REMOVED FROM 40" H.B.C.

The skirt was found to be loose, held only by 4 out of 11 nuts on the bottom and 6 out of 11 on the top. Most of the mounting holes in the skirt were badly enlarged and elongated. No dirt was found on the skirt. The blotches were due to the mylar outer layer of the Scotchlite which locally separated, but the base layer remained firmly attached to the fiberglass base. Some of the blisters formed had broken open, but no reason for blistering (such as association with pin holes or craters) could be found. The upper Scotchlite clamp ring was found to be held by a single screw and the lower by 4 screws. The lower clamp ring had struck and broken off one of the chamber body fiducials. The chamber body fiducials, incidentally remained undamaged, except for mechanical damage caused by the clamp rings. The piston liner was taken out of the chamber and carefully examined. It sustained some mechanical damage and had considerable dirt streaks. The only serious damage, however, associated with the normal run was the small 1" tear in the center of the liner (see Fig. 6). This tear was at the edge of an overlap joint and was due to insufficient epoxy being present to form a fillet where the Scotchlite layers overlapped. The remaining 4" of the central dark streak proved to be steel and fiberglass dust which fell from the top of the skirt where it was rubbed by the loose clamp ring. Additional dirt spots in the form of characteristic "trees" were found at the lower edges of the liner (see Fig. 7). Wherever dirt streaks were present, considerable residual electrostatic

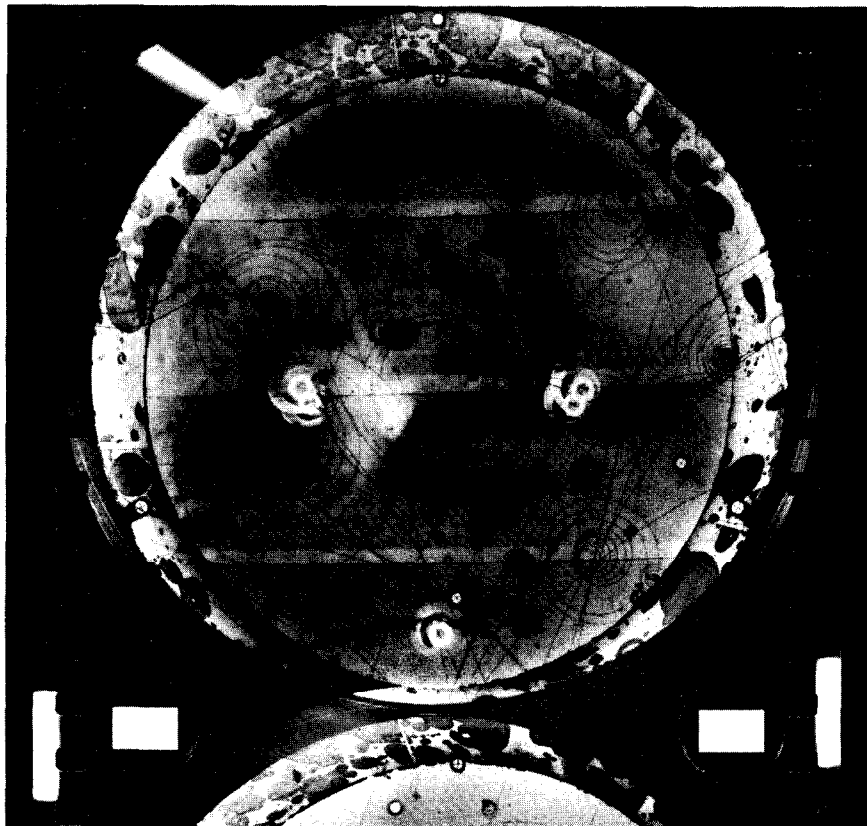
attaining their maximum size in about 48 hours. The resulting loss of Scotchlite's reflectivity gave the photographs from the first run of the 40" HBC their distinctive 'mod' appearance (Fig. 5). No defects were observed on the piston liner, however.

FIG. 5--Typical photograph from 40" HBC.

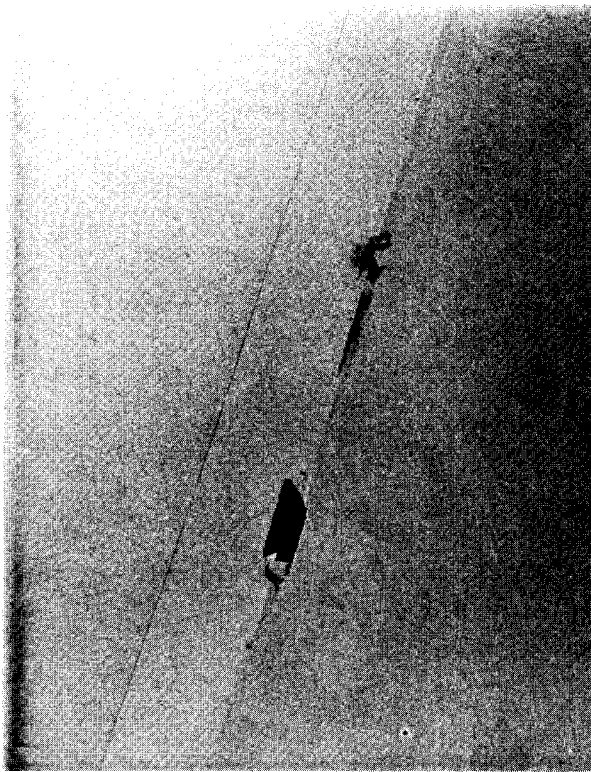
The conclusion drawn from examination of the piston liner was that, had the clamping ring not come loose, the liner would have come out of the run in the same condition as it went in, except for the 1" central tear.

FIG. 6--Detail of Scotchlite tear.

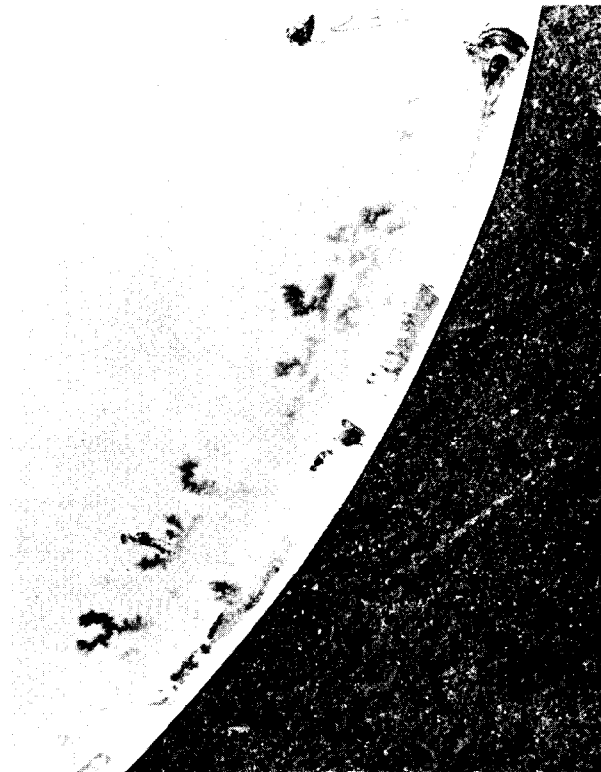
change was found in the mylar outer layer of Scotchlite.

FIG. 7--Detail of dirt "tree."

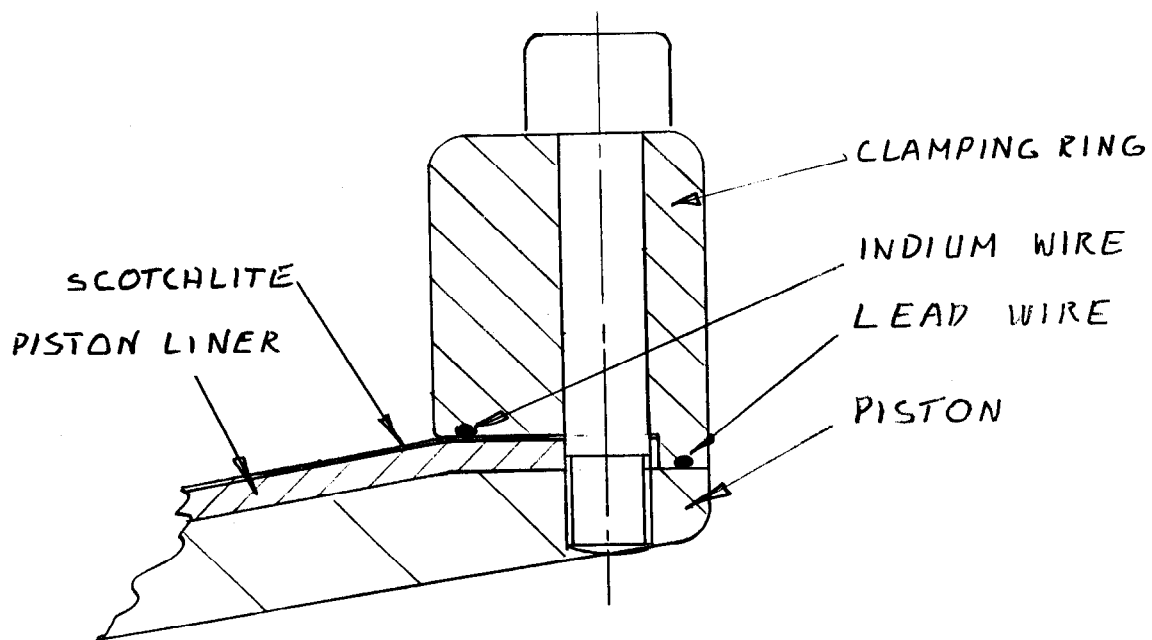
FIG. 8
PISTON LINER CLAMPING ARRANGEMENT.

The piston liner was clamped in place on the piston with a total of twenty-four #10-24 screws holding the two clamping half rings. It was these rings which became loose during the run and forced its termination.

- (c) The remaining skirt segments will be mounted to chamber walls with suitable brackets. (This is a temporary reduction of the skirt size.)
- (d) The piston liner will no longer be truncated. It will be reduced slightly in diameter and bent sufficiently to allow entrance into the chamber through the window opening. The liner will be held in place by a one-piece steel clamp ring equipped with indium sealing wires (see Fig. 8). The ring will also be distorted to allow entry into the chamber. Bolts holding the ring will be tack welded to prevent loosening.
