# Injector RF/TGAS/Subharmonic Bunchers

10-Nov-03

Recently there have been power dips and subsequent timing and SHB problems. Here is some guidance to help diagnose and repair some of these problems:

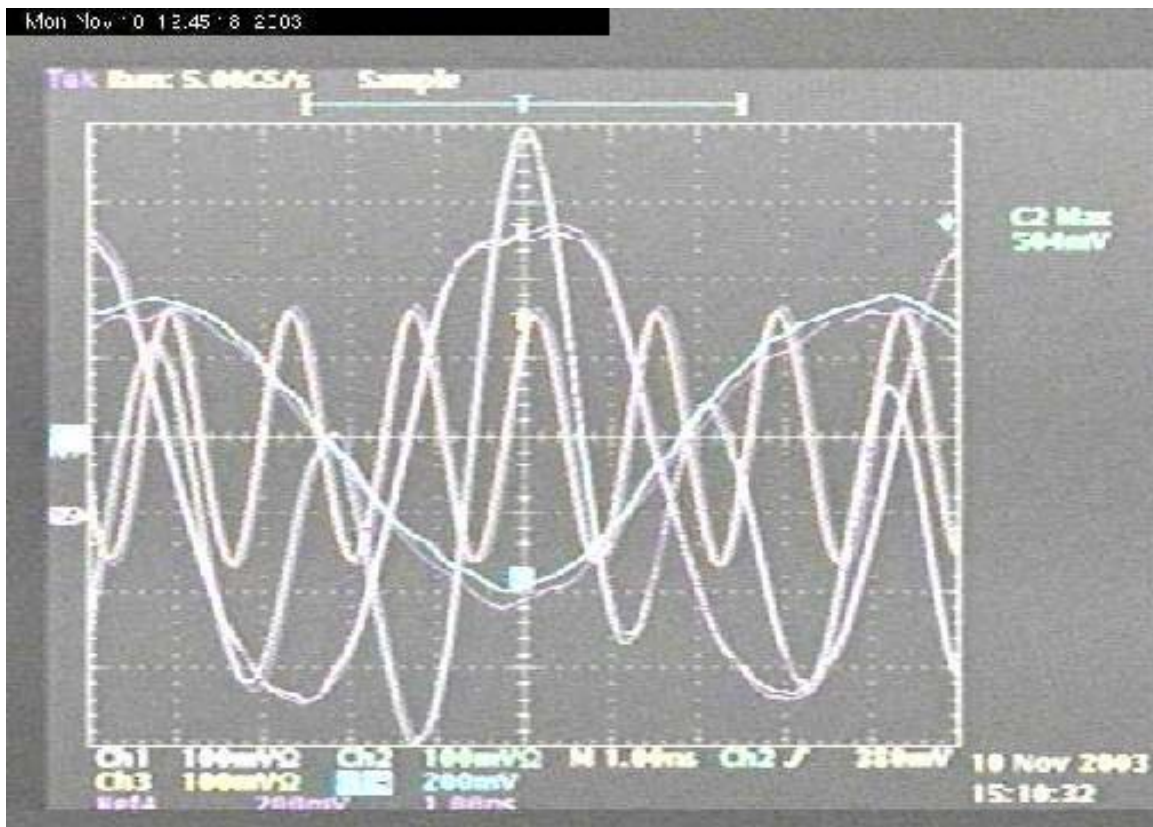
**1. You need too look at the video of Ron Akre's RF scope: 0-53, and the CID HP Scope 3-32.** The RF Scope should look like the picture in Accelerator Elog 10-Nov-03 12:07.

The important thing here is the relationships (phase stability) between the frequencies. (If all the active traces are offset the same amount from the saved traces, that's ok.) Two of these frequencies (the 178.5 and 714 MHz) are generated with dividers which can be reset with a trigger. The trigger is TRIG 213 in LI00 which is part of VDU 214 in LI00. To reset, you select Beam Code 11, and select TRIG 213, and reactivate(, then deactivate) the TRIG.

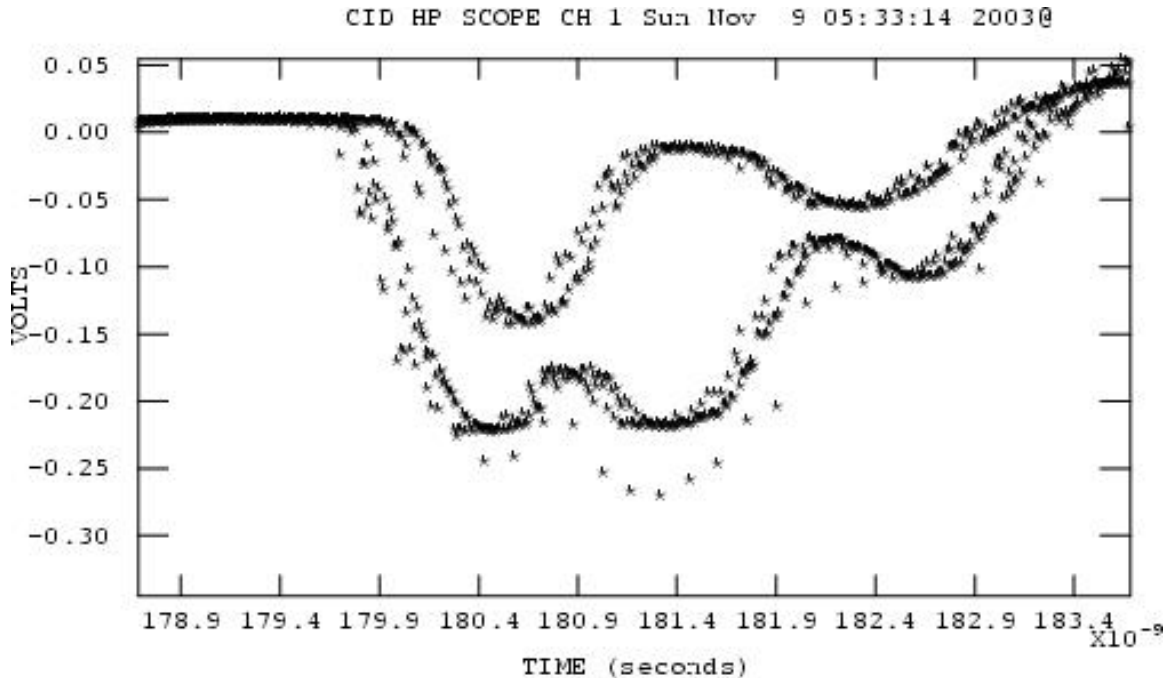
9-NOV-03 05:26:19

Occasionally power dips make the beam go to the wrong time out of the gun due to TGAS losing its marbles. Go look at the CID HP scope: "Video Index", "LI00-1 Scope Index", "CID HP SETUPS", push the top left "TGun Gap Scav (BC 11)" button. The scope should look like the middle trace in the picture in the Accelerator ELOG from 9-Nov-03 5:26:19 (in ELOG lingo this is folder 2003, subfolder 45, book 11.09a). That is, the pulse begins to go down about a nanosecond from the left edge of the screen.

If the pulse is not at the right time, and the RF scope traces are right with respect to each other, then the old database can be re-stuffed into the TGAS module by running the calibration procedure, but NOT accepting any new calibration:

Push Modulator OFF on klystron K02, then go to "Injector Index", "TGun Pulser Panel", select "TGAS 2 (T402)", enter "Beam Prompt" 11 (select beam code 11), go to "TGAS DIAGS PANEL", push "CALIB TGAS", tell it who you are and "no" to resetting the divide by 16. IF the program asks you to "accept new calibration" say "NO". If it asked about the calibration, then it failed and something else is wrong and you need to get help. Page Axel Brachmann, Jim Turner, or Mike Stanek. If it success, then you will get a picture like the one in Accelerator Elog 9-Nov-03 5:25:13.

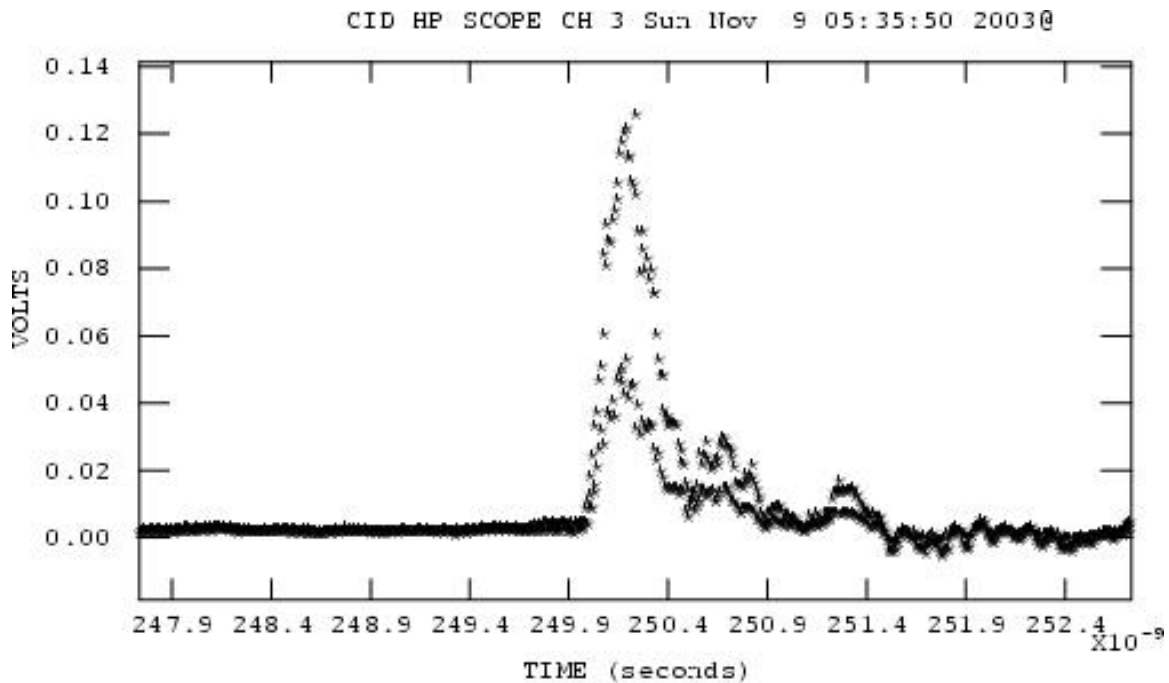
9-NOV-03 05:28:55

Go to the CID HP Setups panel and push the "GAP 540 SCAV" button. You should get a picture (on 3-32) which looks like the top trace in the picture in the Accelerator Elog at 9-Nov-03 5:28:55.

If the timing was wrong from TGAS, the trace may be 1/2 amplitude, but at the same time. This is because the SHB RF has a period of 5.6 nS and can capture some beam even when it is coming out of the gun a nS or two wrong. Don't change the SHB phases. Holes have been dug recently doing that. If there are 2 roughly equal size pulses, the SHB2 may be not functioning.
