# Notes on Scanning Electron Microscope Analysis of 25-Cell W-Band Structure

E. Colby 8/14/98

The 25-cell OFHC copper W-band structure (numbered 1), "bottom" half was examined for contamination and other defects by both scanning electron microscopy and secondary electron emission. The sample was placed as-is into the microscope chamber without additional cleaning or preparation and examined. The object under study is entirely made of copper, and hence, self-grounding.

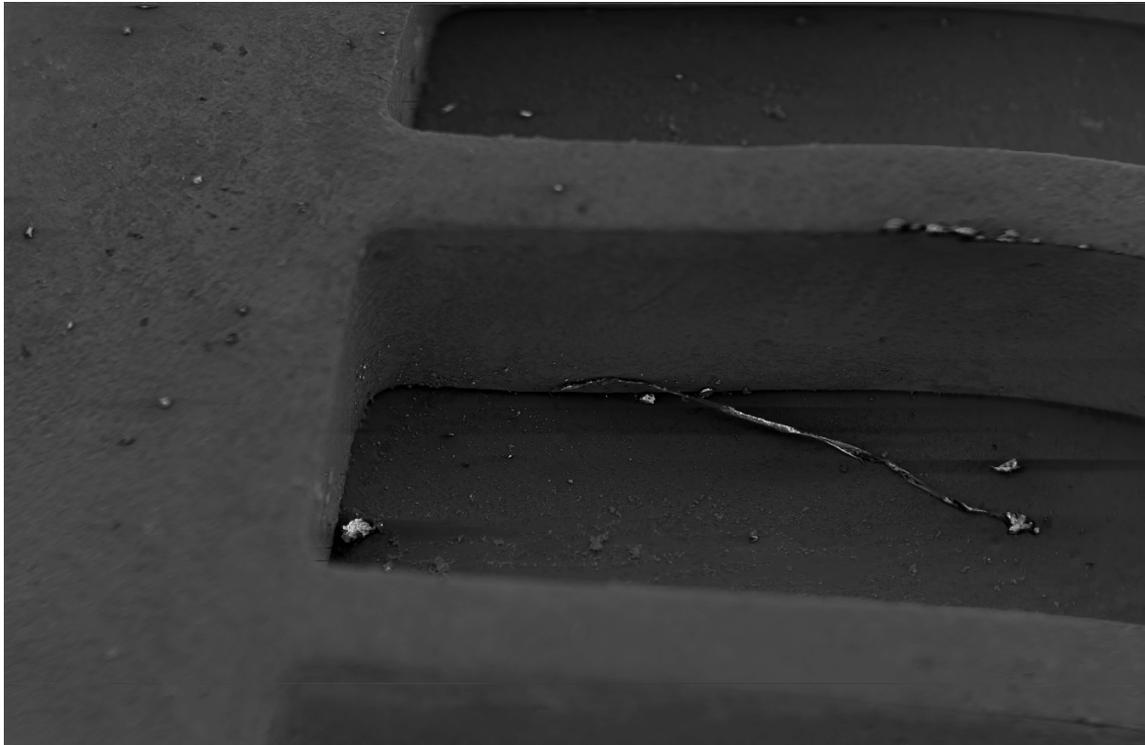
FILE: 000001  
DATE: 7/22/98 TIME: 13:37  
Structure 1, botton, cell 5

The general cleanliness of the 25-cell structure was appalling. Several fibers, a number of >50 m particles and a tremendous amount of finer particulate matter can be seen in most images, but particularly 000881 and 000882. The fibers melted under higher magnification.

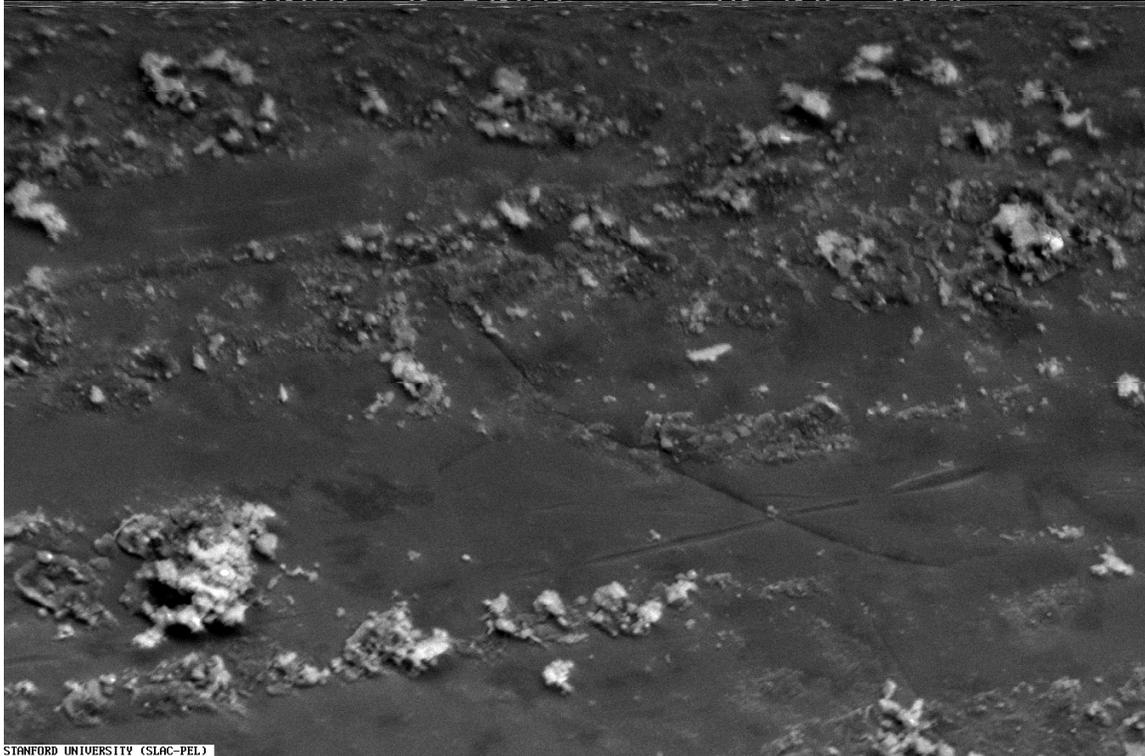
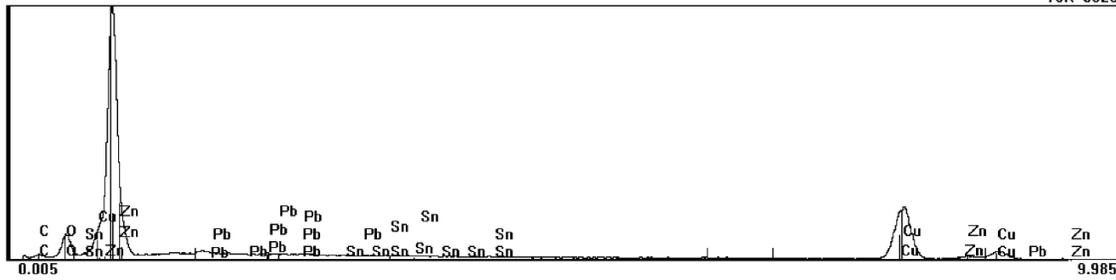
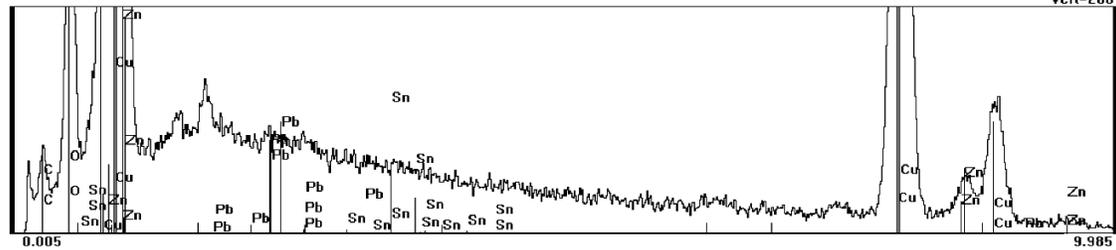
FILE: 980882  
 DATE: 7/22/98 TIME: 13:58  
 Structure 1, botton, cell 5, x-ray spectrum area

Zinc was observed in all secondary electron emission spectra of copper surfaces (e.g. 000882), including the tops of irises where EDM cutting took place, and on the bottom of cells, where lapping had occurred subsequent to EDM cutting. An obvious source for the zinc is the EDM cutting wire, zinc-plated brass.

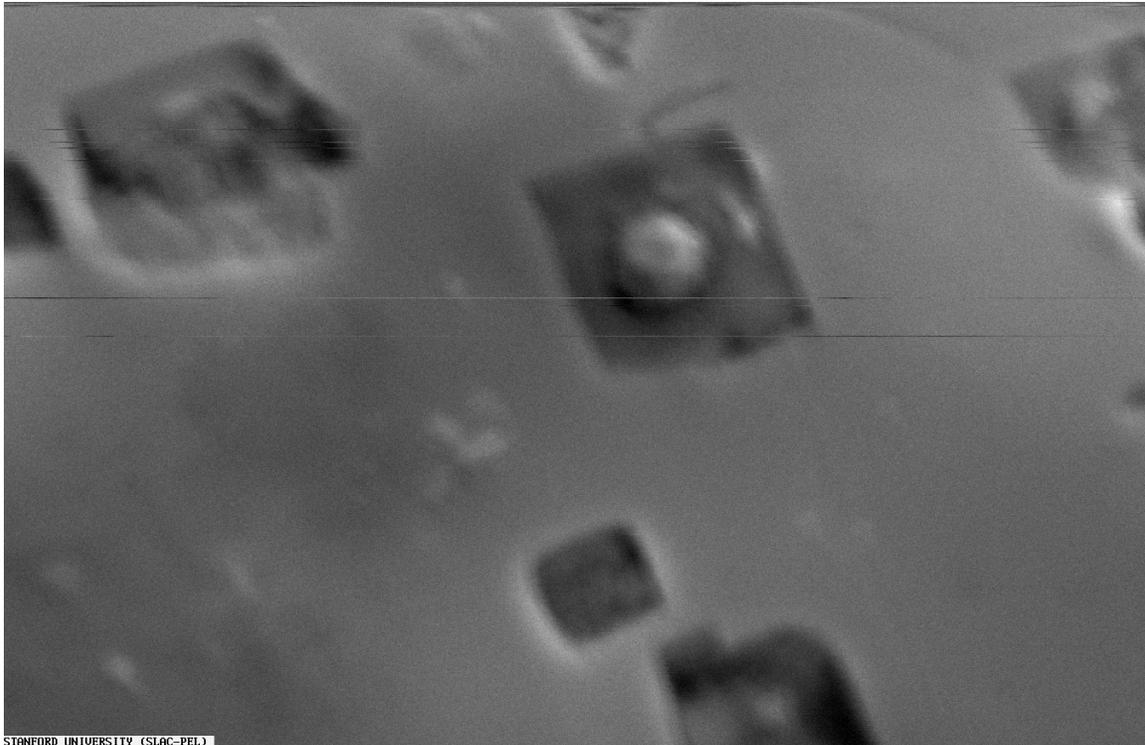
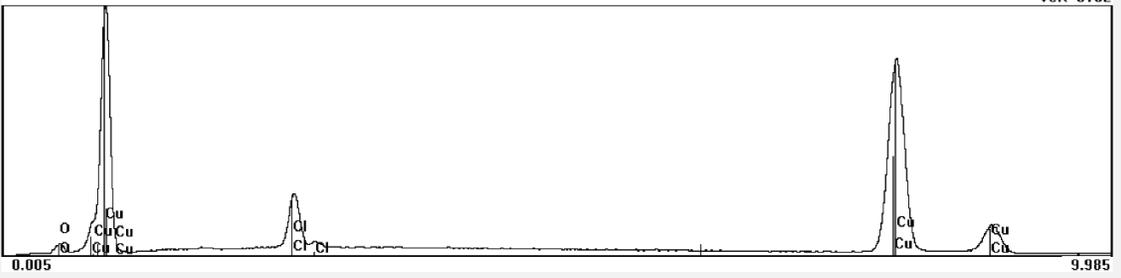
FILE: 000004  
DATE: 7/22/98 TIME: 14:48  
Structure 1, iris BI 5/6,x-ray spectrum area,Cl featur

Chlorine inclusions of the type seen in 000884 were numerous only on the EDM-cut surfaces (see 000893), and never seen on any non-EDM cut surface. Testing of the EDM machine water at RWI was suggested to trace the source of the chlorine.

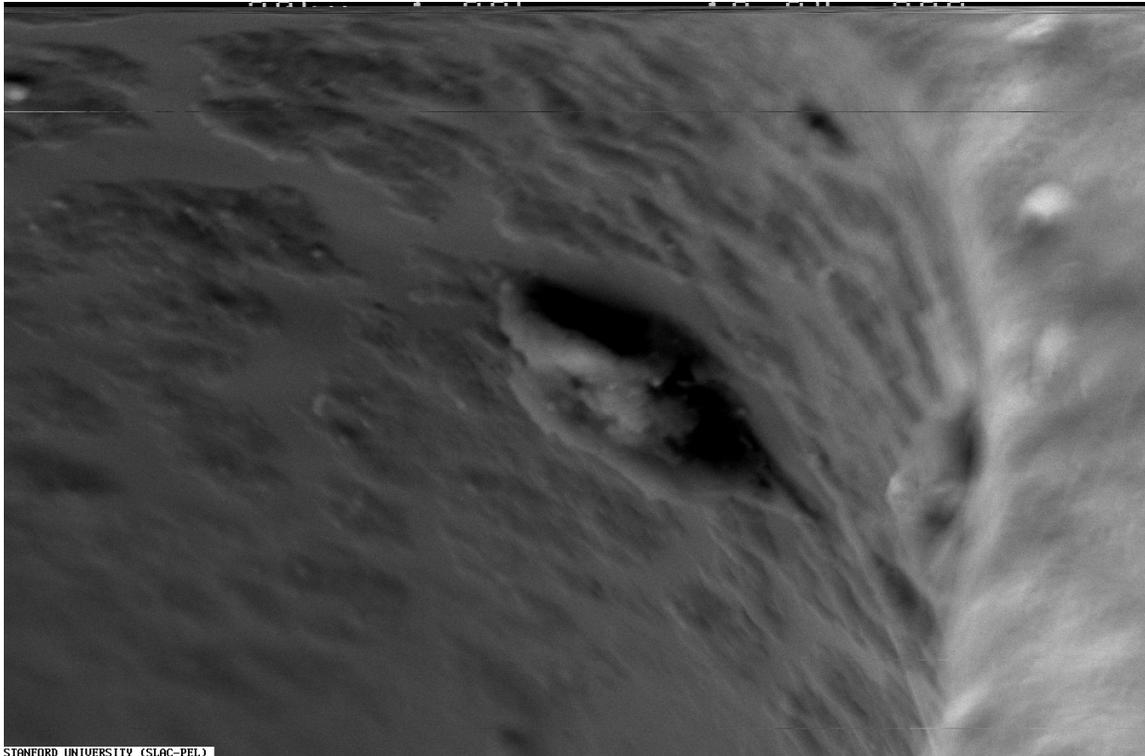
FILE: 000006  
DATE: 7/22/98 TIME: 15:31  
Cell corner, showing "tearout" area

The tear seen in the wall of cell 7 (possibly cell 6 or 8) at the inside corner (image 000886) may be a sign of a more serious problem with EDM cutting of copper in general.

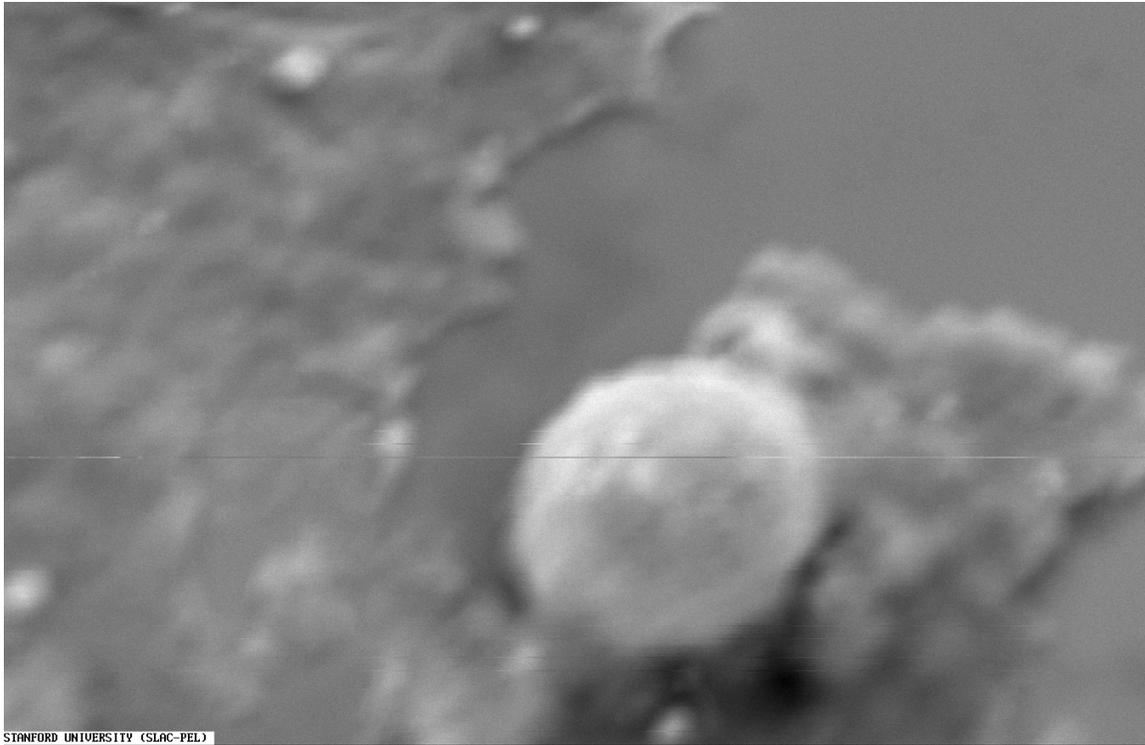
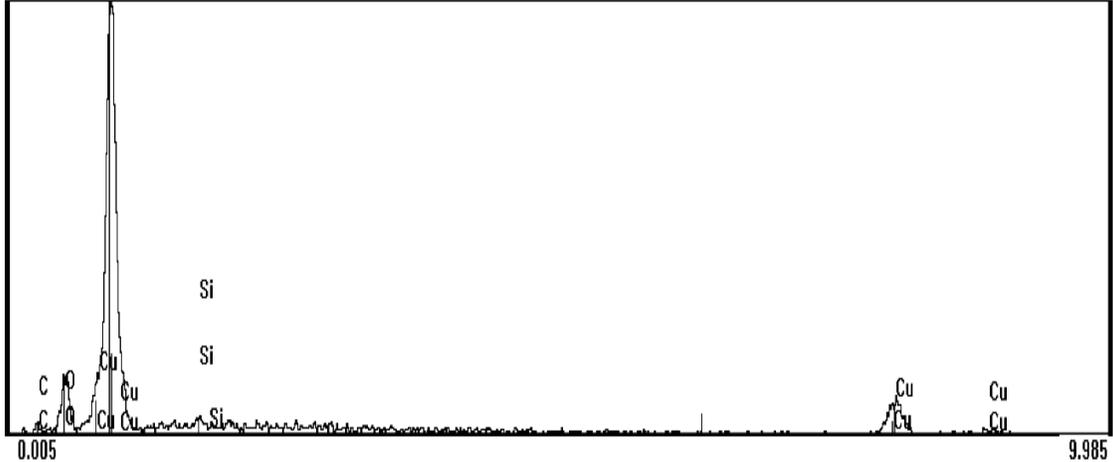
FILE: 000098  
DATE: 7/23/98 TIME: 9:47  
BC13 bottom sphere and blotch

The splatter blotches, striking under optical illumination, are less so under electron illumination. (images 000889, 000890, 000891). Secondary electron emission spectra of the blotches (000891) did not show a significant change above the background. The splatter blotches appear to adhere well to the surface (000890) making removal potentially very difficult.

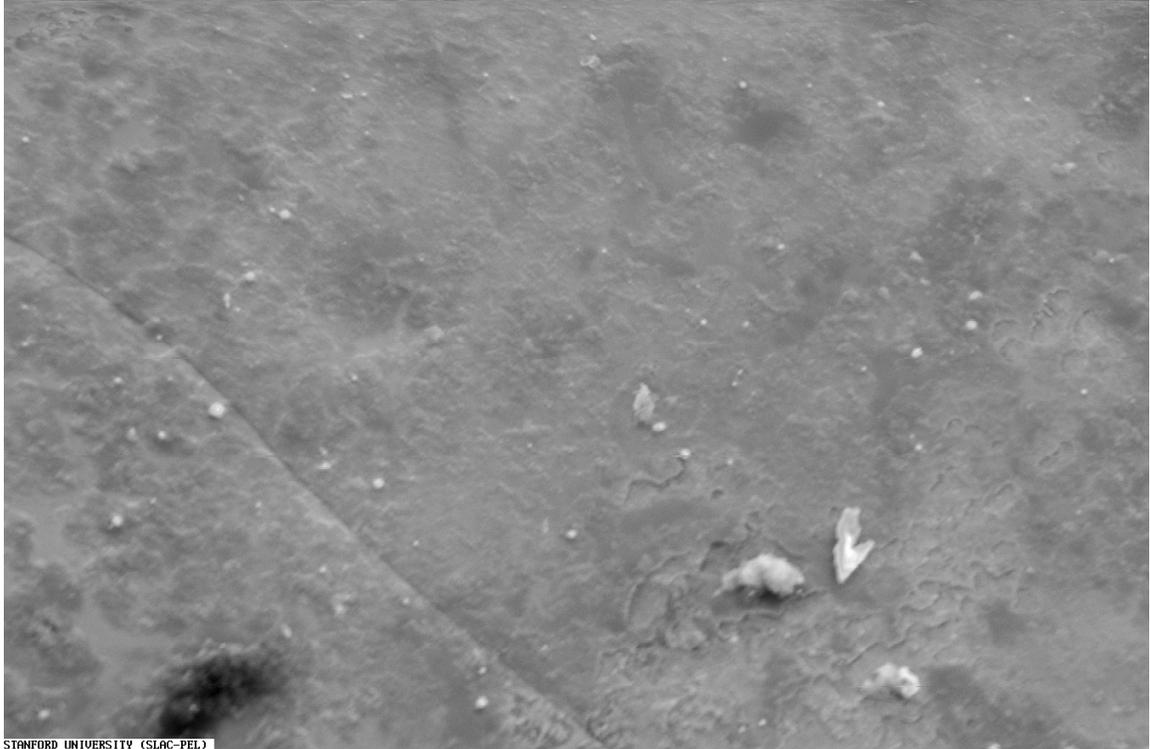
FILE: 000092  
DATE: 7/23/98 TIME: 11:28  
BC2 botton lotch

<a href="#">000892.gif</a>	"Typical", clean non-EDM copper surface on bottom of BC2 at 1000X
<a href="#">000893.gif</a>	"Typical", clean EDM-cut copper surface on top of BI3,4 at 1000X
