An acoustic sensor system for localizing RF breakdown in warm copper accelerating structures

F. Le Pimpec*, J. Frisch, K. Jobe, D. McCormick, J. Nelson, M. Ross, T. Smith

SLAC, 2575 Sand Hill Road, Menlo Park, CA 94025, USA

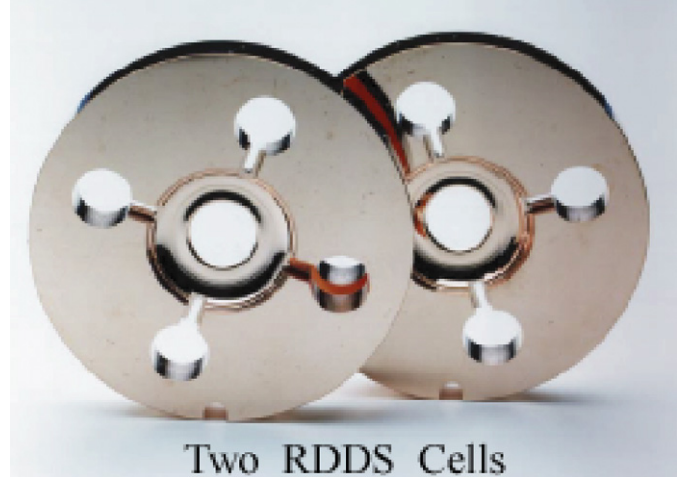
Fig. 2. Rounded damped and detuned NLC type accelerator cell structure.

The choice of adequate sensors for localization is then dependant, not only on the pickup properties of the sensor but also on the frequencies of the acoustic waves to be analyzed. Hence, the resolution which can be achieved by an array of these sensors depends on the diffraction limits, the attenuation of the different types of waves, pressure waves, shear waves and surface waves (Rayleigh waves) [9,10] as well as any anisotropy of the medium [11]. Finally, the complex geometry of the cells forming the structure is also an extra challenge to the resolution, Fig. 2.

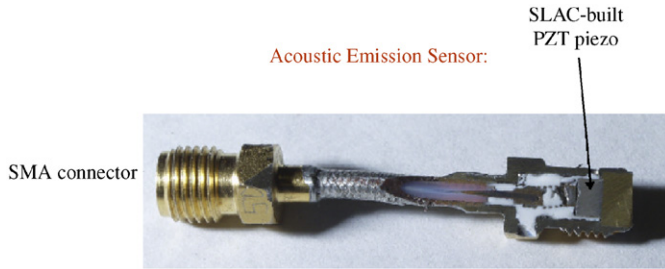
Fig. 3. SLAC type acoustic sensor 200 kHz–1.5 MHz.

Since the first report on this technique [12] several commercial sensors of the kind used to monitor microscopic cracks in bridges or airplane frames, as well as SLAC-made sensors, Fig. 3, have been tested and used [13].

Most of the results presented in this paper were obtained using the sensor shown in Fig. 3. The sensor is made of a piezoelectric ceramic, soldered onto a copper piece. A conductor is then soldered onto the back of the ceramic and connected to an SMA connector. The ceramic is embedded in a Room Temperature Vulcanizing (RTV) silicon which act as a damping material. The power response in dB versus frequency of the SLAC sensor is given in Fig. 4 when it is driven by a commercial microdot 100 sensor, Fig. 5.

In the frequency range of the SLAC-made sensor, Figs. 3 and 4, the wavelength of the phonon lies between 2.4 cm at 200 kHz and 3 mm at 1.5 MHz, assuming a speed for the longitudinal wave of 4760 m/s ($\lambda = c/v$). Fig. 13 shows the frequency response of sensor #6 (Pulse #3) of Fig. 7 on the T53VG3F structure, after a breakdown close to or at, its location. Almost no signal is recorded for frequencies above 1 MHz despite the frequency range of the SLAC sensors (200 kHz to 1.5 MHz). However, those sensors have a higher power attenuation at frequencies above 1.2 MHz cf Fig. 4.

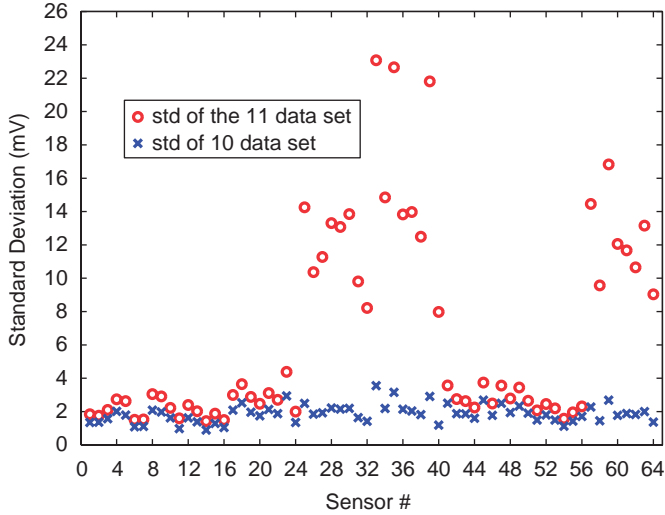
Fig. 10. Standard deviation of the difference between the data set of a given sensor and its associated fit.

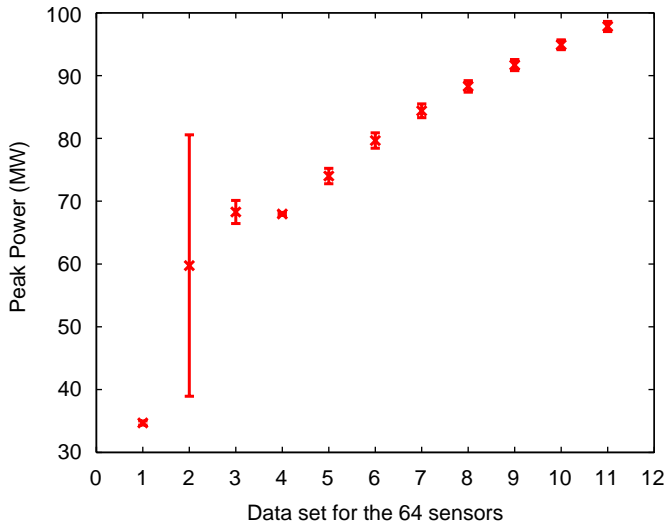
Fig. 11. Standard deviation of the difference between the response in mV of the 64 sensors and their associated fit at a given power and for a given set.

sensors have a much larger deviation (circles). Fig. 11 displays the difference at a given power between the data and their fit for 64 sensors (the error bar is the response in mV of the sensor). The data Set #2 at RF power of 58 MW has a variation of the response which is much larger than at any other RF power: 20 mV compared to 2 mV. Thus the real accuracy of the fit to the data in Fig. 8 is given by the cross set in Fig. 10, after data set #2 has been withdrawn from the standard deviation calculation.

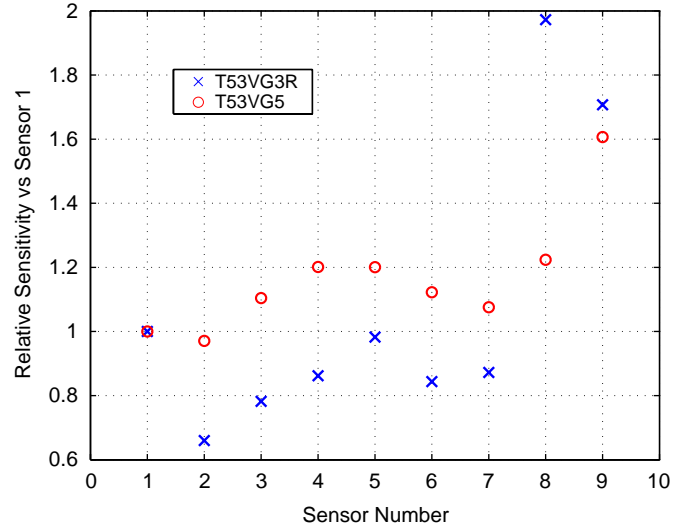
Fig. 12. Sensitivity of the sensors relative to sensor 1 for T53VG3R (crosses) and T53VG5R (circles) structures.

As an absolute calibration is not yet in reach, we might use a relative calibration, Fig. 12. A set of data is recorded at a given pulse length and a ratio of the output of the voltage versus one of the sensors is calculated. The data are recorded in three sequences of 1024 points corresponding to three consecutive RF pulses, Fig. 7. We have chosen to calculate the sensitivity based on the first 200 points or 20 μ s of the signal.

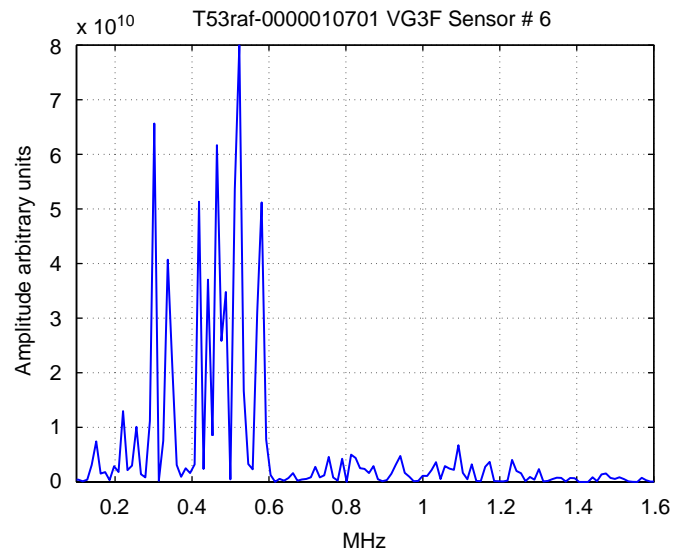
Fig. 13. Fourier transform of the signal of sensor #6 after a recorded breakdown in Fig. 7.

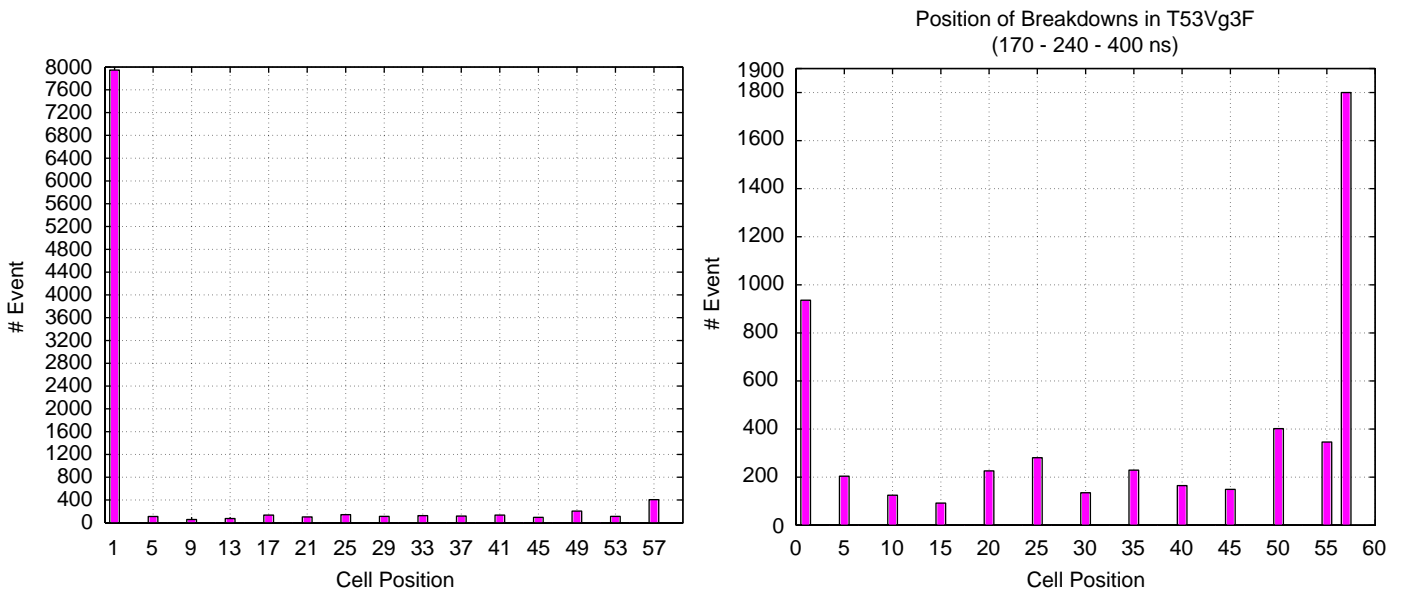
Fig. 14. Number of single breakdown vs location of the 53 cm long RA (left) and F (right) travelling wave structure; for RF pulses of 170, 240 and 400 ns length.

Due to the quantity of data, automatic analysis is necessary. Simple analysis will calculate the RMS of the first 200 points of the n pulse. The biggest RMS value is then considered to be the location of the breakdown. From this sensor we can compare the other RMS and determine if the second highest RMS value is a valid second breakdown. This automatic method benchmarked with a manual scan of a given sample of data has given very good results. Fig. 14 shows two histograms, one for the T53VG3RA (left) and one for the T53VG3F (right) accelerating structures. Each plot displays the recorded number of breakdowns or events during a given time of RF processing, versus the position in the structure where the event occurred. These results are in good agreement with the RF analysis, Fig. 15. The clusters of dots located on cell 0 and 60 are related to breakdowns attributed to events in

the input and output couplers. The dots in between are events localized inside the body of the structure.

The results obtained from the T53VG3RA structure, where more than 75% of the breakdowns are localized in the input coupler, caused us to rearrange the position of our sensors, Fig. 14. It was believed that some breakdowns

Following the results obtained by the acoustic sensors on the localization of events during RF breakdown as shown for example in Fig. 14, autopsies of the T53VG3R and T53VG3RA structures have been carried out [1]. Extreme damage on the “horns” of the input coupler has been identified, cf Figs. 21 and 22. The horns are the corner separating the waveguide from the cell, as shown in the schematic drawing in Fig. 19. In another travelling wave

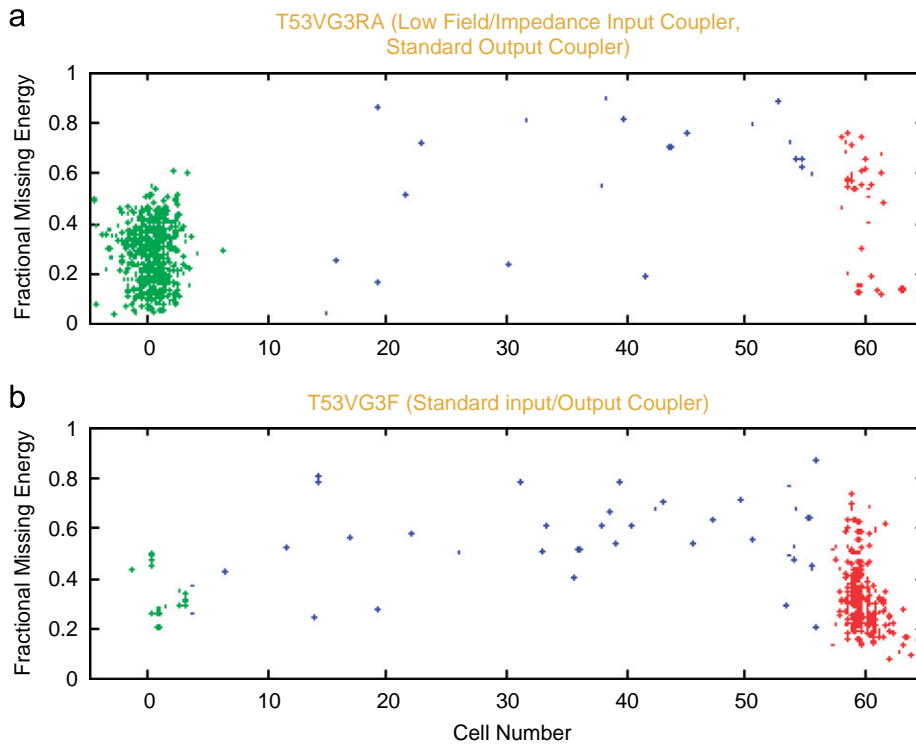
Fig. 15. Localization of RF breakdown by the use of RF analysis. One hundred and twenty hours of operation, at 60 Hz repetition rate, 400 ns pulse width. Electric field: 73 MV/m [17].

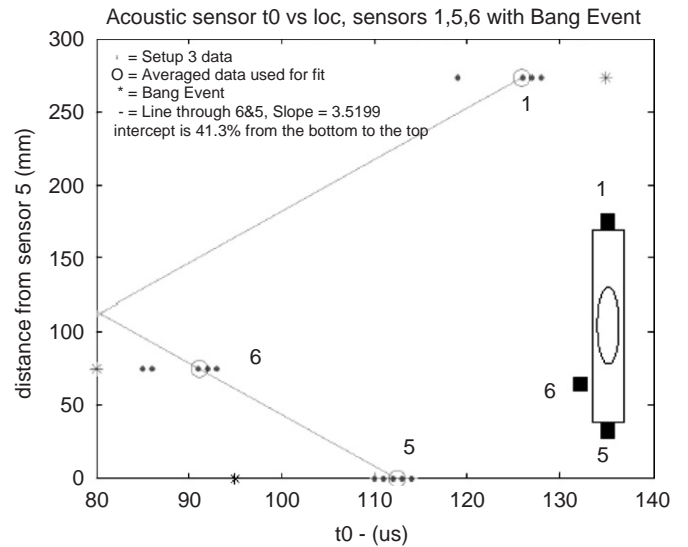
Fig. 17. Sensor distance from sensor 5 vs t_0 for the sensors mounted around the periphery of the rectangular waveguide (see lower right hand corner for positioning of the sensors) at its connection point to the coupler cavity. Sixteen events are indicated by the dot symbols and the single large “bang” event is indicated by *. The circles show the mean t_0 of the 16 events [18].

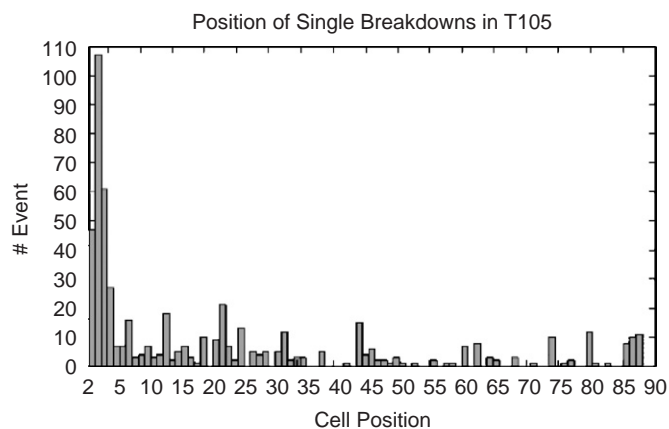
Fig. 20. Manual localization (events vs cell position) of single breakdown inside T105VG5 at 240 ns RF pulse length.

A clear asymmetry could be seen each time the input coupler was arcing. This asymmetry was similar to the video data recorded for one of the RF processed Standing Wave (SW) structures [19]. As a result of monitoring activity in structures, we found that most of the breakdowns were localized at the beginning of the structure, Fig. 14 (right) and Fig. 20. The location of single breakdowns in the T105 (travelling wave structure 105 cm long) is presented in Fig. 20. Sensors are located every six cells starting at cell 2. The localization of every breakdown

is done manually by analyzing every event and interpolating the timing and the intensity of the response of the sensors. The data shows clearly a serious problem in the input coupler, and also, to a lesser extent in the output coupler.

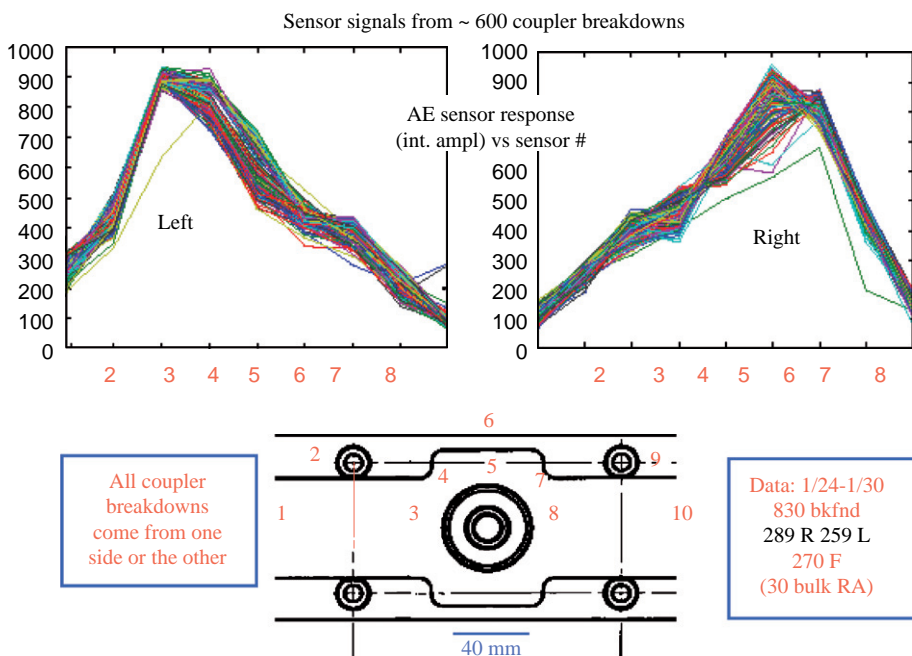
Fig. 19. Localization of breakdown inside the input coupler of T53VG3RA.

were also happening in the arm of the waveguide. As a result a certain number of sensors were moved from the body of the structure to the arms and to the input coupler, Fig. 18. The results of the acquisition are shown in Fig. 19.

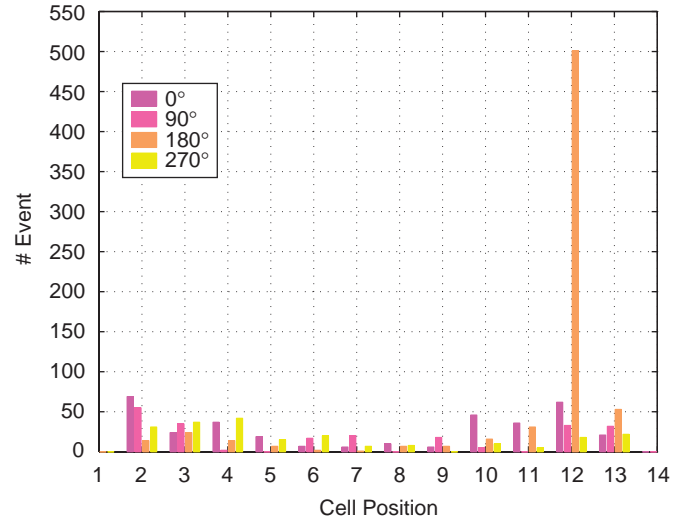
Fig. 23. Position of RF Breakdown in H90VG5 after processing at 50, 100 and 240 ns pulse length. Four acoustic sensors are placed around each cell 90° from each other, and thus on the first 13th cells of the RF structure.

structure (90 cm long 5% group velocity) one cell had more breakdowns than the neighboring cells, cf Fig. 23. As the cross check between RF analysis and the acoustic measurement was not concordant, visual inspection and an autopsy were performed. On the predicted cell, we discovered many craters, indicating more intense activity as well as a piece of aluminium foil sitting on the bottom of

the structure [20], labelled 180° in Fig. 23. Sensors were located in a similar arrangement to Fig. 1, 0° being the top of the structure.
