Results on an RF Pulsed Heating Experiment at SLAC

D. P. Pritzkau and R. H. Siemann

Presented at 20th International Linac Conference (Linac 2000) ,
8/21/2000—8/25/2000, Monterey, California, CA, USA

Stanford Linear Accelerator Center, Stanford University, Stanford, CA 94309

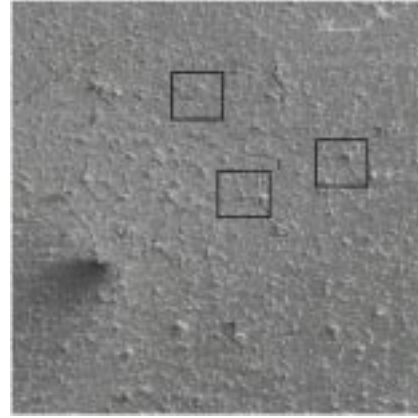
The endcaps were examined with a scanning electron microscope using secondary emission and a 5 keV electron beam. Figure 2 shows a region where maximum damage is expected. Note that this endcap pictured is different from the one shown in Figure 1; however, all four endcaps are similar in appearance. The little bumps along the surface are the copper globules sputtered from breakdown at the coupling iris. More importantly, one can easily see the numerous cracks that have occurred on the surface. For comparison, a region at the center where the temperature rise is close to zero is shown in Figure 3. This picture was taken at the same magnification. There are no cracks in this region. The copper globules are also noticeable here. Because of the sputtering, we cannot isolate the unloaded Q degradation shown in Table 1 due to sputtering from that due to the presence of the cracks.

Figure 2: Region (0.9 mm × 0.9 mm) where maximum damage is expected. The scale in the upper right-hand corner is 100.7 μm. Figure 4 has higher magnification images of the indicated regions.

taken. For the endcap shown in Figure 2, the average location of all higher-magnification images of cracks is approximately 10.4 mm from the center with a standard deviation of 1.3 mm. Close-up shots of a few of these cracks are shown in Figure 4.

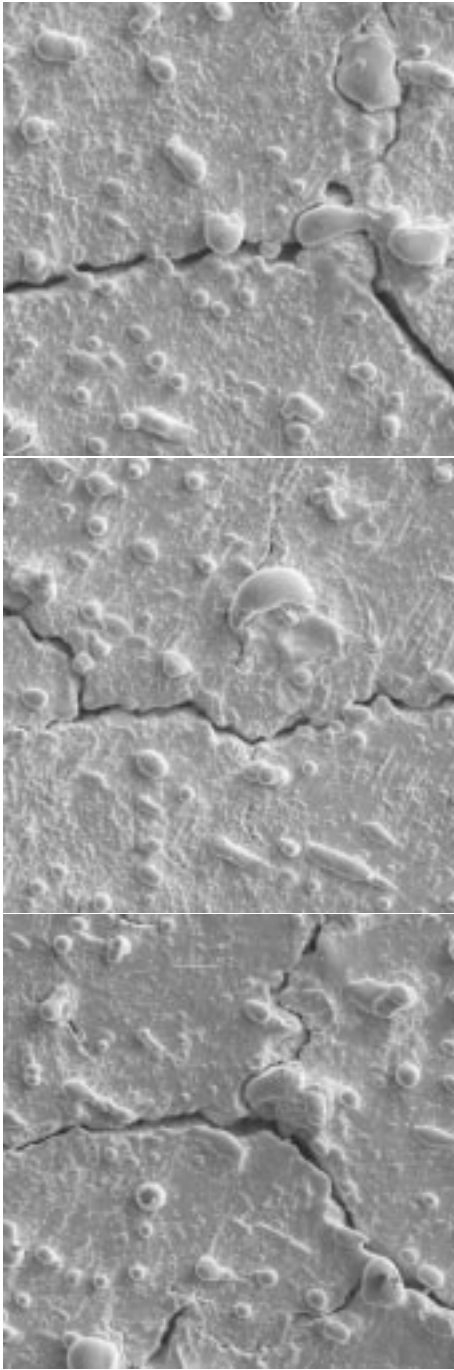
Figure 4: Regions 1–3 from Figure 2. The scale shown in each image is $10.0\ \mu\text{m}$.

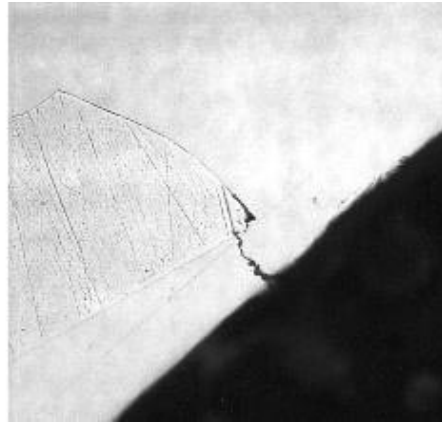
An internal cross-section of the endcap shown in Figure 1 was completed. Not as many cracks were evident in the cross-section, but they did occur in the region of maximum temperature rise. One interesting crack is shown in Figure 5. It begins at the surface and propagates down to an internal grain boundary. Afterwards, the crack propagates along the grain boundary.

Figure 5: A cross-section of the endcap shown in Figure 1 showing an internal crack in the region of maximum temperature rise. The crack extends $24\ \mu\text{m}$ into the surface before touching the grain boundary.

We have demonstrated that RF pulsed heating with a temperature rise of 120 K poses a danger to OFE copper structures. The evidence is the surface modification and damage shown in Figures 1, 2, 4 and 5. We have measured degradation of the cavity Q_0 also. Because of copper sputtered from breakdown at the coupling iris, it is not conclusive that this degradation was caused by the surface damage.
