Development of Double-sided Silicon Strip Detector

H. Park (BAERI, KNU)
On behalf of Korean Silicon Group

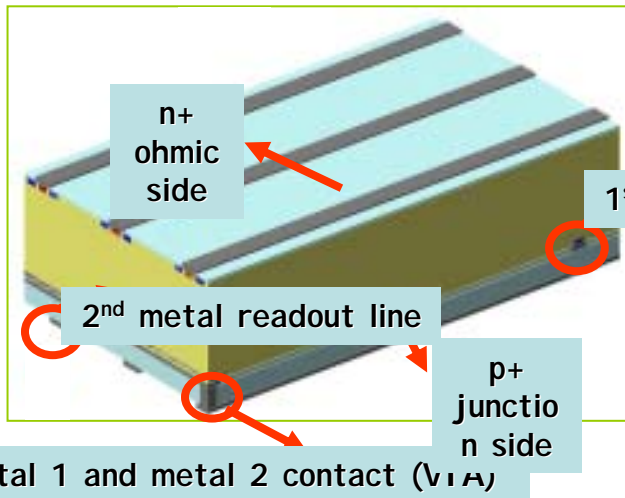
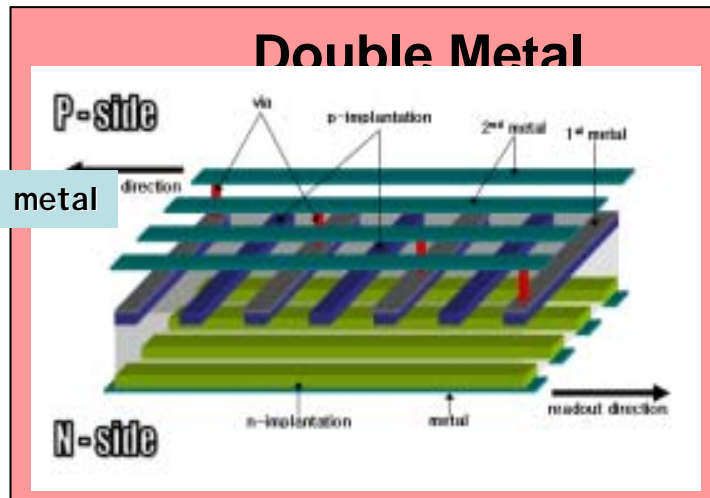
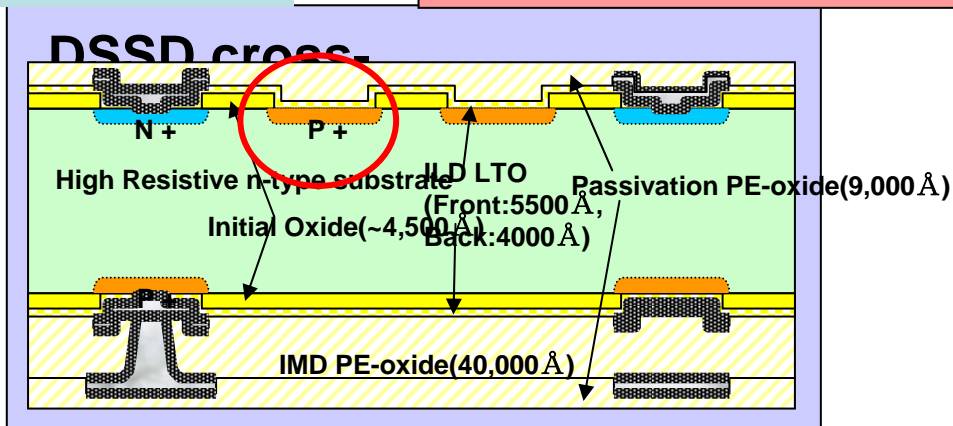
- We fabricate DSSD (no company involved; a fab in research inst.)
- 5" wafer is used

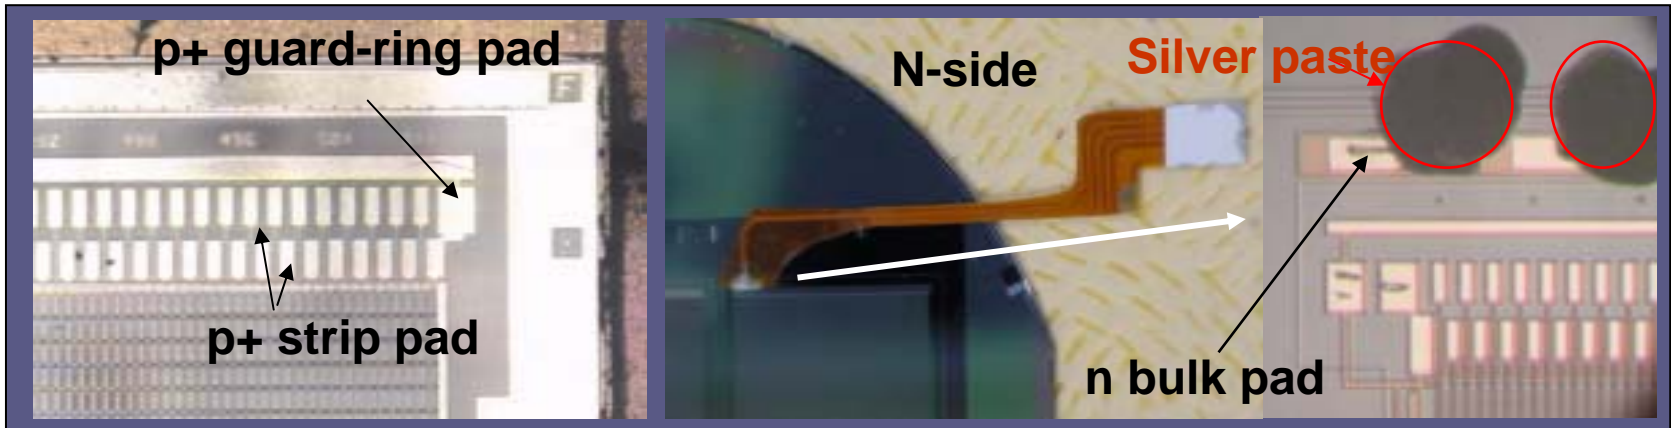
Scope

Wafer

positioner

p+ guard-ring pad

p+ strip pad

N-side

Silver paste

n bulk pad

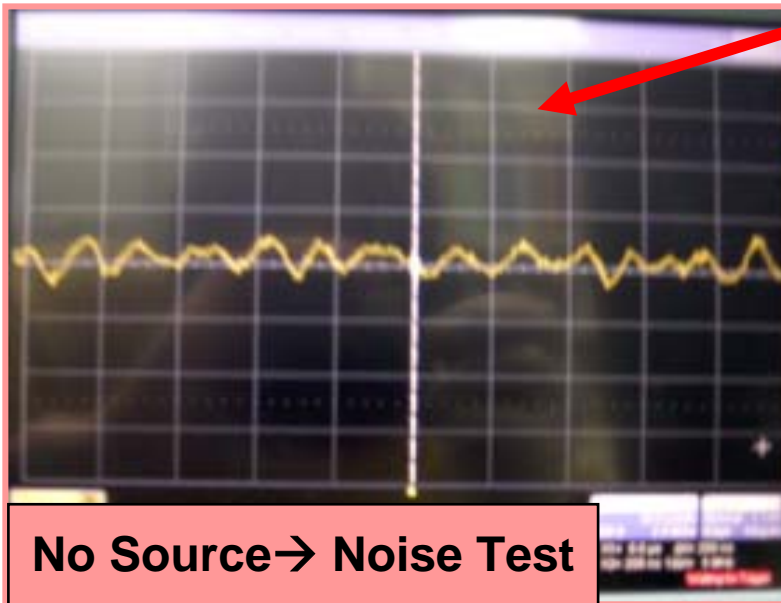
Dark Box

No Source → Noise Test

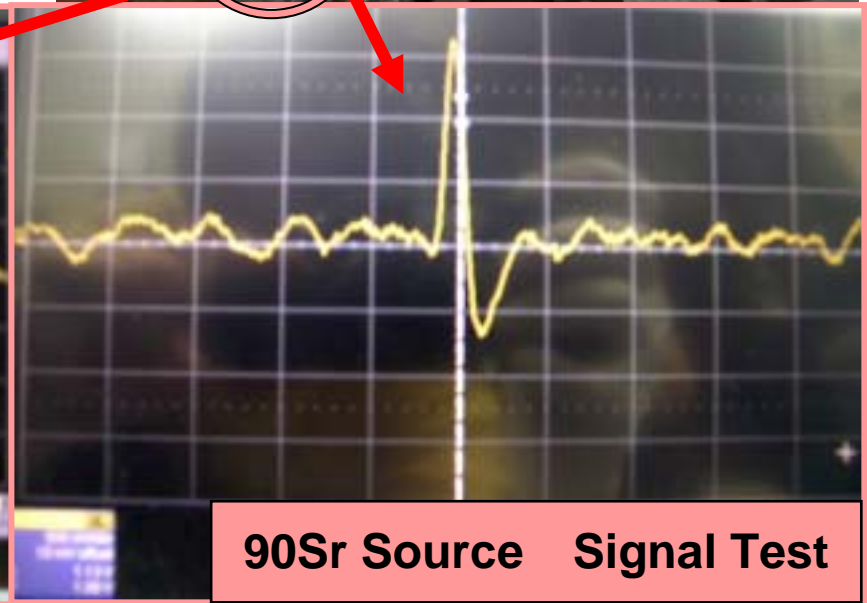
^{90}Sr Source Signal Test

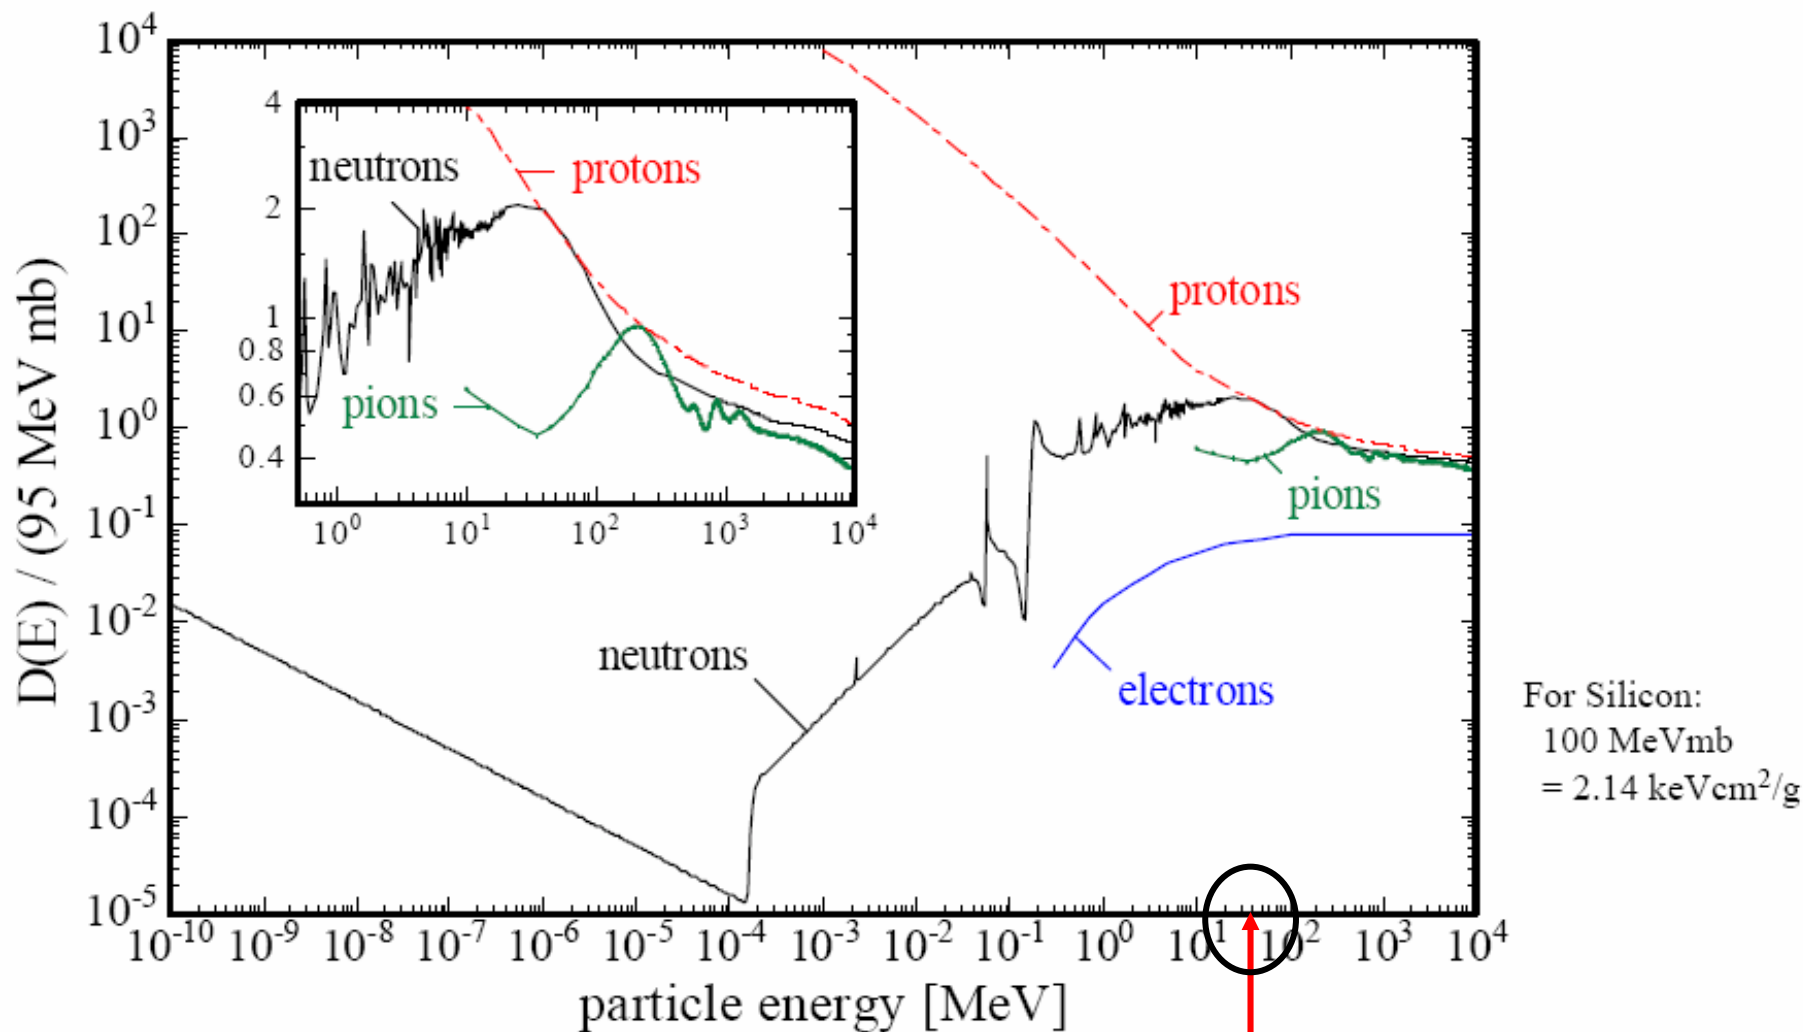
Displacement damage functions

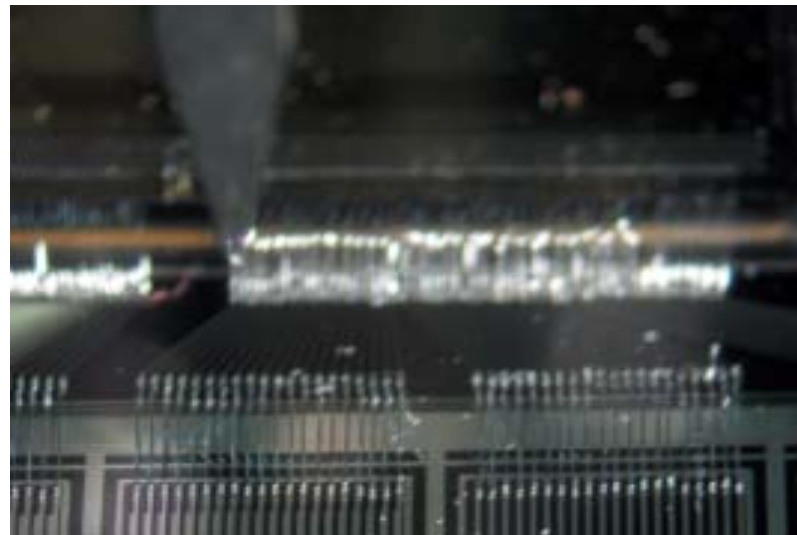
A type Readout pads are
In Guardring

B type Readout pads are
out Guardring

Region1-original

Region2-1/2 [read/strip]
Al Floating

Region3-overhang

Region4-overhang

Region5-1/4 [read/strip]

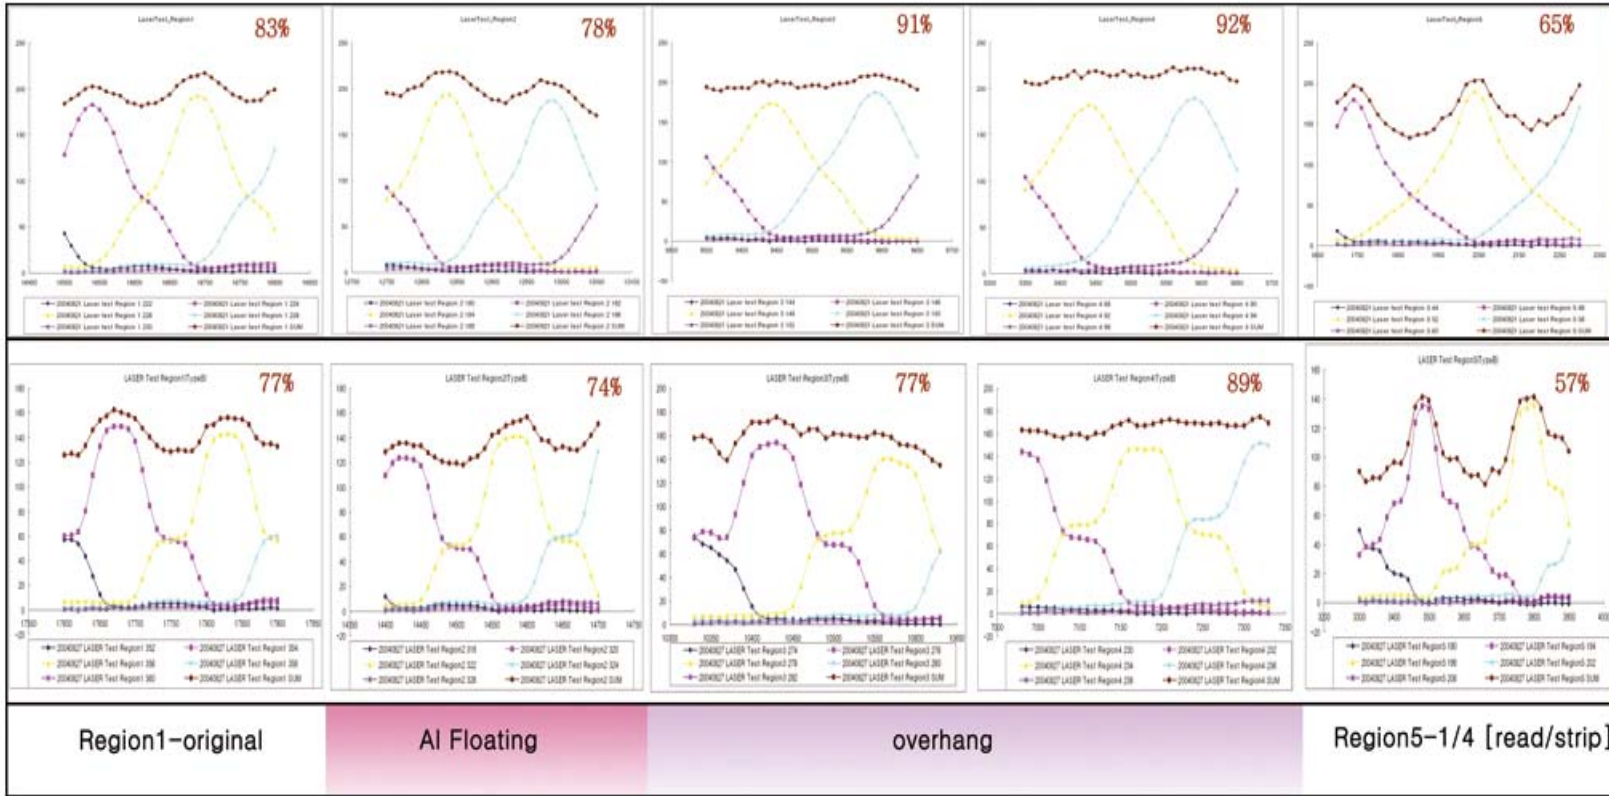
*전하수집효율(%)=최저값/최고값*100

결론 : Type A가 Type B 보다 좋다.

Floating Strip(Region2) 결과가 기대보다 좋지 못함

Overhang (Region3,4) 전하 수집 효율은 좋으나, 정확한 위치 파악 여부에 대해서는 조사가 더 필요

Region5 는 ReadOut 채널이 다른 센서 보다 적기 때문에 효율이 떨어짐

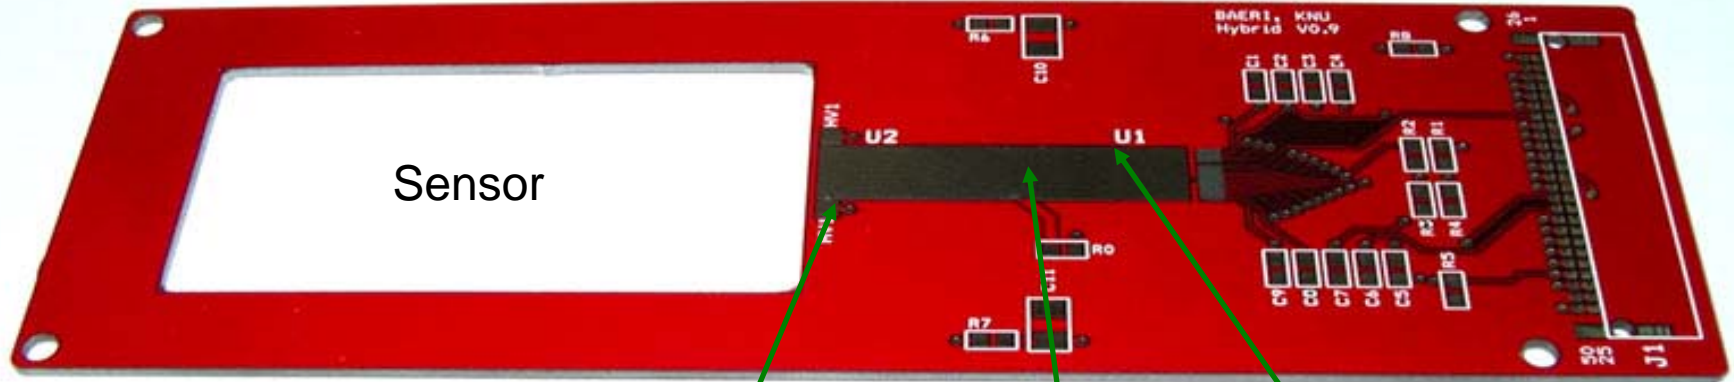
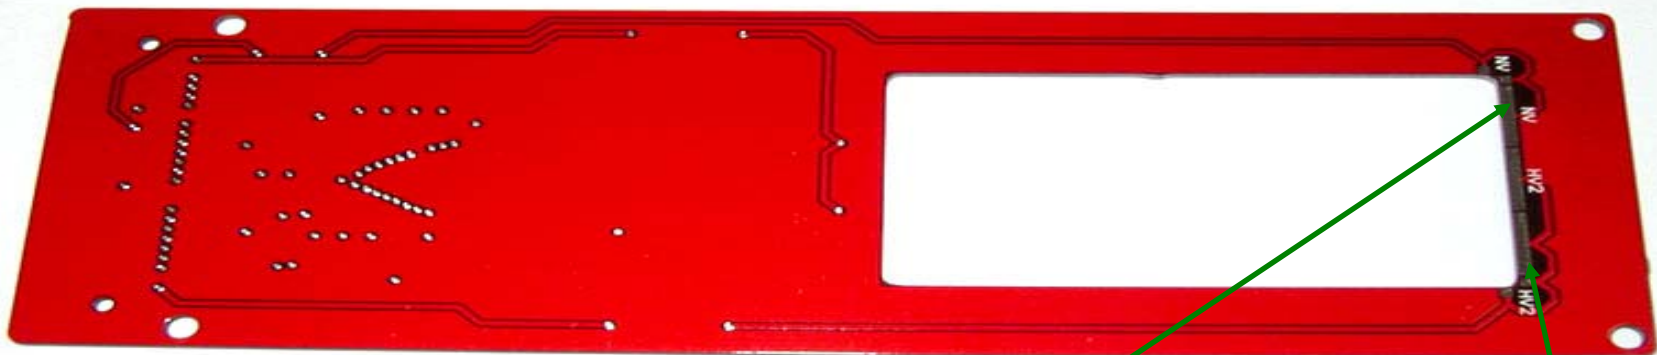
Hybrid Board: 1st prototype

1st Bias

RC Chip

VA Chip

15V Supply

2nd Bias
