# RPC experience: Belle, BaBar and BESIII

ALCPG Workshop, Snowmass, August 14-27, 2005  
Changguo Lu, Princeton University

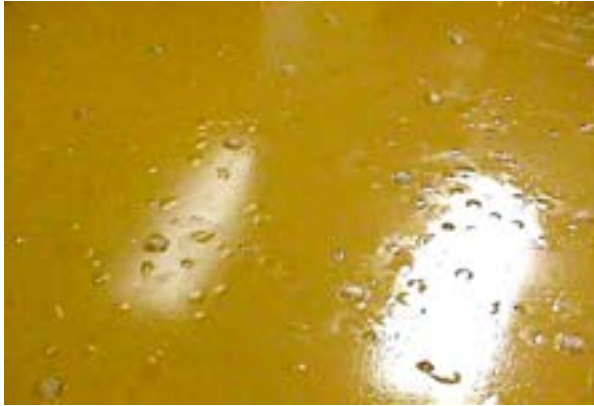
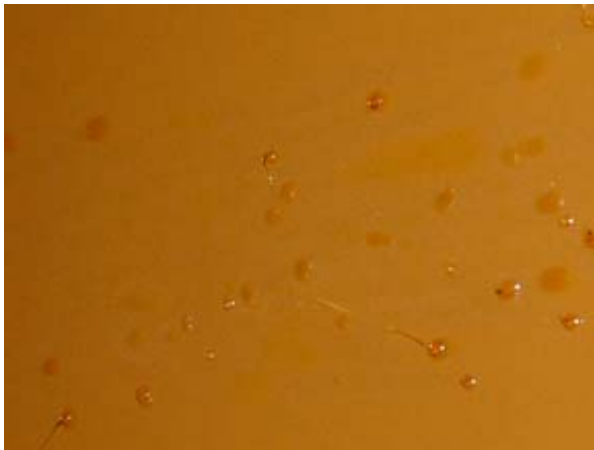
## Autopsy of the bad RPC chambers: Linseed oil stalagmites

Three basic conditions for forming linseed oil droplets on the inner surfaces of RPC :

- **Enough linseed oil** existing on the surface, which is the source of the droplets;
- **Elevated temperature** to soften the oil film, make the oil molecules movable;
- **High electric field** to help pull the soften oil layer away from the Bakelite sheet. Electric force could be 70 times stronger than the gravity force!

Unfortunately all three conditions were meet for the BaBar RPC chambers in summer 1999 !

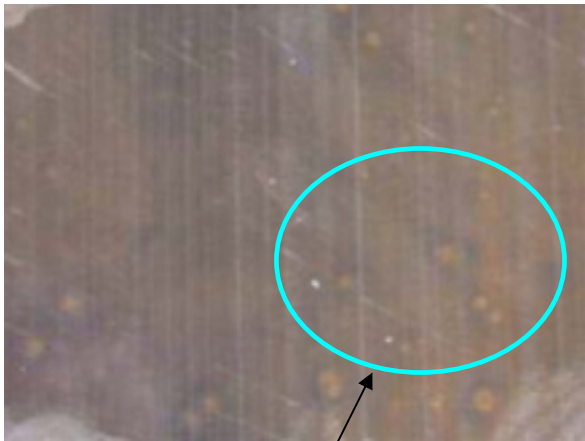
The anode side graphite film of a dead RPC with low dark current, low capacitance and almost zero efficiency. It shows semitransparent looking, indicates vanished graphite.

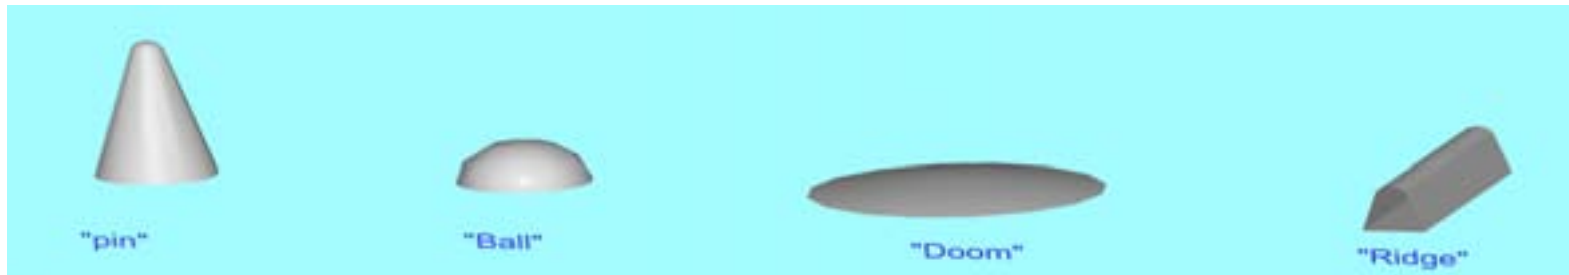
We have calculated four types of surface defects as illustrated bellow: the tips of "pin" and "ridge" have been rounded,  $R = 0.5\mu\text{m}$ , the height is the distance from the base to the tip (before being rounded).

For 2mm gap, 1000V across the gap:

The FEA calculation shows that “pin” is the most serious surface defect in respect of the surface electric field variation. IHEP’s Bakelite surface may have its advantage in this regard, therefore they can abandon the oil coating on the surface.
