ALIGNMENT DESIGN AND STATUS OF TAIWAN PHOTON SOURCE

National Synchrotron Radiation Research Center, No 101, Hsin-Ann Road, Hsinchu 30076, Taiwan

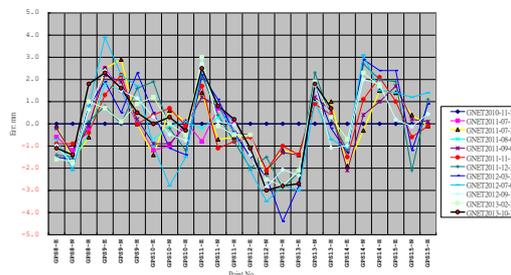
Considering the variation of outdoor temperature, the GPS fiducial points are made by granite to reduce the effect of thermal variation. After the one year of construction, the GPS fiducial points seem to stabilize within time, as shown in figure 2.

Figure 2: The variation of GPS fiducial points

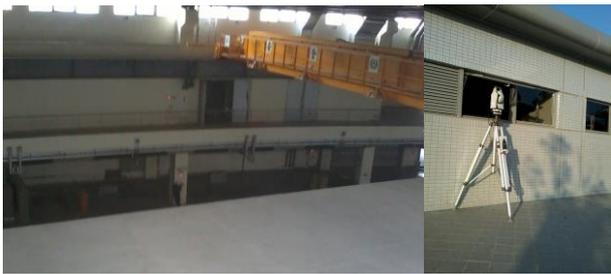
The coordinates of fiducial points is needed to be recorded as well as the current temperature. To construct the fiducial points of survey network, there are several windows installed on the inner wall in the TPS construction that are available for surveying through an outdoor laser tracker (AT401), as shown in figure 3. It can provide the longer chord length to correct the error propagation from the imprecise geometry of the TPS ring.

Figure 3: The survey window of TPS

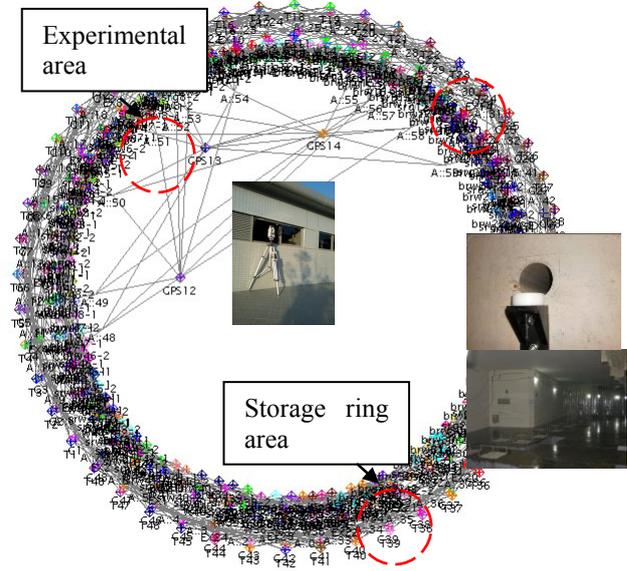
There are also two survey holes on each shielding wall, and the survey targets are installed on the two side of the wall, as shown in figure 4. The survey network could then be connected so that the storage ring and the experimental area could then be observed by these holes. Thus, by using the two methods mentioned above, the whole survey network can be expanded, as shown in figure 4. After the wide network has been constructed, we can then have a much precise fiducial point for alignment.

Figure 4: The survey network of TPS.

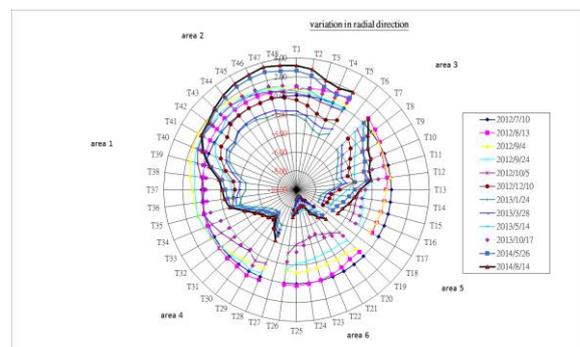
For the requirement of construction, the concrete floor is constructed 6 times until it is completed. The sequence of the concrete floor of construction is from area 1 to area 6. The area from T18 to T26 is the last one to be grouted, and it was constructed on June 2012. Other than the sixth area, the building was contracted about 5mm and the variation of temperature is approximately 15 °C from July 2012 to January 2013. From January 2013 to May 2013 the building was expanded at about 3mm and the variation of temperature is then 10 °C, as shown in figure 5. According to these data base, the construction of TPS should be influenced at about 0.3mm per °C. The alignment of pedestals was started in June 2013, and the closest data base observed is on 14 May 2013. The temperature at that moment is around 28 °C, after the air condition is installed, the whole building will then be reduced to 25 °C. According to this condition, the pedestals were aligned with the shift of 1mm.

Figure 5: The variation in radial direction with time

The air condition of TPS is operated on May 2014, and the internal temperature is controlled at 25 °C. In figure 5, the variation of the survey network is only about 1mm even if the change of temperature compared to the external ring is to up to 5°C. More survey data is needed to be recorded to understand the temperature effect on the

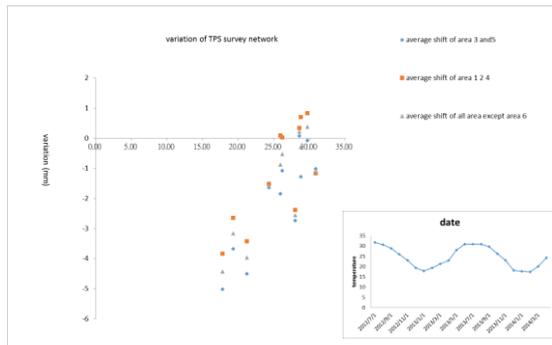
After the alignment of pedestals is completed, the coordinates of fiducial points were surveyed in October 2013. The temperature interval of that time is about 25°C, but the contraction of the building is only about 0.3mm. There is maybe two reason that causes this situation; the first situation might be because the factor of the thermal extension has been fitted in with the data base roughly, as shown in figure 6. The second part is from the error of the survey. The repeatability of the TPS survey network is 1mm(±0.5mm).

Figure 6: The Variation in radial direction with temperature

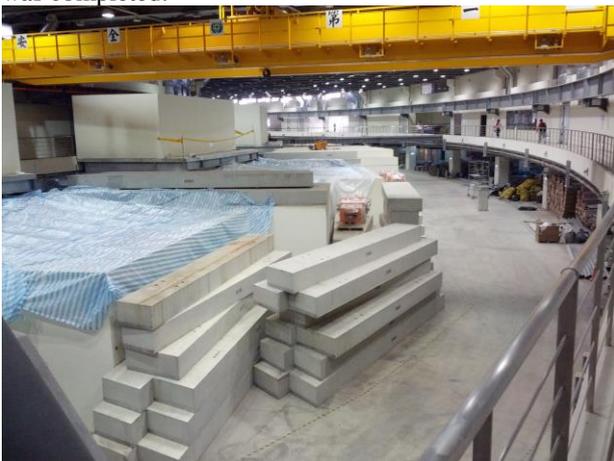
For the requirement of installation and repair of the cement ceiling, the cement ceiling were then removed and been placed on the experiment area from October 2013 to May 2014, as shown in figure 7. That is the reason for the data of survey network to be incomplete for a long time. If the area of survey network is just in the storage ring area, the repeatability of the TPS survey network would be approximately 2 mm. Thus, the data of survey network was recorded again when the installation and recondition was completed.

Figure 7: The state during installation and repair of the cement ceiling

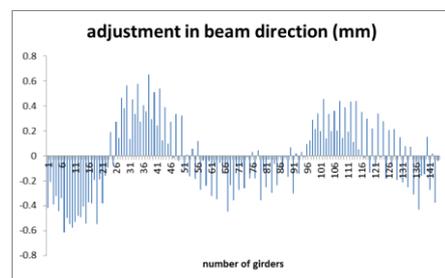
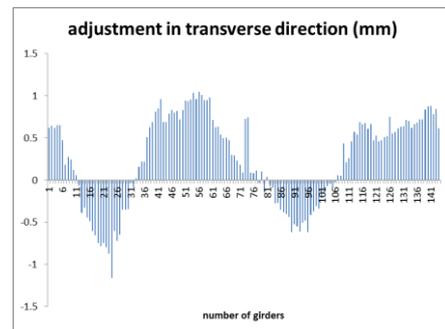
building in the future. In figure 8, the adjustment of the whole ring girders are less than 1mm. the reason is that the temperature on October 2013 is close to 25°C, and the temperature of building now is also controlled to 25°C under air condition. Even when the building has been placed for over 6 months, the structure of the survey network has not changed seriously. The position data from the survey network can therefore be defined as a basis for the motorized girder system for auto-tuning and will then be applied to improve the accuracy of the alignment [1,2]. When the amount of adjustment needed to adjust is within 1mm, the adjustment time for the auto-tuning is approximately 30 minute per cycle.

Figure 8: The adjustment of TPS on May 2014
