8 August 2005

Gamma-ray Large
Area Space
Telescope

GLAST Large Area Telescope: AntiCoincidence Detector (ACD) Pre-Ship Review

ACD Team
NASA Goddard Space Flight Center

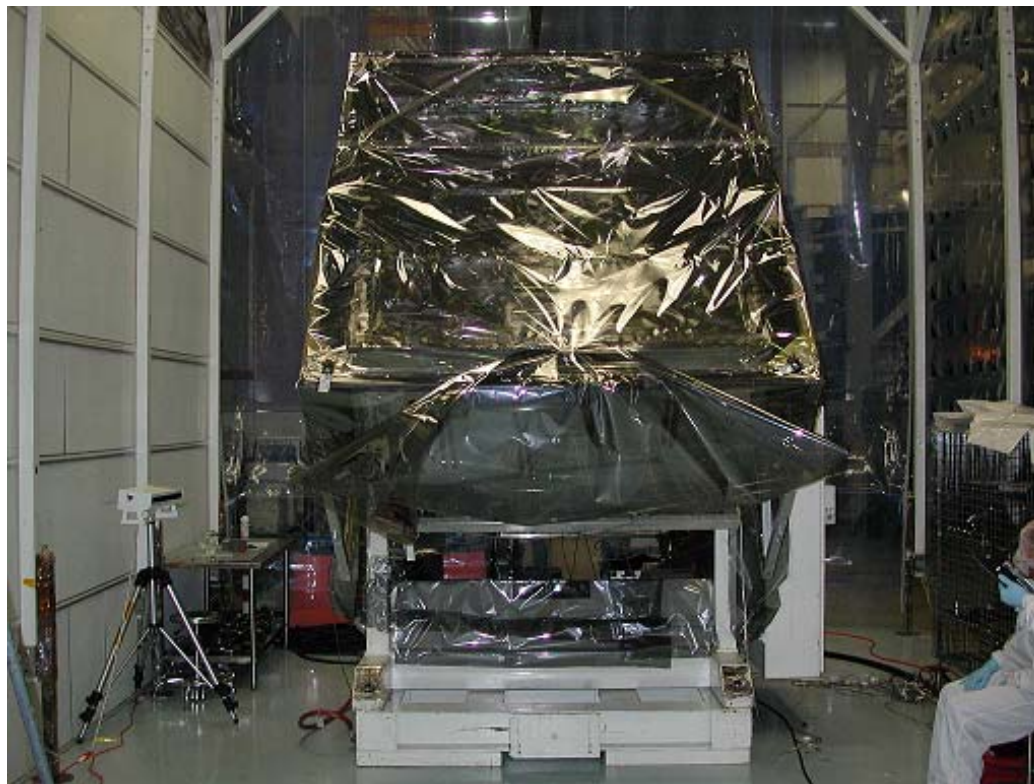
- ◆ **Completed ACD functional and performance testing.**
 - *This required that the ACD be rotated on its side to orientate the side Tile Detector Assemblies perpendicular to the flux of Cosmic Ray Muons.*

ACD being rotated on its side (cover in place to provide protection from Helium exposure) for performance testing

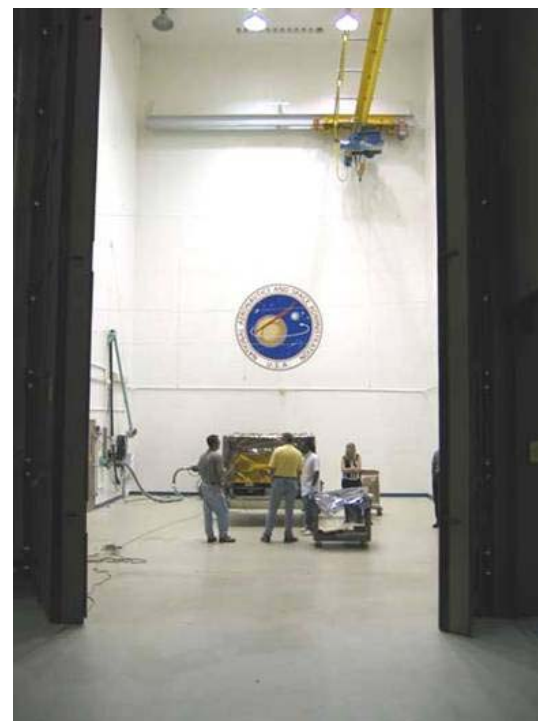
The ACD in the acoustics chamber

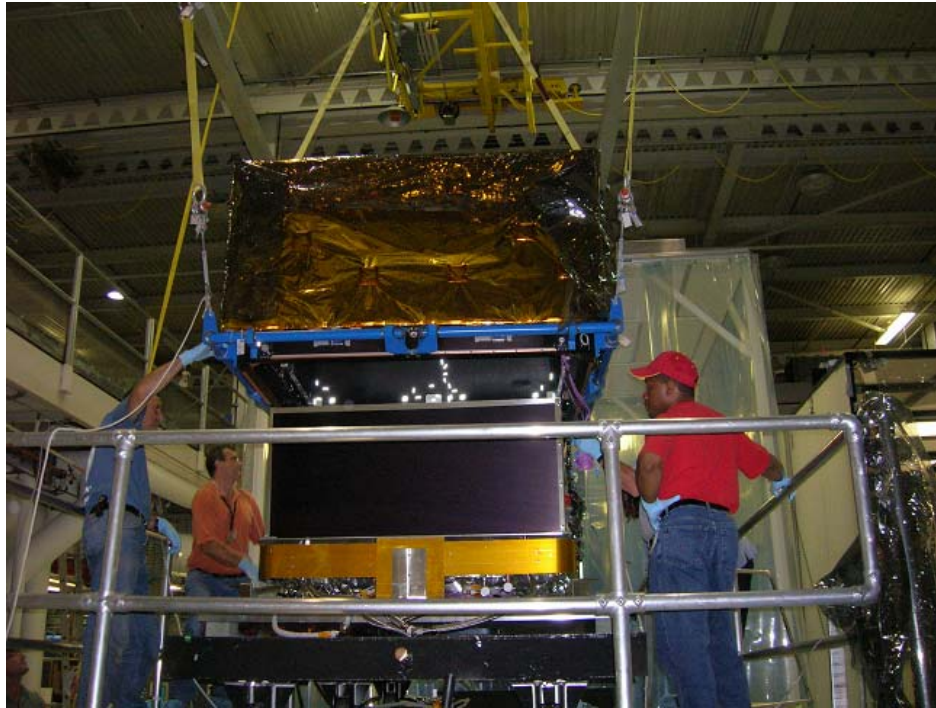
Lowering the ACD over the Tracker thermal simulator (required to drive the temperature of the ACD)

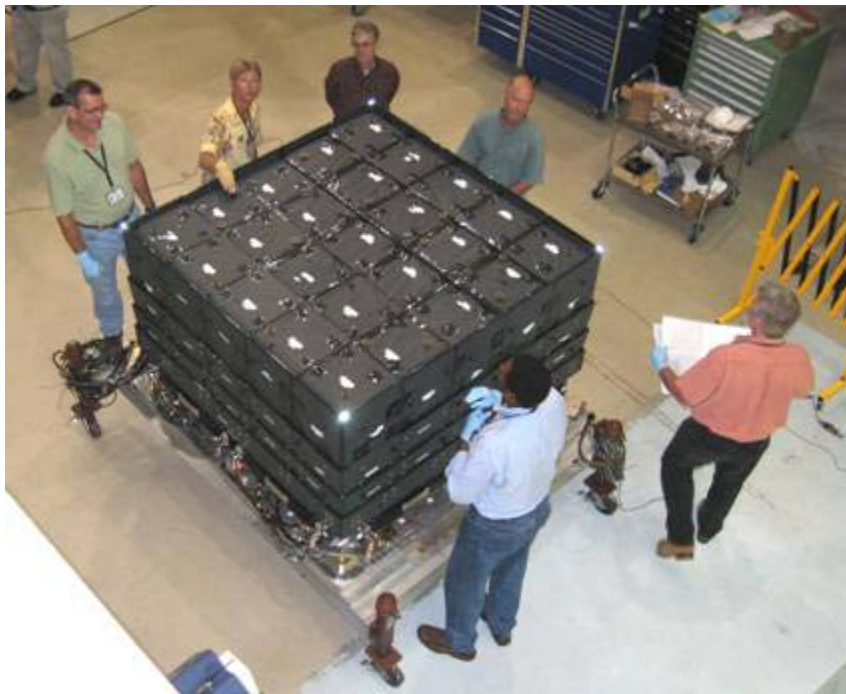
Completed ACD, with all detectors and electronics

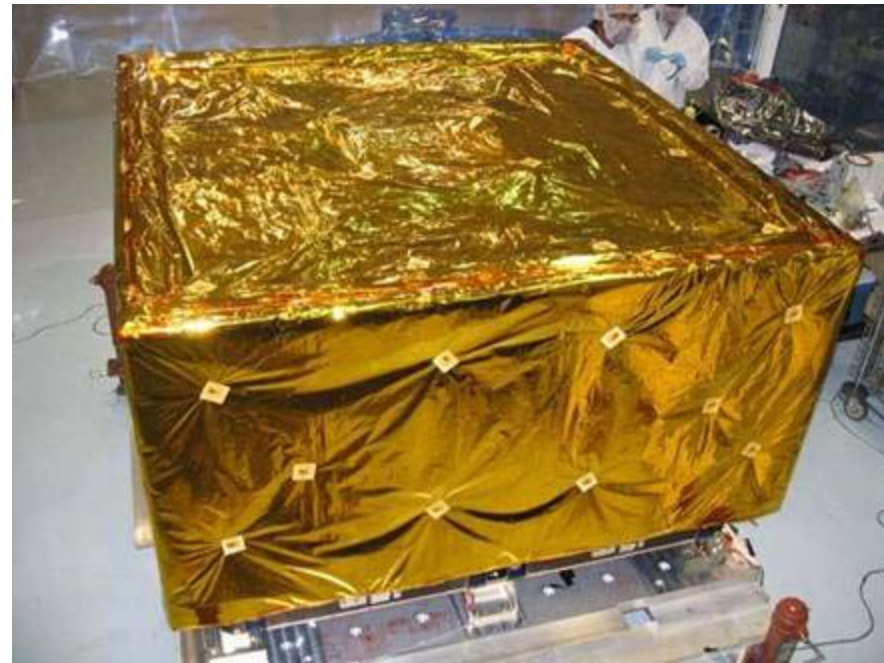
ACD with Micrometeoroid Shield and Multi-Layer Insulation (except for Germanium/Kapton outer layer)

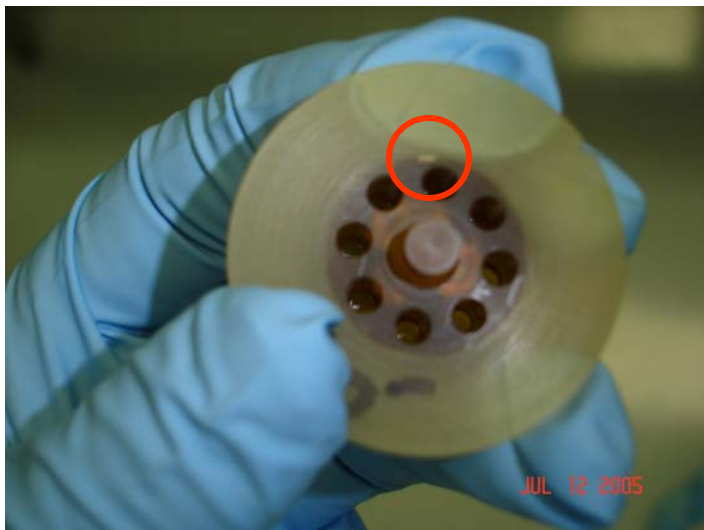
- One cracked MMS post in place on +X side as shown
 - Passed test without catastrophic failure
 - Will replace with acceptance tested post
- Drawing Configuration could not be met with hardware delivered
 - EO produced to reflect what we tested and what will fly

A cracked -9 EO #4 post (1) was used in the left middle position marked "E" as per MMS Installation Assembly, GE2054591 on the +X Side of the MMS. This was instead of a -7EO#4 post.

- ◆ *The fabrication shortage and test schedule drove decision to substitute existing posts for the redesigned posts, some of which arrived with cracks and were rejected.*
- ◆ *However, the best of the cracked -9 EO #4 posts (1) was used in the left middle position marked "E" as per MMS Installation Assembly, GE2054591 on the +X Side of the MMS.*
- ◆ *This decision was strictly for test and the post is planned for replacement with a flight tested post after Environmental testing is complete.*
- ◆ *Environmental qualification tests on replacement posts completed.*

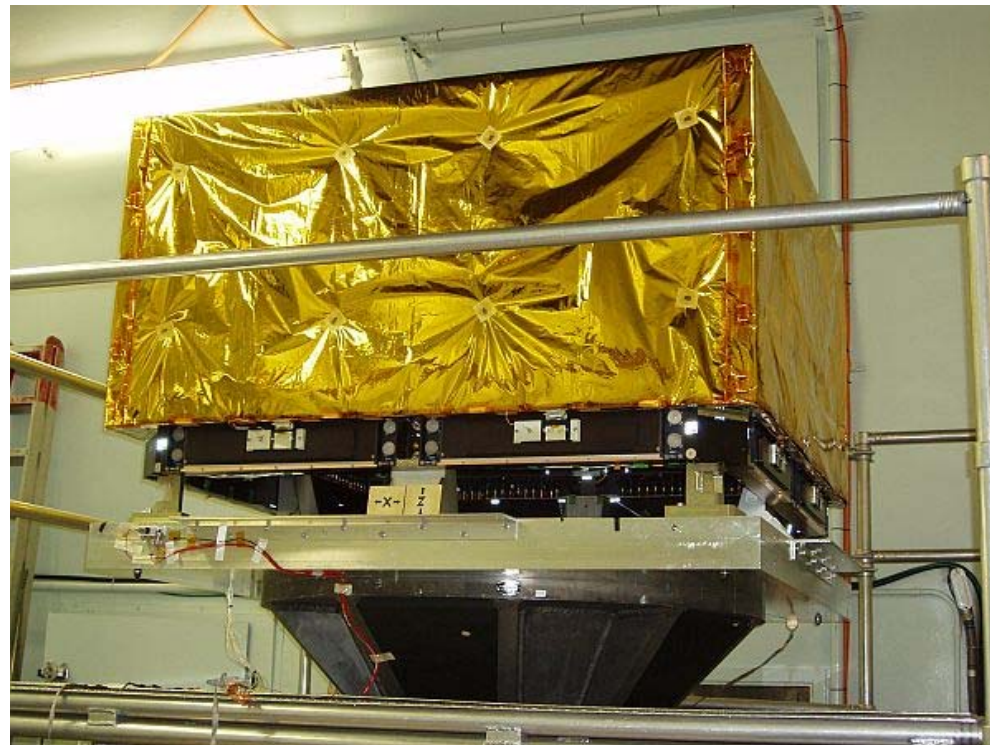
- ◆ ***ACD Shown in Z- Axis Test Configuration on the vibration fixture***
 - *2" plate and additional 3" plate for thrust axis vibration (z-axis only)*
 - *Eight mounting posts representing LAT I/F*

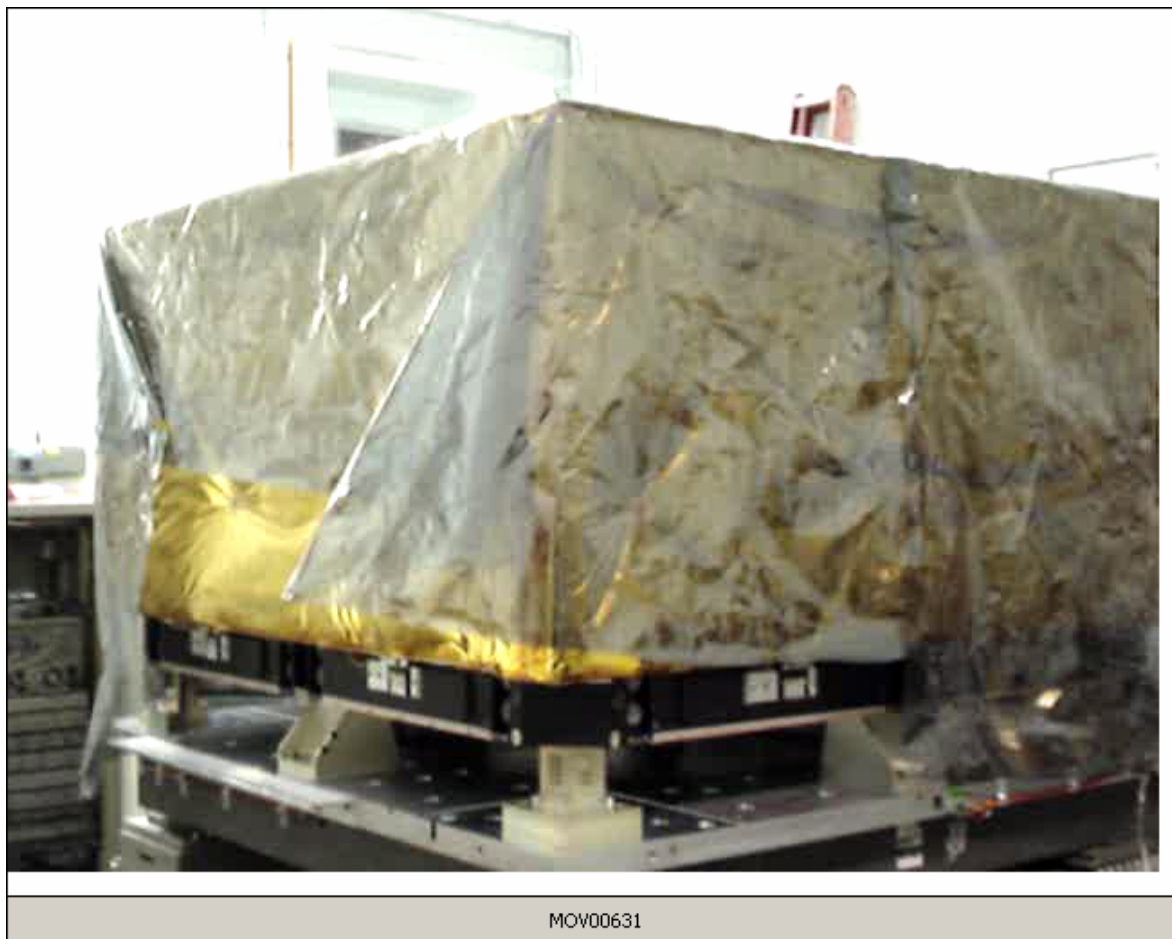
- ◆ *Lateral Axis Test and Test Configuration Shown*

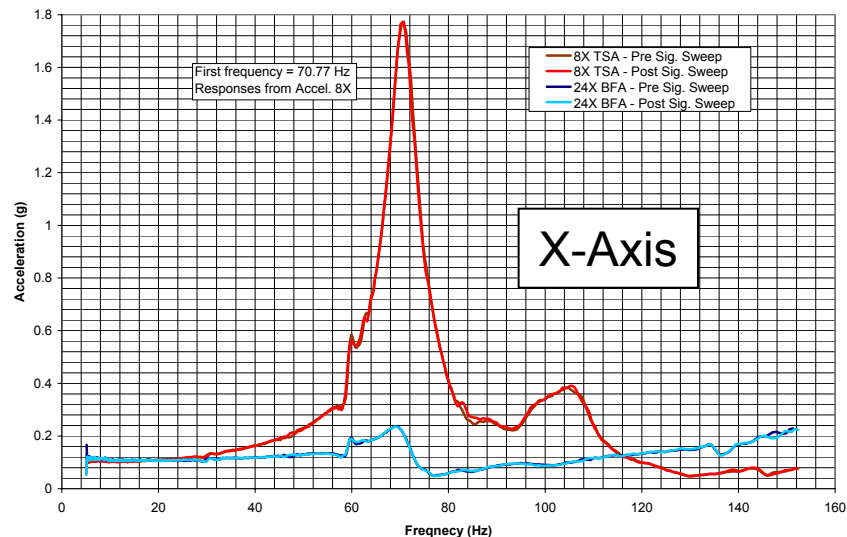
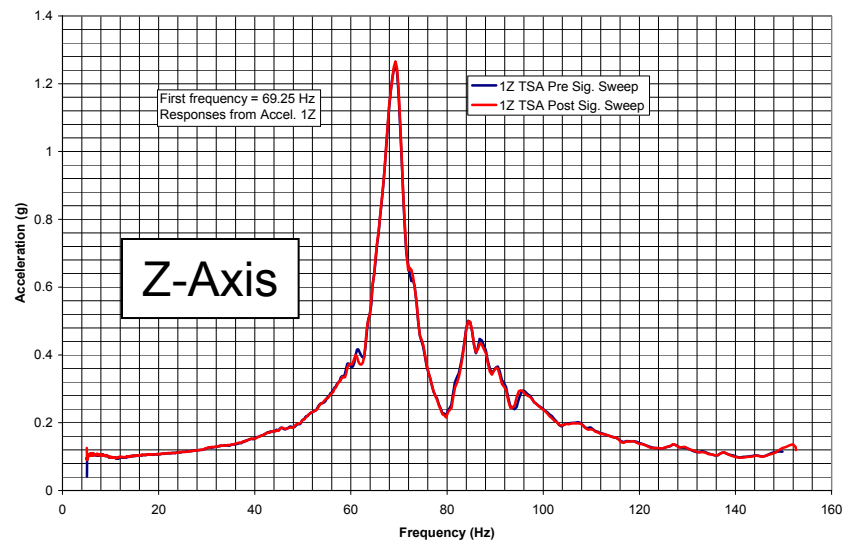
ACD Sine Vibration Test Results

– **Z = 69.25 Hz**

All first modes are on the TSA

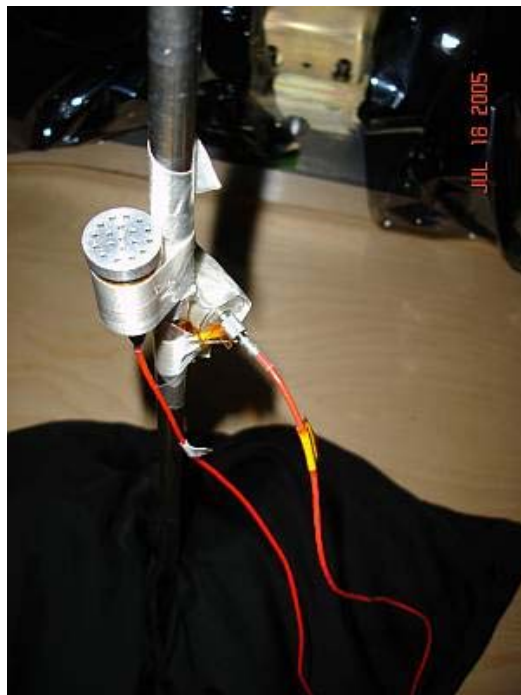
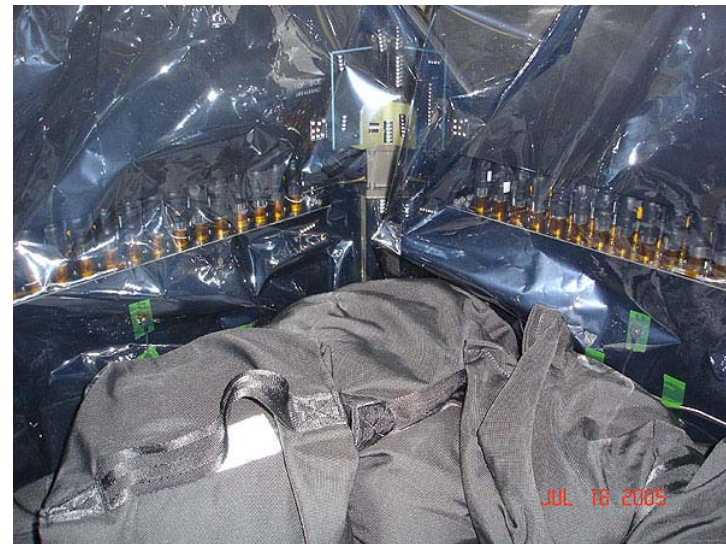
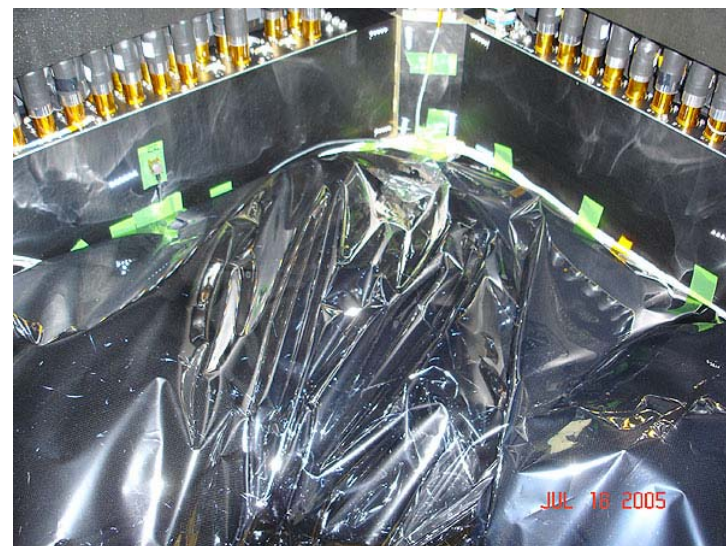
- ◆ Two internal microphones were placed inside the ACD cavity
- ◆ Sandbags were used to close out the cavity to simulate the presence of LAT

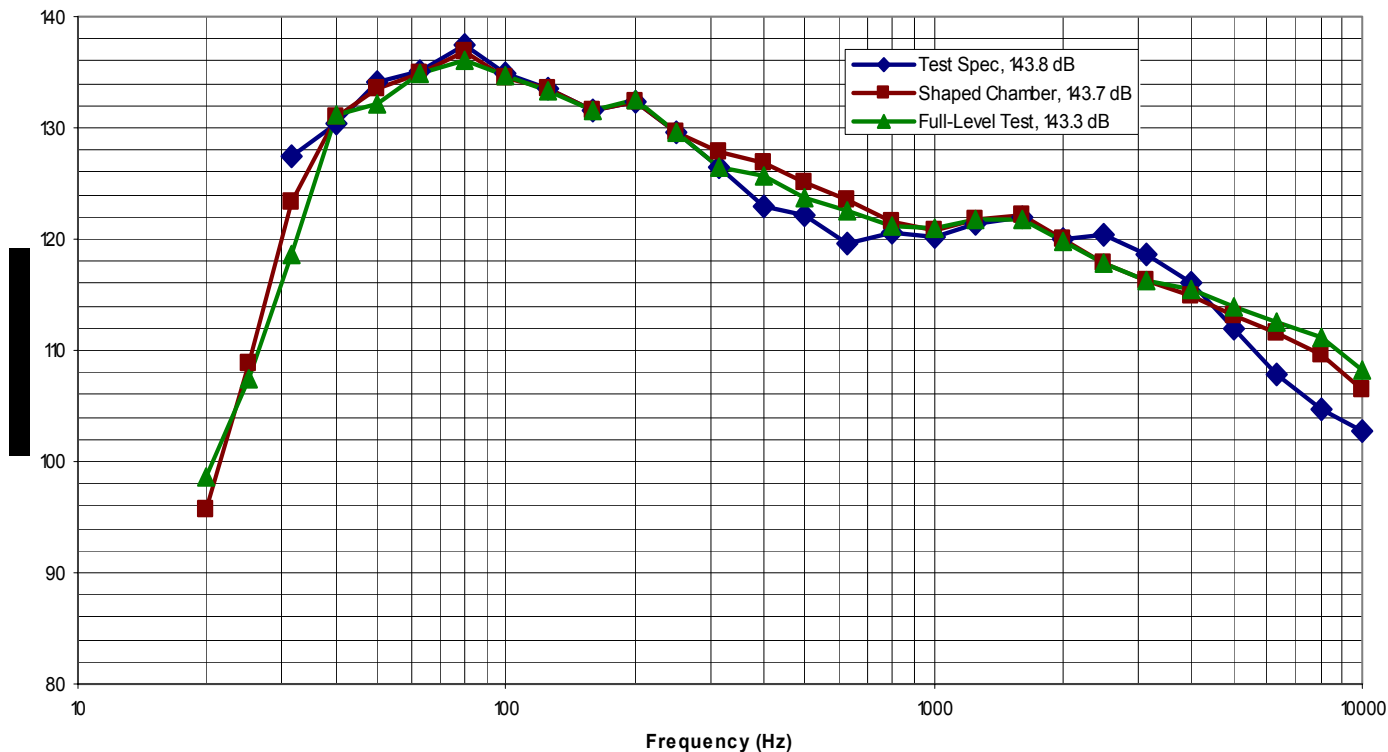
ACD Acoustic Test Results

- ◆ **Acoustic input was within protoflight specification**
 - *Input spec 143.8 dB*
 - *Shaped chamber at 143.7 dB (prior to bringing ACD in)*
 - *Final level 143.3 dB, well within the ± 3 dB limits*

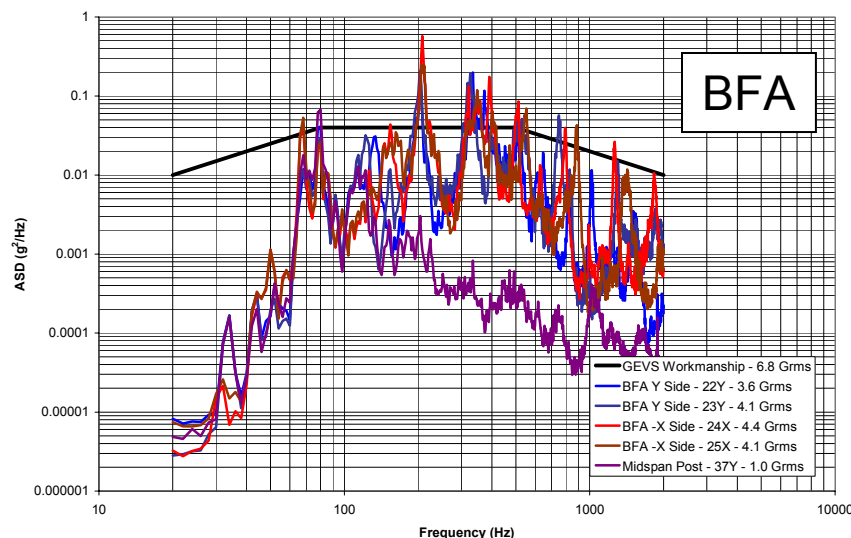
ACD Acoustic Test Results

- ◆ **ACD acoustic tests were nominal**
- ◆ **All responses were as expected**
 - *Prior component random vibration testing was to GEVS minimum workmanship level of 6.8 Grms (shown on plots)*
 - *Acoustic results show that minimum workmanship levels were conservative*
- ◆ **Chris Fransen, the GLAST acoustic analyst, is satisfied with the test results**
- ◆ **One post-test issue found (see next slide)**

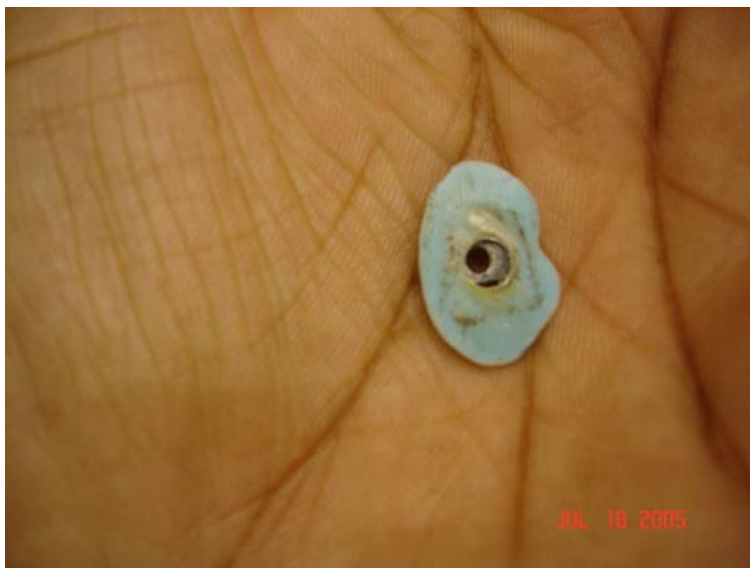
- A Nut Plate like those used to secure tiles to tile flexure was found on floor in ACD +X, -Y corner after testing was completed.
- Assessment
 - The Nut plate is believed to have been on ACD dolly before testing started. The nut plate in question had debonded from the angled shim it was mounted to during TDA installation and was inadvertently left behind. During acoustic tests it shook free. If this came off the flight assembly, analyses show that a tile mounted with 3 fasteners shows positive margin of safety.

Where do nutplates reside?

Where did this one come from?

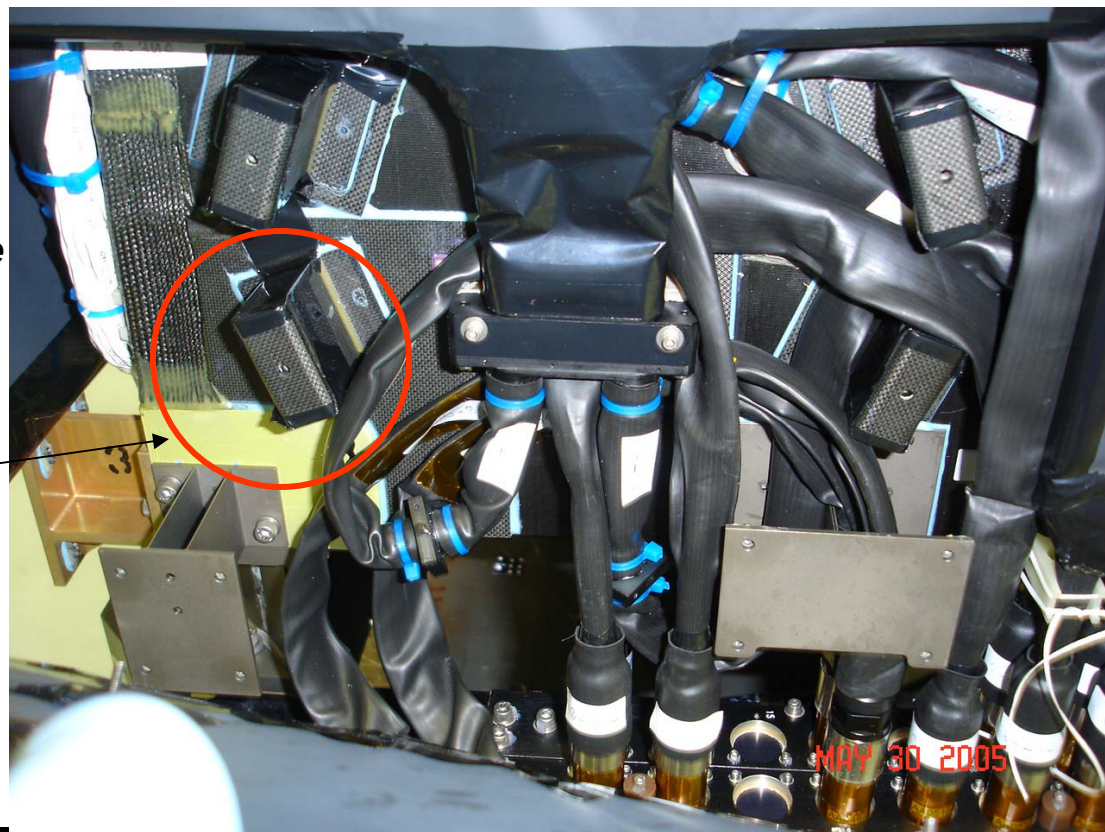
Meaning: It is unlikely that a loose nutplate would get 'free'

Example of a taped
Flexures are Shown

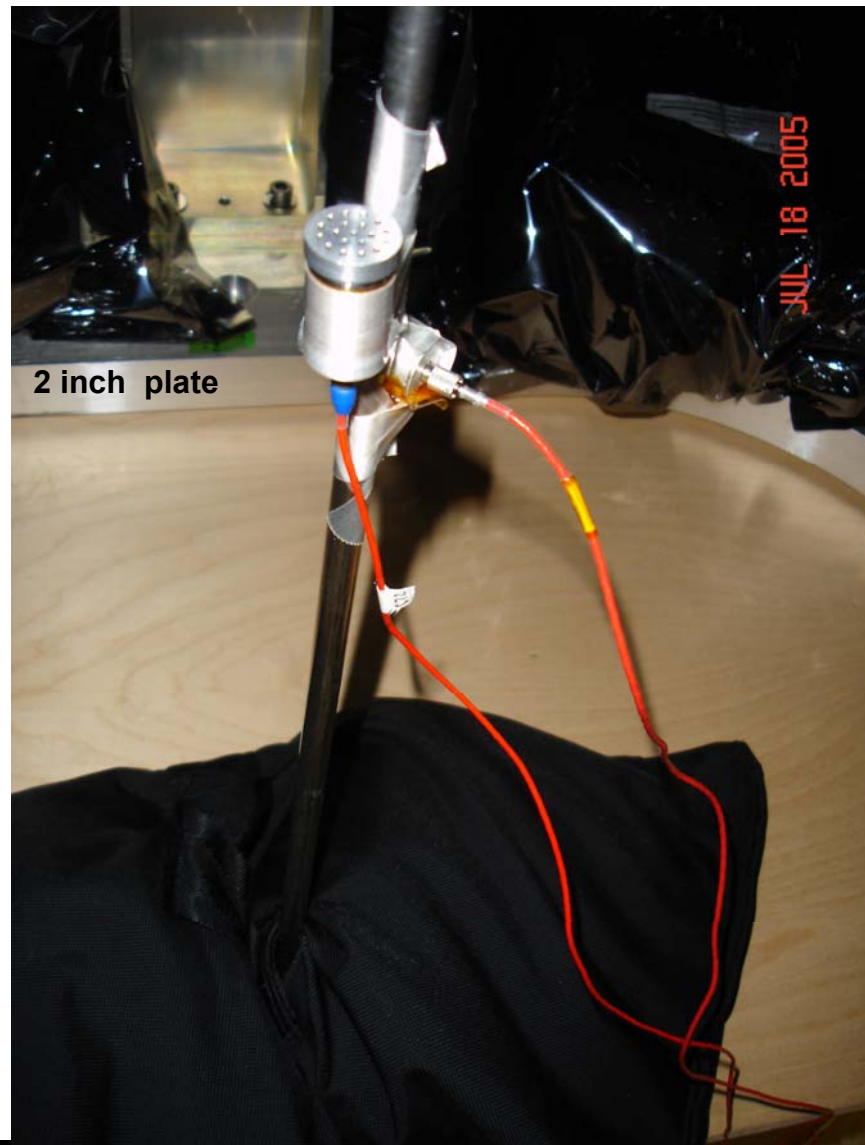
- The ACD had closeouts between the ACD and the 2" plate and covering the hole in the 2 inch plate
- Picture shows inside the ACD for the Acoustic test.
 - Notice: the wooden plywood used to closeout the 2" plate and the closeouts in place between the ACD and the 2" plate

- ◆ The ACD had closeouts between the ACD and the 2" plate and covering the hole in the 2 inch plate.***
- ◆ Post Acoustic Test Inspection revealed nutplate installation tool found in the +x, -y corner of the ACD dolly.***

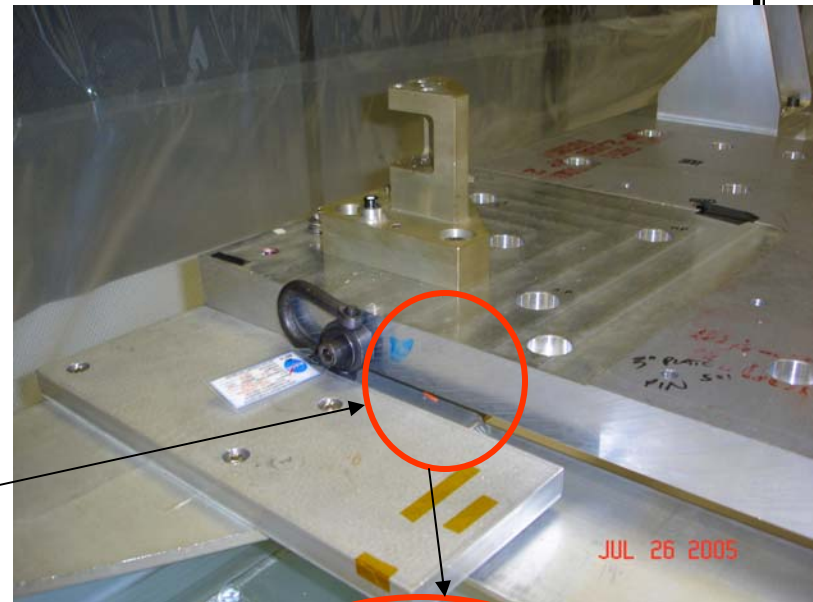
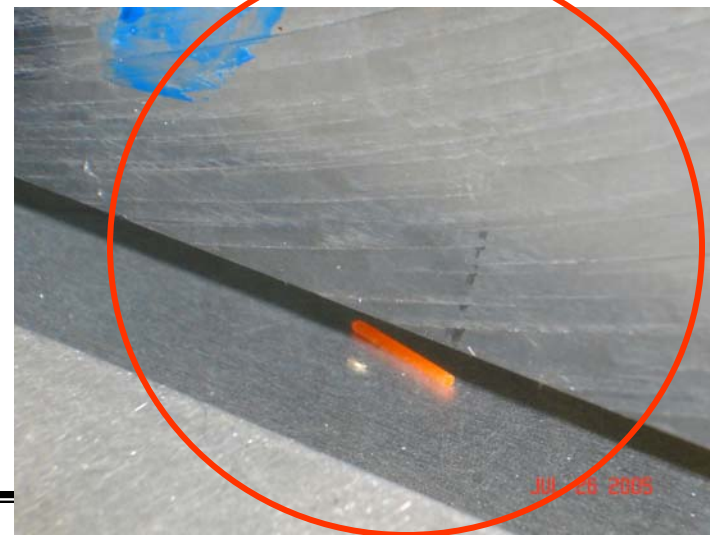
- Post Acoustic Test Inspection result:
- nutplate installation tool found in the +x, -y corner of the ACD dolly

- A nutplate replacement is likely to have occurred in this location and the nutplate may have been in this location and it was missed during cleanup.

- ***The flight structure most probably did not shed any parts, and if one fastener is loose it does not pose a performance problem: therefore, proceed with ACD shipping.***
