RESULTS OF METALLURGICAL STUDIES ON AN ELECTROPLATED COPPER STRUCTURE

P.J. Chou
April 23, 1997

To study the metallurgical property of electroplated copper structures and its impact on the RF high-power operation.

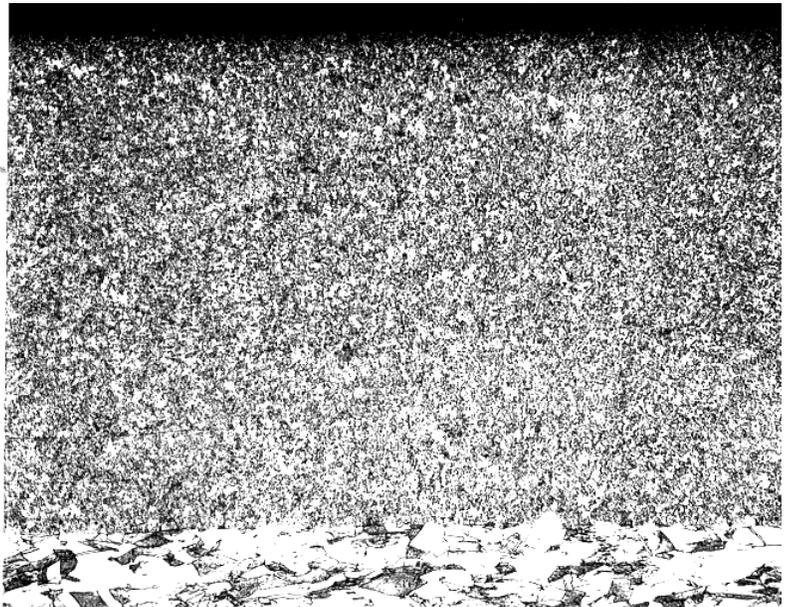
- scan203.tif= interface between the plated copper and the OFE copper, before the heat treatment. Magnification 100X.

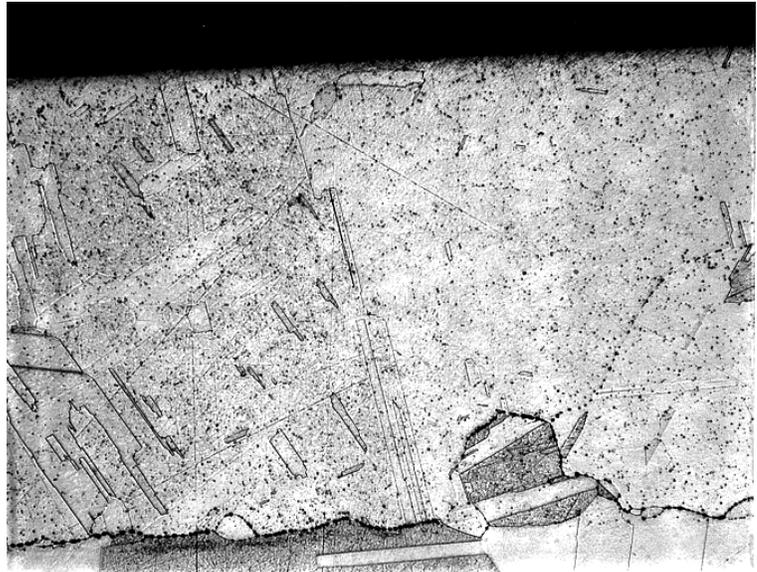
- scan202.tif= interface between the plated copper and the OFE copper, after the heat treatment. The top layer is the air, the middle is the plated copper, and the bottom is the OFE copper slab. Magnification 100X.

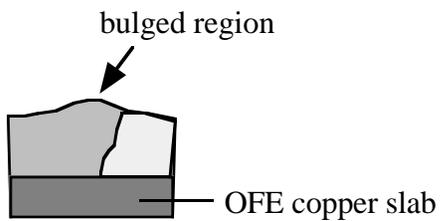
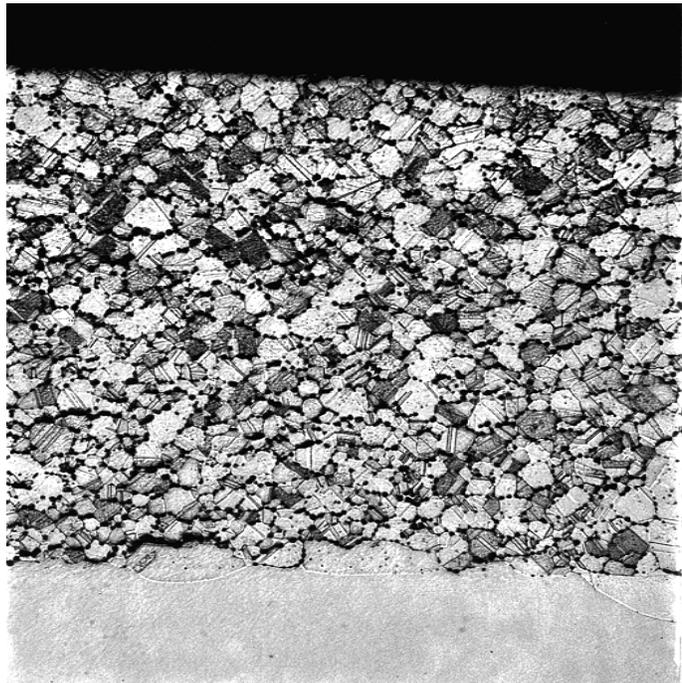
Some bulged regions were observed after the heat treatment.

- scan204.tif= the interface between the bulged region and the OFE copper, after the heat treatment. Magnification 100X.

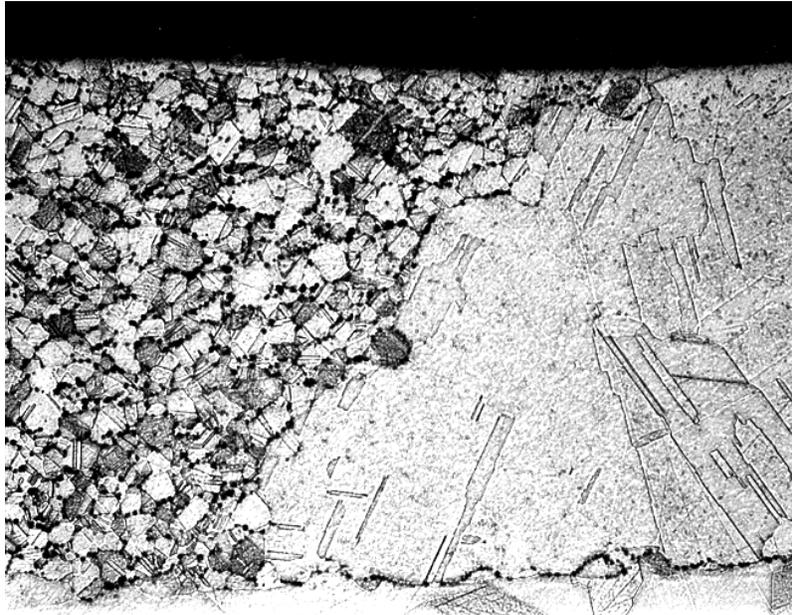
- scan205.tif= the interface between the normal plated copper and the bulged region, after the heat treatment. The top layer is the air, the middle is the bulged and normal plated copper, and the bottom is the OFE slab. Magnification 100X.
