Results of an RF Pulsed Heating Experiment at SLAC*

D. P. Pritzkau and R. H. Siemann
Stanford Linear Accelerator Center, Stanford University, Stanford, CA 94309

Results are reported from an experiment on RF pulsed heating of copper at SLAC. Damage in the form of cracks may be induced on the surface after the application of many pulses of RF. The experiment consists of two circularly cylindrical cavities operated in the TE_{011} mode at a resonant frequency of 11.424 GHz. Each cavity received 8.5 MW, $1.2 \mu s$ pulses at 60 Hz corresponding to a calculated temperature rise of 120 K on the copper surface. After 5.5×10^7 pulses, the experiment was stopped and the copper surfaces were examined. Damage is present on the area of the surface where the maximum heating occurred.

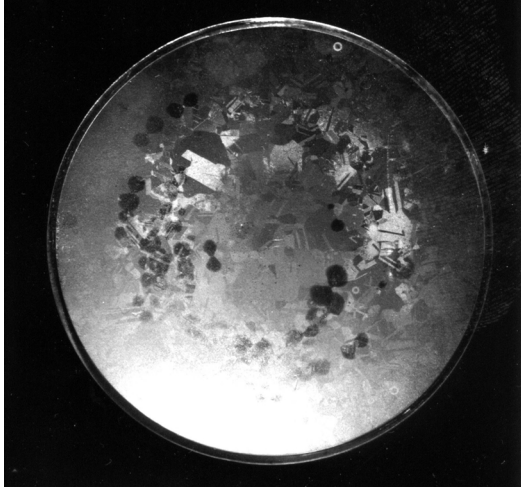
Figure 1: One of the copper endcaps. The other endcaps are similar in appearance.

In Figure 1, one can see a visible change in the crystal grains in the region approximately 10.4 mm to 11.0 mm from the center with an average width of approximately 4 mm to 5 mm. From GdldL [8] simulations, the fields in the region closer to the coupling iris is 5% higher than the fields diametrically opposite of this region. This simulation would then explain why there is more damage in the region closer to the aperture, since the region farther away has a temperature rise approximately 10% lower.

density of the copper globules increases closer to the plane of the coupling irises. One may also see dark circles along the area of maximum magnetic field. Since they seem to occur in pairs and the magnetic field in this area is radial, we believe these patches are due to multipacting. However, it is not yet understood why this occurs since the electric field in this region is zero.

Each endcap was scanned along a random diameter. The scans show that cracks are only evident in the region of visible grains in Figure 1 where maximum damage is expected. Higher magnification images of the regions of cracks were taken. For the endcap shown in Figure 2, the average location of all higher-magnification images of cracks is approx-

We have demonstrated that RF pulsed heating with a temperature rise of 120 K poses a danger to OFE copper structures. The evidence is the surface modification and damage shown in Figures 1, 2, 4 and 5. We have measured degradation of the cavity Q_0 also. Because of copper sputtered from breakdown at the coupling iris, it is not conclusive that this degradation was caused by the surface damage.

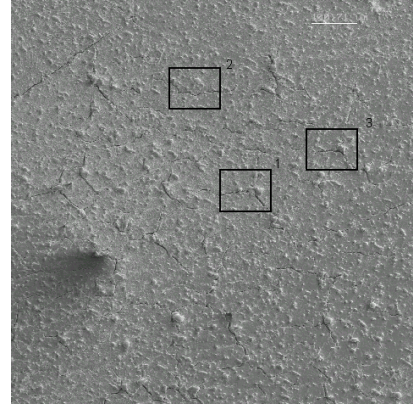
Figure 2: Region (0.9 mm × 0.9 mm) where maximum damage is expected. The scale in the upper right-hand corner is 100.7 μm. Figure 4 has higher magnification images of the indicated regions.

The endcaps were examined with a scanning electron microscope using secondary emission and a 5 keV electron beam. Figure 2 shows a region where maximum damage is expected. Note that this endcap pictured is different from the one shown in Figure 1; however, all four endcaps are similar in appearance. The little bumps along the surface are the copper globules sputtered from breakdown at the coupling iris. More importantly, one can easily see the numerous cracks that have occurred on the surface. For comparison, a region at the center where the temperature rise is close to zero is shown in Figure 3. This picture was taken at the same magnification. There are no cracks in this region. The copper globules are also noticeable here. Because of the sputtering, we cannot isolate the unloaded Q degradation shown in Table 1 due to sputtering from that due to the presence of the cracks.

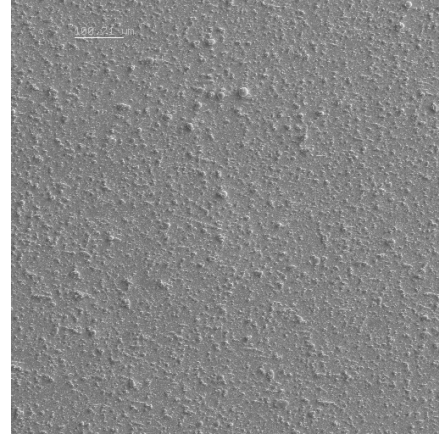
Figure 3: Center of endcap. The scale in the upper left-hand corner is 100.7 μm.

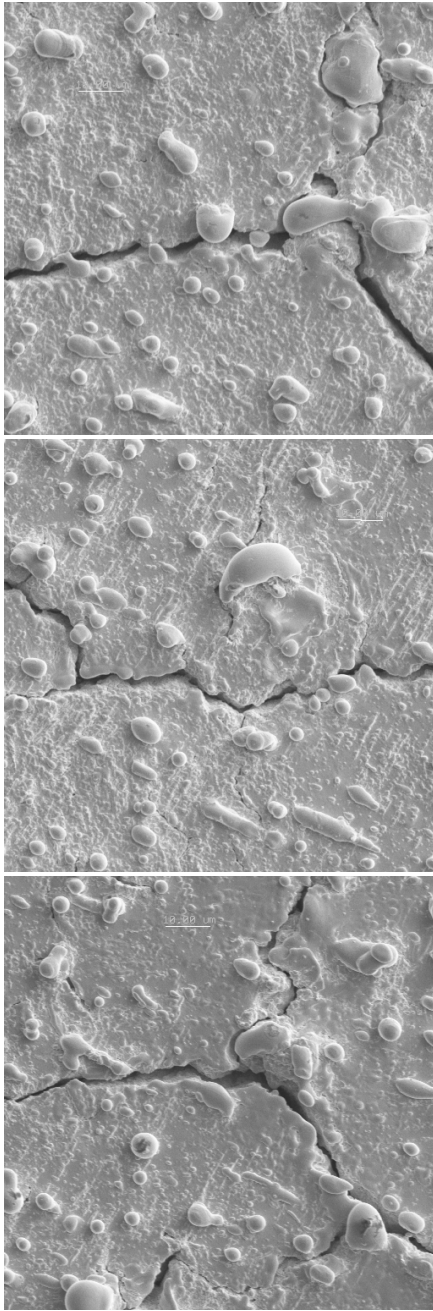
Figure 4: Regions 1–3 from Figure 2. The scale shown in each image is $10.0\ \mu\text{m}$.

imately 10.4 mm from the center with a standard deviation of 1.3 mm. Close-up shots of a few of these cracks are shown in Figure 4.

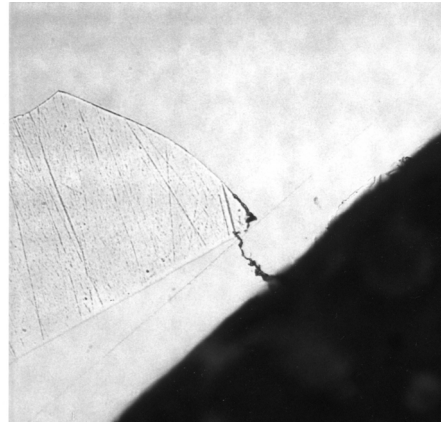
Figure 5: A cross-section of the endcap shown in Figure 1 showing an internal crack in the region of maximum temperature rise. The crack extends $24\ \mu\text{m}$ into the surface before touching the grain boundary.

An internal cross-section of the endcap shown in Figure 1 was completed. Not as many cracks were evident in the cross-section, but they did occur in the region of maximum temperature rise. One interesting crack is shown in Figure 5. It begins at the surface and propagates down to an internal grain boundary. Afterwards, the crack propagates along the grain boundary.
