## RECENT PERFORMANCE, LIFETIME, AND FAILURE MODES OF THE 5045 KLYSTRON POPULATION AT SLAC\*

R. F. Koontz, T. G. Lee, C. Pearson, and A. E. Vlieks  
Stanford Linear Accelerator Center, Stanford University  
Stanford, CA 94309

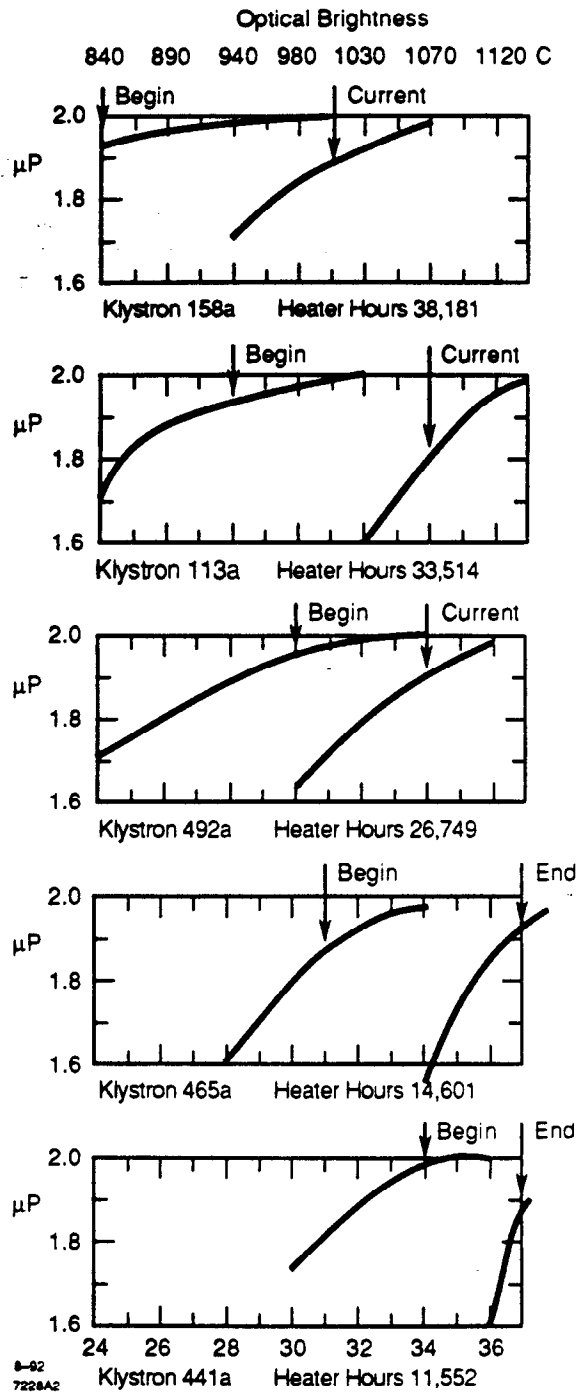
Figure 2 shows the emission characteristics of five selected klystrons removed from the gallery, and retested in the test lab. The first three tubes had "good" to "excellent" cathodes, have given long service, and are still in operation. The last two examples started out with "marginal" cathodes that required

Fig. 2. Beginning and ending emission characteristics for klystrons with "good" to "bad" cathodes.

initial high temperature operation. Both failed due to end-of-life symptoms at rather low operating hours. The pictures in Figures 3 and 4 show the annode surface of one of these failed tubes. The failure mode was arcing and gassing in the tube. Note the barium compound buildup on the anode surface, and the flaking. Most of this flaking happens after the tube is cut open,

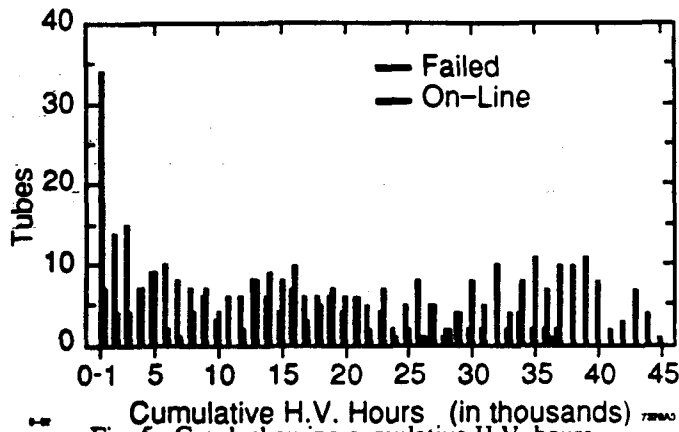
Figure 5 is a graph of cumulative high voltage hours for klystrons that have been, or are currently in operation. There is a large group of tubes that is approaching 40,000 hours of life. Most of the "infant mortality" type failures occurred during the initial installation phase seven years ago. Currently, tubes passing test lab tests do not show any serious "infant mortality" problems when put into SLC service. The average age of failed tubes returned from SLC service is 19,000 hours of high-voltage running time. The average age of operating tubes in SLC service is 23,000 high-voltage hours, and 29,000 hours of cathode heater time. The mean time between failure of SLC service klystrons is presently 52,000 hours. The history chart of these numbers is shown in Figure 6. In a random-population, steady-state-system, these three averages should converge, but even with seven years of operation, this convergence has not occurred for the SLC klystron population. During this time,

Fig. 5. Graph showing cumulative H.V. hours of online and failed 5045's.

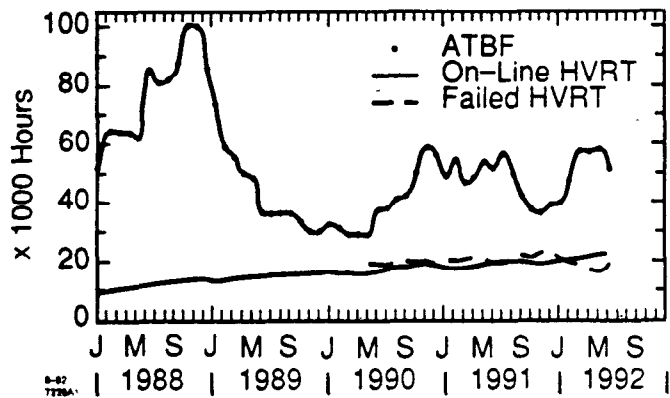
Fig. 6. 12-month average time between failures, average HVRT of failed 5054 klystrons, and average HVRT of online 5054 klystrons.
