Experimental Study of RF Pulsed Heating on Oxygen Free Electronic Copper

Submitted to Physical Review Special Topics - Accelerators and Beams

David P. Pritzkau* and Robert H. Siemann†

Stanford Linear Accelerator Center

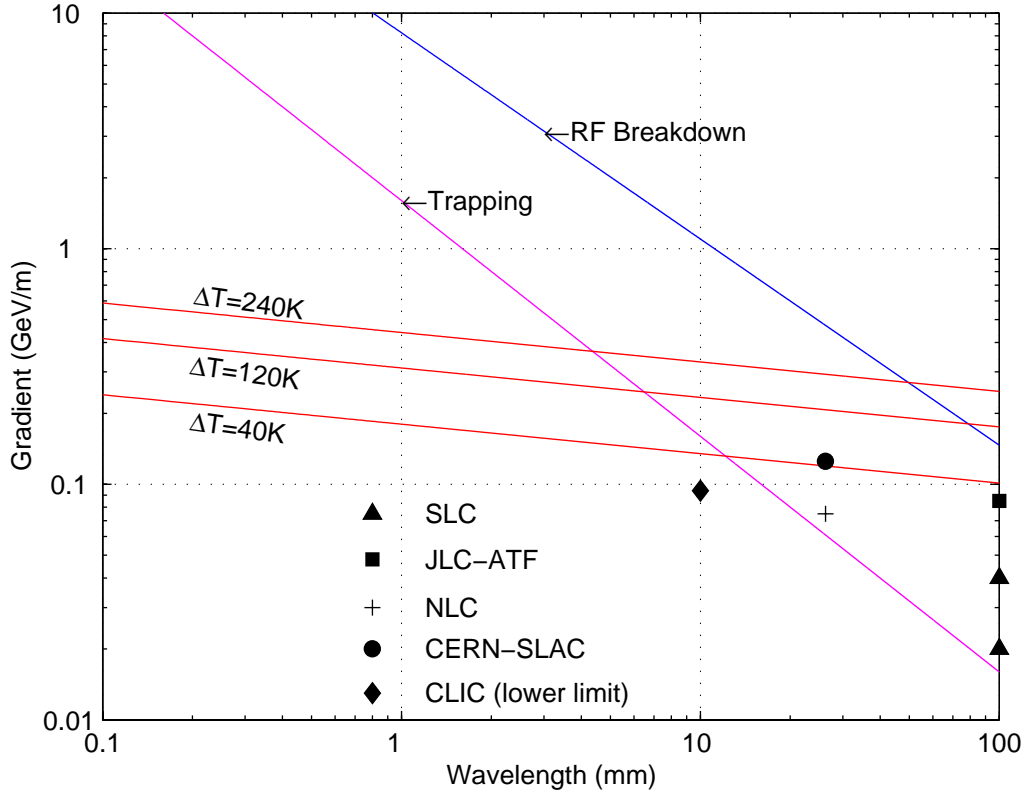
FIG. 1: Gradient limits due to RF breakdown, dark current trapping and pulsed heating. The data points represent gradient achieved with reasonable dark current [4]. The gradient limit for pulsed heating assumes a damage threshold of $\Delta T = 40$ K and is scaled from parameters of the Next Linear Collider assuming the filling time scales as $T_p \sim \lambda^{3/2}$.

A plot of these limits (Fig. 1) shows that pulsed heating could become the most restrictive phenomenon at short wavelength. Recent experiments have shown that breakdown is a multifaceted phenomenon [2, 3], and gradient limits are not as simple as implied by Eqs. (1). Underlying physical phenomenon are complex, material properties are important, and details of the structure geometry can matter because local regions of high field or high pulsed heating may determine the overall behavior.

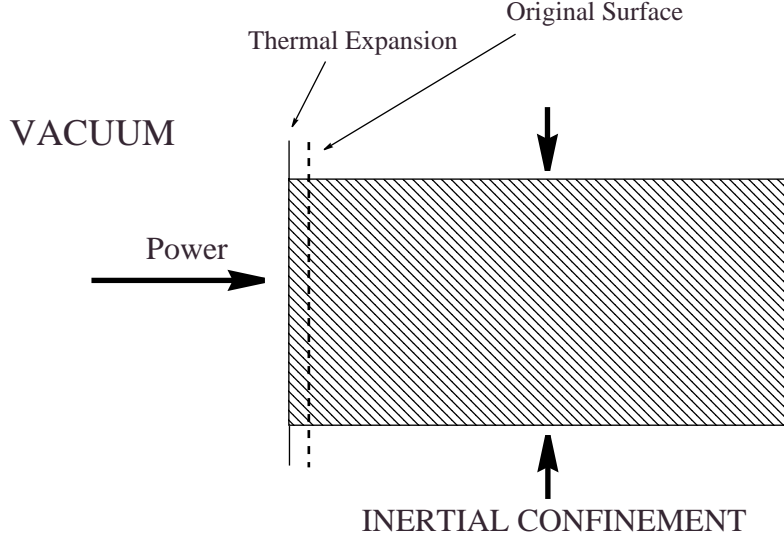
FIG. 2: Metal surface being heated with a fast high-power source [5]. The surface itself expands normally into the vacuum.

Thermal fatigue is cyclic fatigue caused by repetitive heating and cooling. Eddy currents that are developed from tangential magnetic fields on the surface will heat the surface. A simple example is shown in Fig. 2 where a fast high-power source heats the surface [5]. The heating happens quickly enough that the bulk of the metal is inertially confined and cannot expand transversely. Inertial confinement is the mechanical constraint that causes stress to occur on the surface. Using static linear elasticity with the assumptions that the transverse strain and normal stress are zero, the temperature rise at which the stress on the surface exceeds the yield stress σ_y is [5]

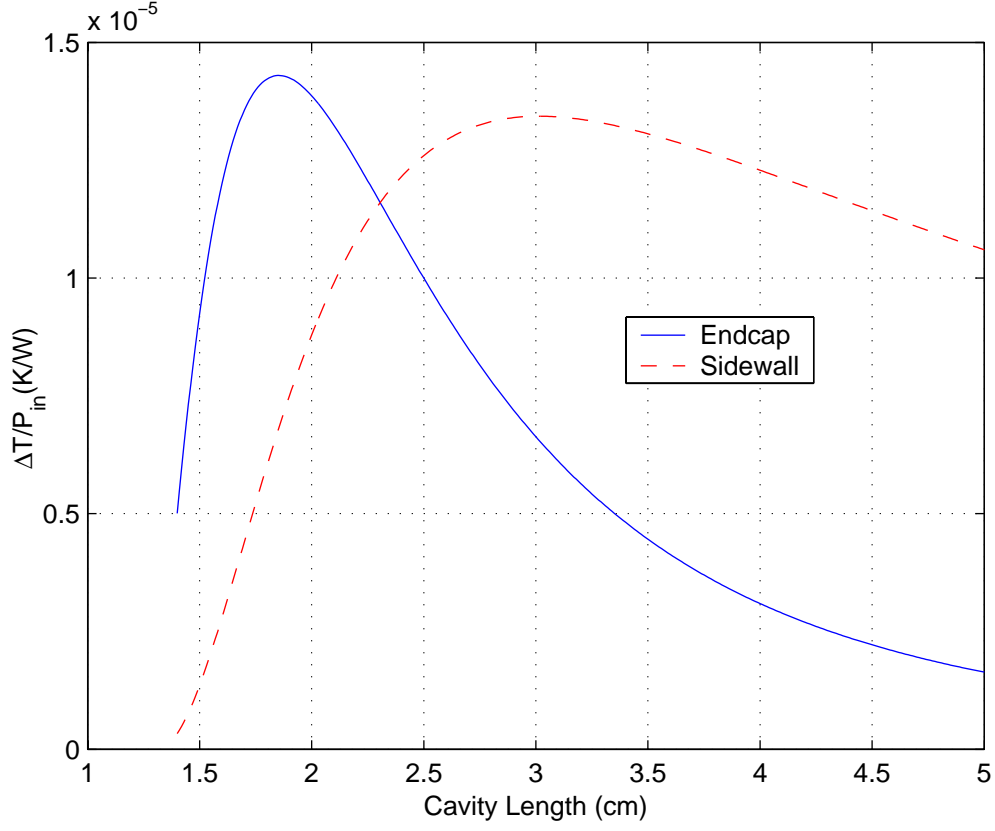
FIG. 3: Maximum temperature rises on cavity endcaps and sidewall normalized to input power as a function of cavity length d at a fixed resonant frequency of 11.424 GHz. This plot does not include consideration of temperature rise at the coupling iris.

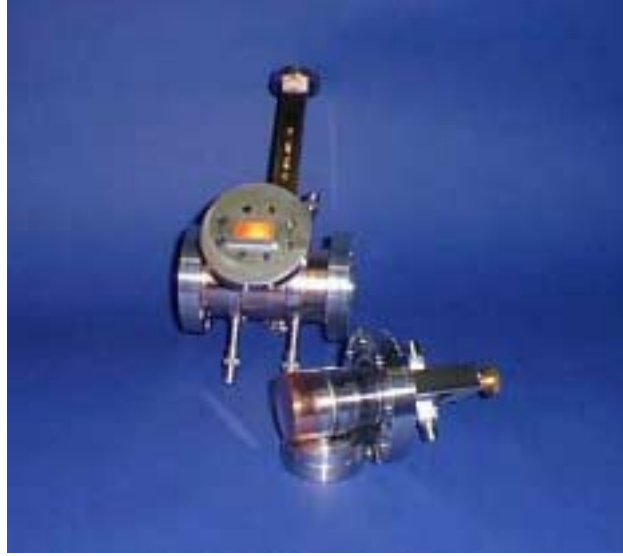
FIG. 4: A picture of the cavity body with one endcap shown on the outside. The water-cooling pipes can be seen on the bottom of the cavity body.

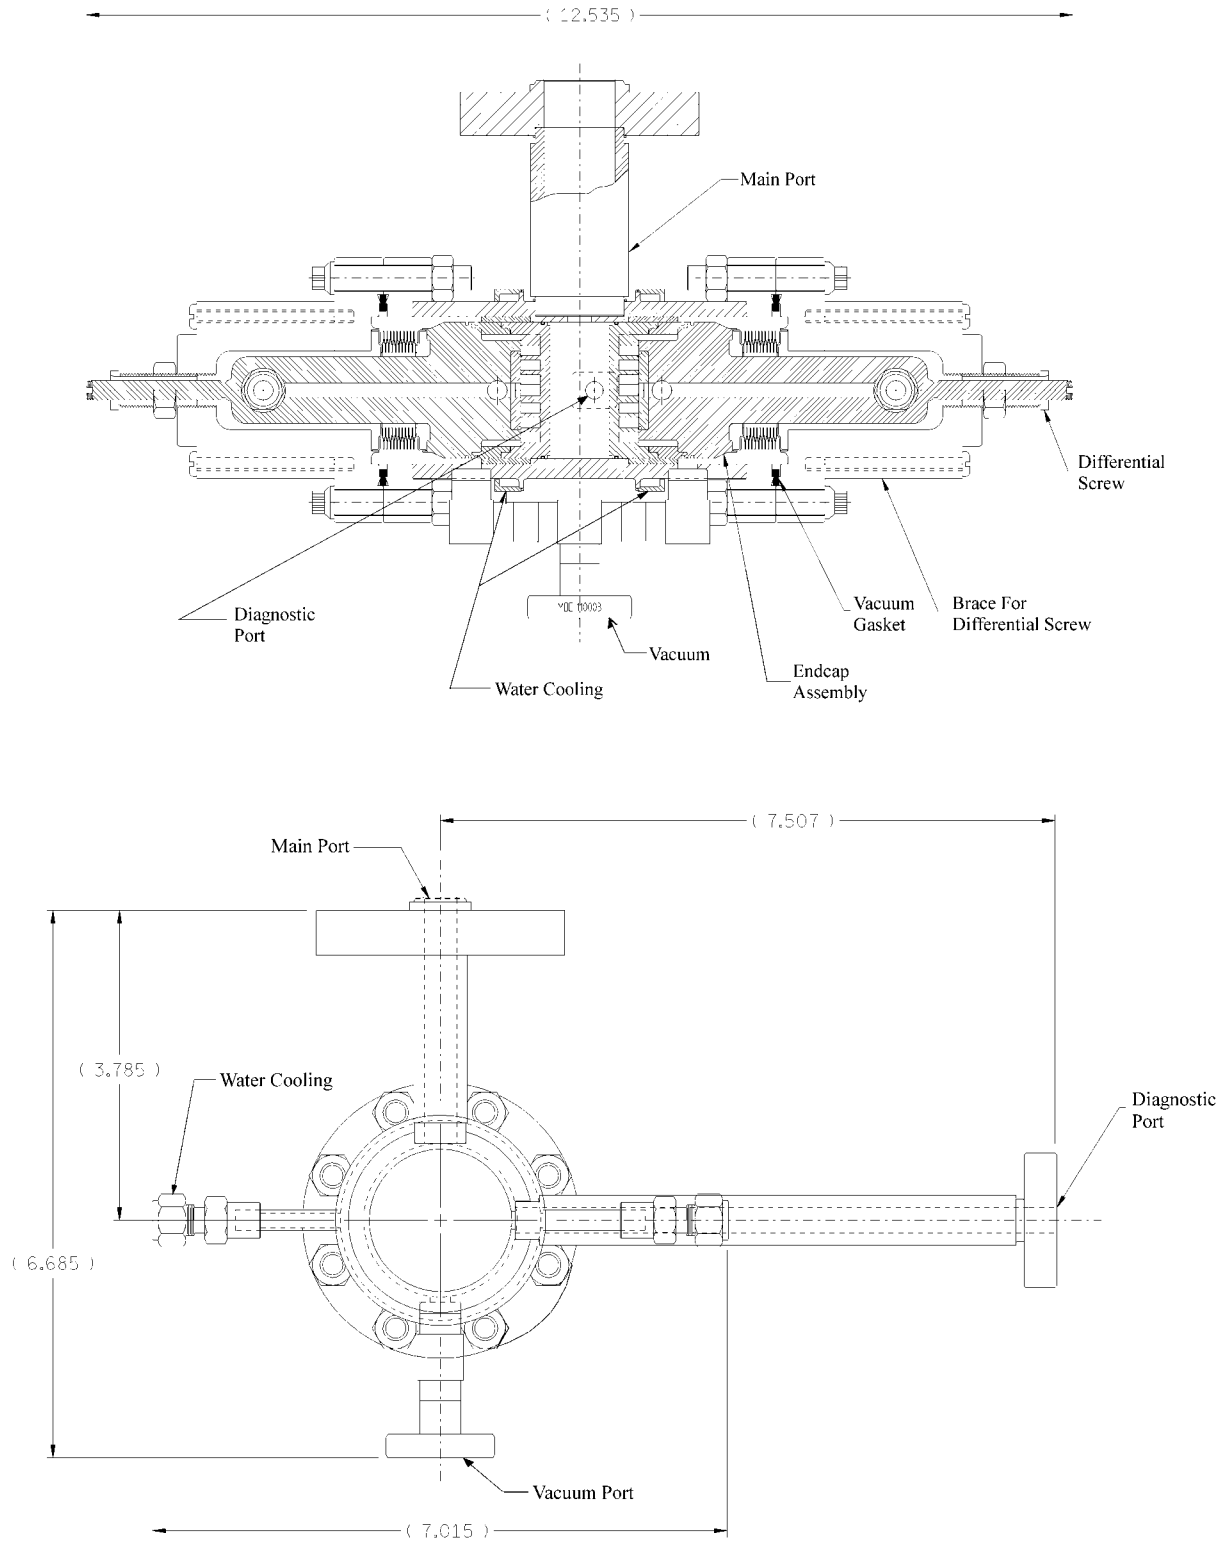
FIG. 5: Assembly schematic of cavity with endcaps. The sideview of the cavity is shown on the right. All dimensions are in inches.

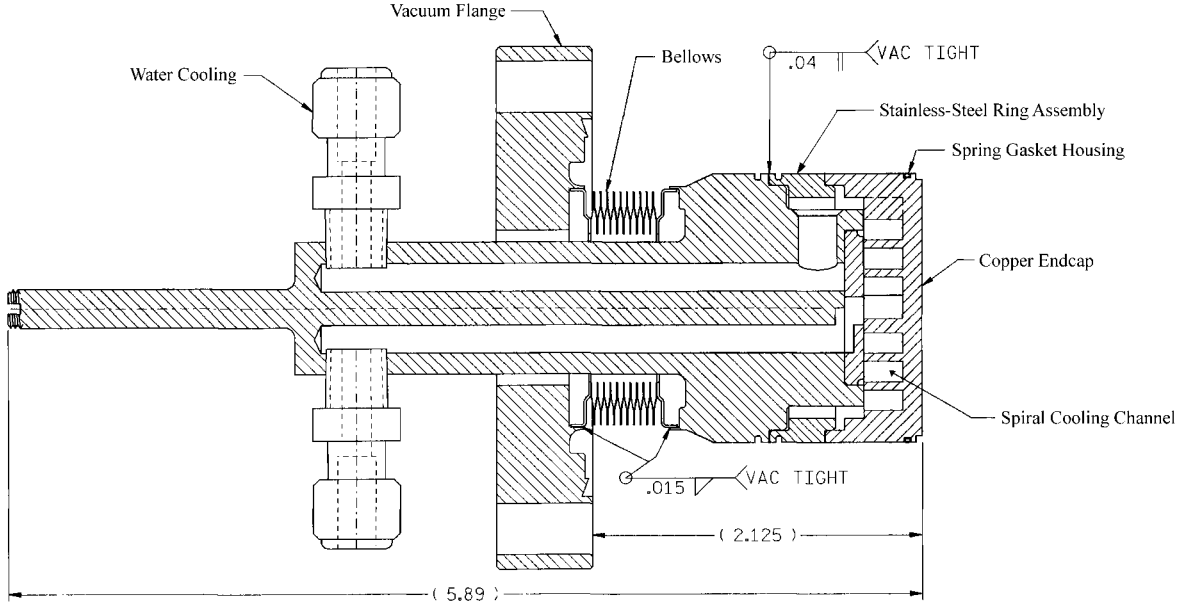
FIG. 6: Assembly schematic of endcap and piston. All dimensions are in inches.

A close-up schematic of an endcap assembly is shown in Fig. 6. The bellows and differential-screw assembly for each endcap allow fine-tuning of the cavity resonant frequency. The copper endcap is mounted onto a stainless-steel piston assembly in order to facilitate the re-use of the assembly for future endcaps. A detailed assembly procedure for the endcap is given in Tab. IV. The preparation of the endcap surface will impact the measured lifetime of the material [8]. The steps and chemicals used for vacuum cleaning of the copper endcap surfaces mentioned in Step 6 of Tab. IV are detailed in Tab. V.

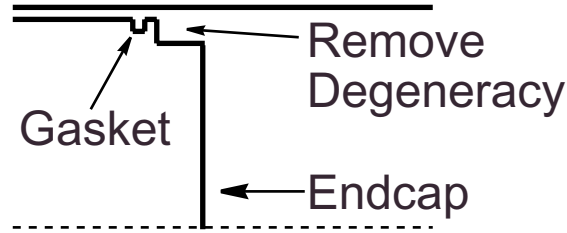
FIG. 7: Close-up of endcap with grooves. Not to scale.

Two grooves are cut along the outer radius of the endcaps as shown in Fig. 7. One groove is used to remove the degeneracy between the TE_{011} mode and the TM_{111} mode as well as the degeneracy between the TE_{012} mode and the TM_{112} mode. The TM modes require current to cross from the endcap to the cylindrical sidewall, hence their resonant frequencies

are shifted by creating a gap. The gap between this groove and the sidewall is 1.1 mm. The depth of the groove was initially set to 1.0 mm. However, at this depth, there were interference of other modes with the TE_{012} mode that prevented the temperature diagnostic from being used during the first high-power test. Using a cavity mock-up, the correct depth of the groove was empirically determined to be 2.5 mm to isolate the TE_{012} mode and this was used for the second high-power test.

The second groove houses a gold-plated stainless-steel spring gasket that becomes an RF short when compressed. The RF short prevents coaxial modes from being excited in the gap along the length of the piston and prevents RF breakdown from occurring in this gap.

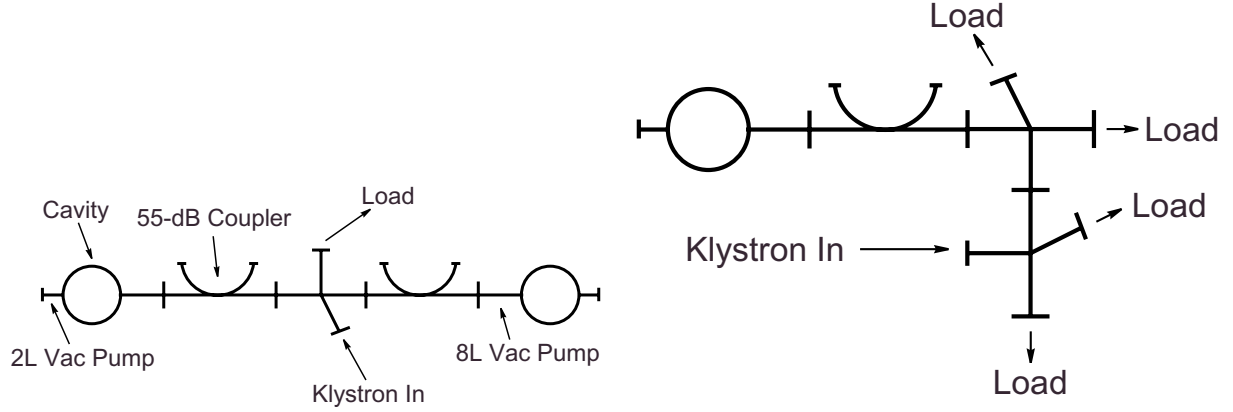
FIG. 8: Schematic of the klystron setups for the first and second high-power test.

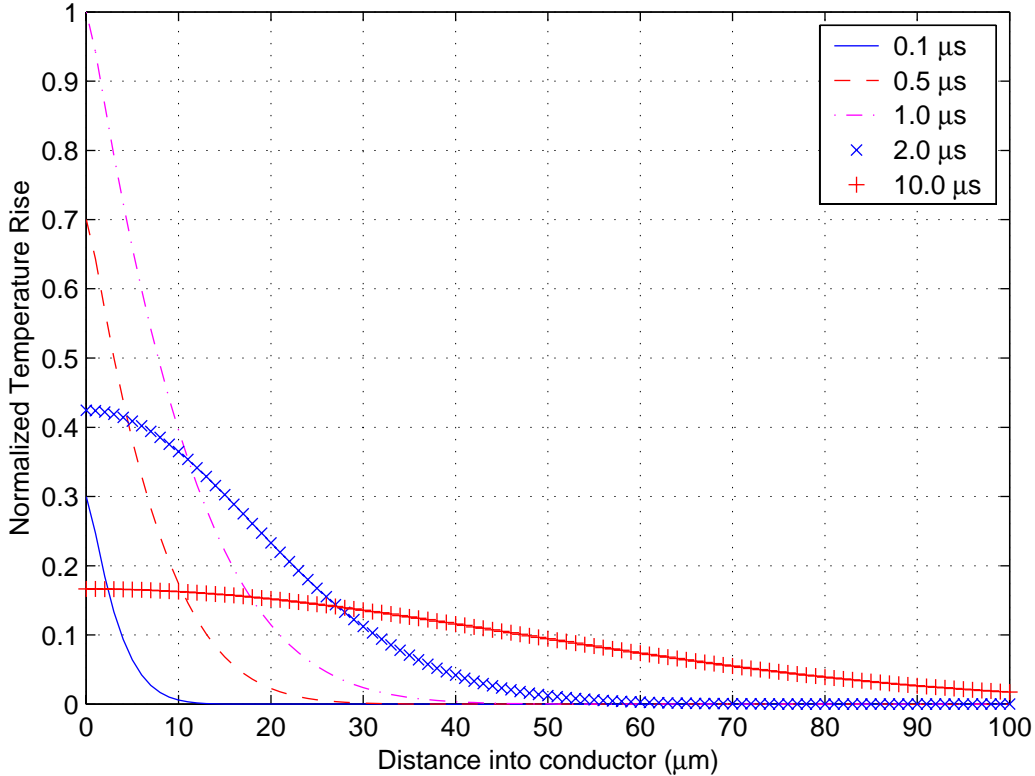
FIG. 10: The temperature rise at various times in the conductor normalized to the surface temperature at $t = 1.0 \mu s$, for a pulse length of $t_p = 1.0 \mu s$.

This is the same result if we had considered a prescribed surface heat flux $dP(t)/dA$ with no volume energy generation. For a $1 \mu\text{s}$ pulse, Fig. 10 shows the temperature rise on the

surface normalized to the temperature rise at $1 \mu s$. The error from ignoring the skin-depth on temperature rise is less than 3%.

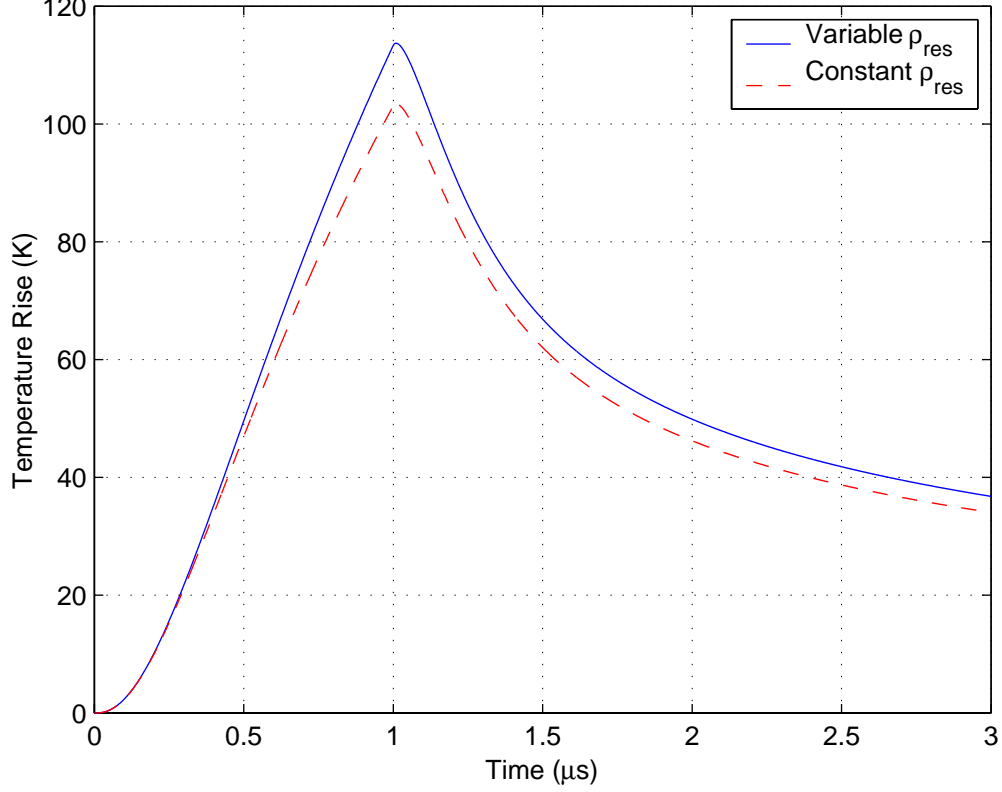
FIG. 12: Comparison of variable ρ_{res} with constant ρ_{res} on the temperature rise of the cavity endcaps for a 10 MW, 1 μ s pulse.

fill-time. The details of this calculation are fully explained in [17, Chapter 3, Appendix A]. Using the cavity parameters given in Tab. II, Fig. 12 shows the effect of including the temperature dependence of ρ_{res} for a 10 MW, 1 μ s pulse on the cavity endcaps. The inclusion of this effect increased the temperature rise by 10%.

Notice after a time longer than 3 pulse-lengths, the temperature rise on the surface decays to within 30% of its maximum value. Since there is approximately 17 ms between pulses, the temperature rise decays close to zero by this time. There will be some average temperature rise due to the combined effect of many pulses; however, water-cooling stabilizes this temperature rise to about 10 K above room temperature [17, pp. 63–64].

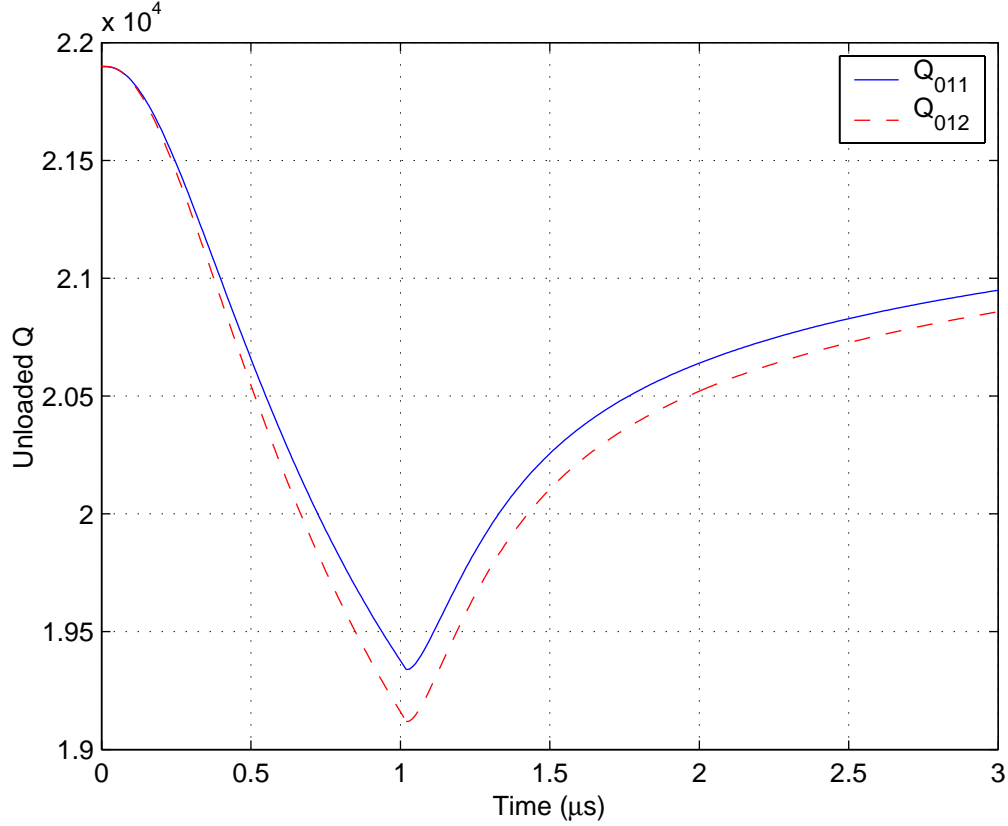
FIG. 13: Change in Q_0 for both TE_{011} and TE_{012} modes for a 10 MW, 1 μ s pulse.

where S_w is the entire cavity surface and \vec{r} is a point on the surface. For the above example, the Q change for both modes is shown in Fig. 13.

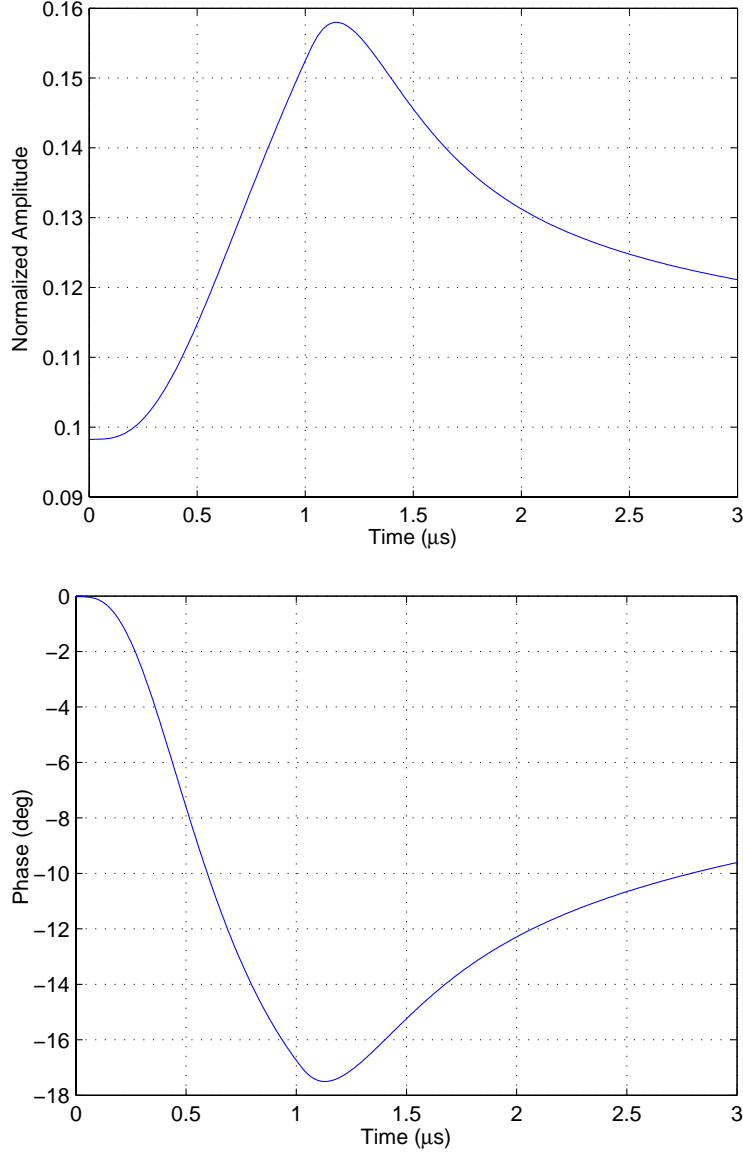
FIG. 14: Magnitude and phase of the reflected signal with respect to the input signal due to the change in Q_0 of the TE_{012} mode.

A calculation of the expected signal looking through the diagnostic port from the TE_{012} mode is shown in Fig. 14 for a 10 MW, 1 μ s pulse. In this case, we've assumed coupling through the diagnostic port of $\beta = 1$, and, in addition, leakage out the high-power port with coupling $\beta = 0.22$. It is to be noticed that the extrema of these curves occur some time after the pulse shuts off. This lag time is on order of the cavity fill-time.

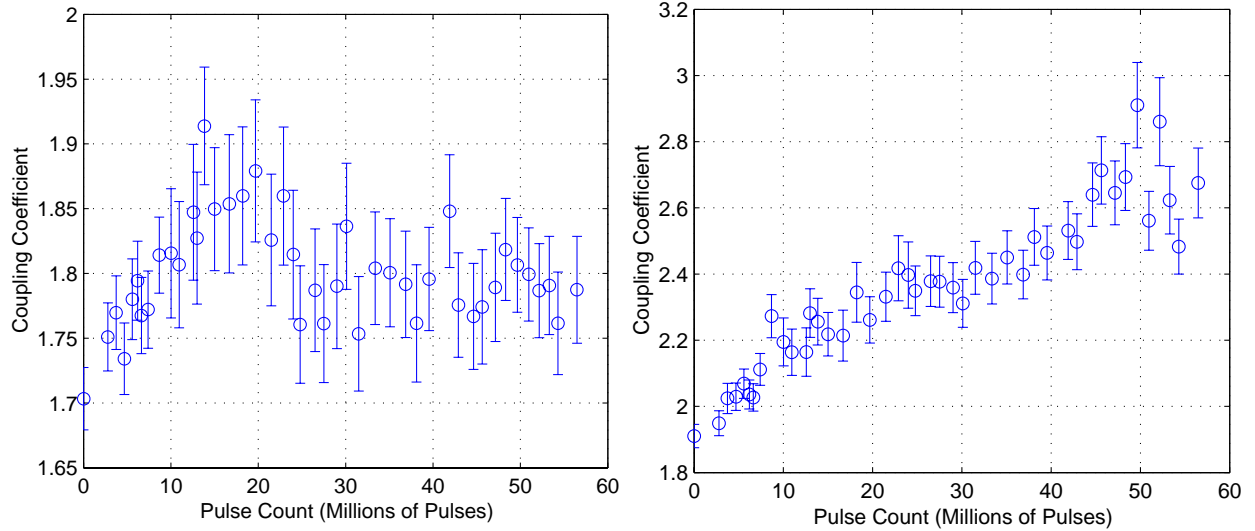
FIG. 15: Variation of β for cavity 1 (left) and cavity 2 (right) as a function of pulse count at a 120 K temperature rise on the endcap surfaces. The errors shown are due to random errors only.

The coupling coefficient, $\beta = Q_0/Q_{ext}$, is determined by measuring the forward and reflected power to and from the cavity. The reflected power is measured near its steady-state value before the RF pulse shuts off. This measurement over the course of the experimental run is shown in Fig. 15 for both cavities. The time-domain measurement of β at the end of the run is consistent with the frequency-domain measurement. A few general points can be made about the changing trend in the value of β for both cavities. In the first 20 million pulses, β increases for both cavities. This must be due to a degradation in Q_{ext} because Q_0 can only decrease due to damage. After 20 million pulses, β decreases for cavity 1 and increases more slowly for cavity 2. This demonstrates that the degradation of Q_0 from surface damage has become dominant. The overall decreasing trend for cavity 1 as compared to the increasing trend demonstrated for cavity 2 is supported by the data given in Tab. VI. Cavity 1 suffered a smaller change in Q_{ext} than cavity 2 but suffered a greater change in Q_0 .

In principle, Q_L can be measured through the exponential decay of the reflected power when the RF pulse turns off and Q_0 can be determined by combining β and Q_L measurements. However, that was not possible for a combination of reasons. Pulsed heating affects RF properties and measurements, so the input power had to be lowered to below 2 MW before measurements could be made. The cavities, which were tuned to each other under full power, become mismatched to each other and, in addition, mismatched to the klystron output cavity. This problem became worse over time as β for cavity 2 increased. These mismatches mixed together the characteristic decays, and the variations of Q_L and Q_0 during the experimental run could not be determined [17, pp. 144–150]. However, the trend in Fig. 15 with the data in Tab. VI shows a clear degradation of Q_0 for each cavity.

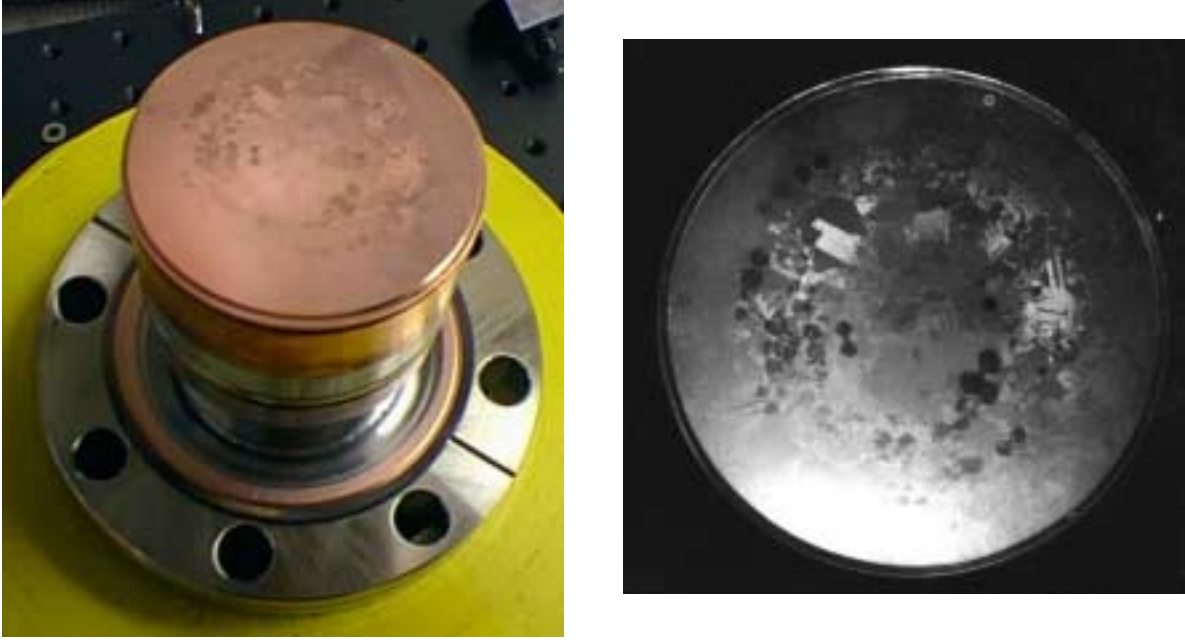
FIG. 16: Picture of one endcap from the first high-power test. A change in the crystal grains is visible even in the region where the temperature rise was lower by 10%. The region of the endcap nearest the high-power coupler is on the lower left in the right-hand picture. Tarnish from the sputtering of copper is on the lower part of the endcap.

At the end of the experimental run, the endcaps were removed from the cavities and inspected. One such endcap is shown in Fig. 16. Each endcap is made from polycrystalline OFE copper; therefore, the structure on the surface is made from crystal grains whose lattices are oriented in a generally random direction with respect to each other. Fig. 16 shows an obvious visual change in the crystal grains in the region where the temperature

rise is maximum, which is approximately half-way between the center and outer radius of the endcap. In this area in which there is high-amplitude cyclic straining, steps may form in crystal grain boundaries with height differences on the order of microns [18, p. 126]. This would change the direction of light specularly reflected from the surface, which will cause a contrast between the grains in the fatigued area as compared to the rest of the surface.

There is also a tarnish visible on the surface. The tarnish is thicker at the outer radius and at the azimuth closest to the high-power coupling aperture. As will be shown in the next

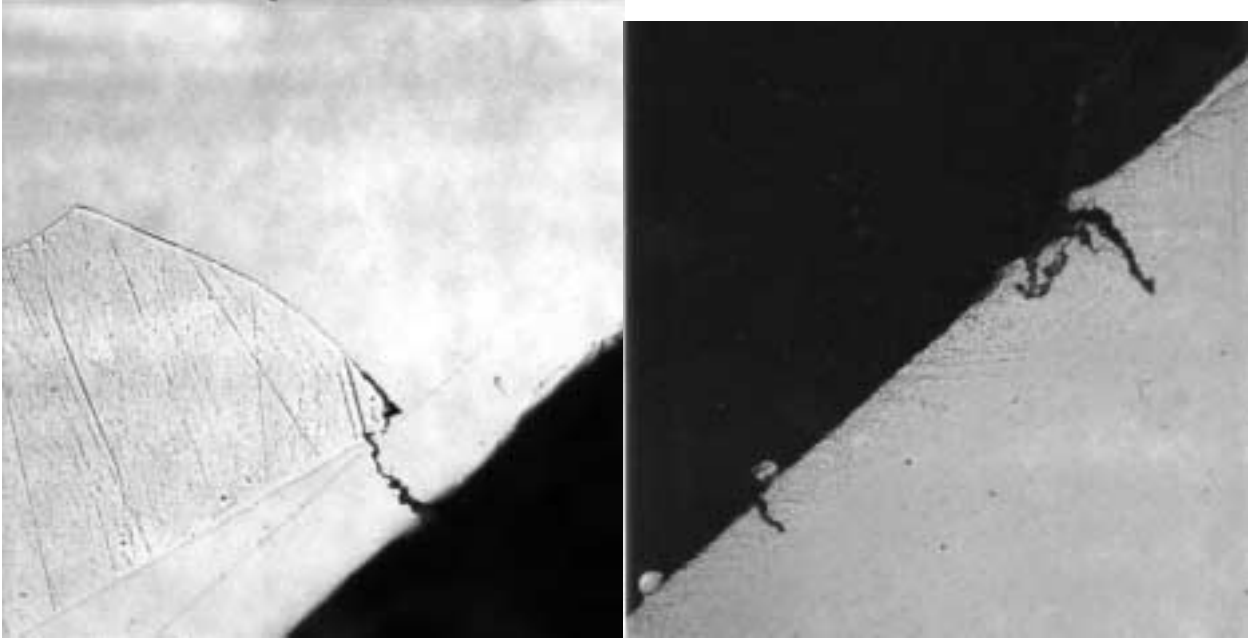
FIG. 17: An internal cross-section of one endcap in the region of maximum temperature rise on the surface. The endcap surface is the boundary between the white and black regions of the pictures. The crack on the left propagated $25\ \mu\text{m}$ into the surface before reaching an internal grain boundary. The crack on the right propagated $15\ \mu\text{m}$ into the surface.

Cracks nucleated at the surface may propagate into the interior of the metal. One endcap was cut internally along a diameter and polished to view its cross-section. Cracks were only found near the area of maximum temperature rise. Less than 10 cracks were visible at a microscope magnification of 1000 and only 2 cracks are longer than $10\ \mu\text{m}$. These cracks are shown in Fig. 17. These cracks were first created at the surface and then propagated internally, because higher stresses and strains occur at the surface than in the interior of the metal [19, p. 66]. Only a few cracks will propagate internally as compared to the amount of cracks that are nucleated at the surface.

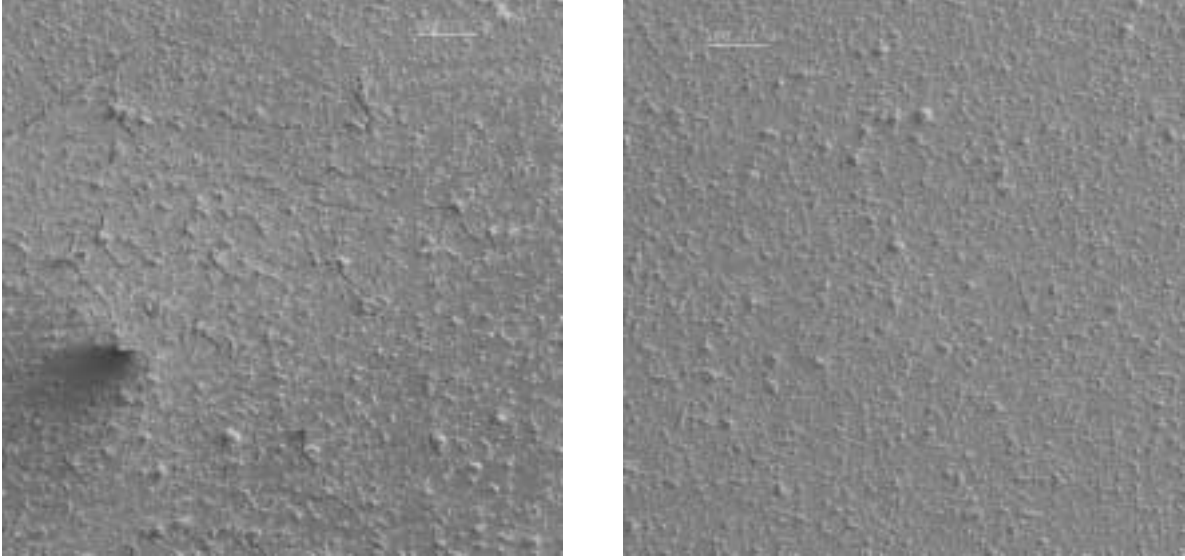
FIG. 18: Comparison snapshot of a region of maximum temperature rise on the left and a region of zero temperature rise on the right for one endcap. The length scale is $100.7 \mu\text{m}$.

Second, scans were taken around the region of maximum heating at different magnifications. One such region is shown on the left of Fig. 18. Numerous cracks are visible on the surface. The bumps that occur on the surface are due to the copper globules that sputtered onto the endcaps from the high-power coupling aperture. For comparison, the center of

the endcap is shown on the right of Fig. 18. No cracks are visible in the center where the temperature rise is close to zero. The copper globules sputtered on the surface are most dense near the outer radius where no cracks are visible. This suggests that pulsed heating and not the copper globules are responsible for the nucleation of cracks on the surface.

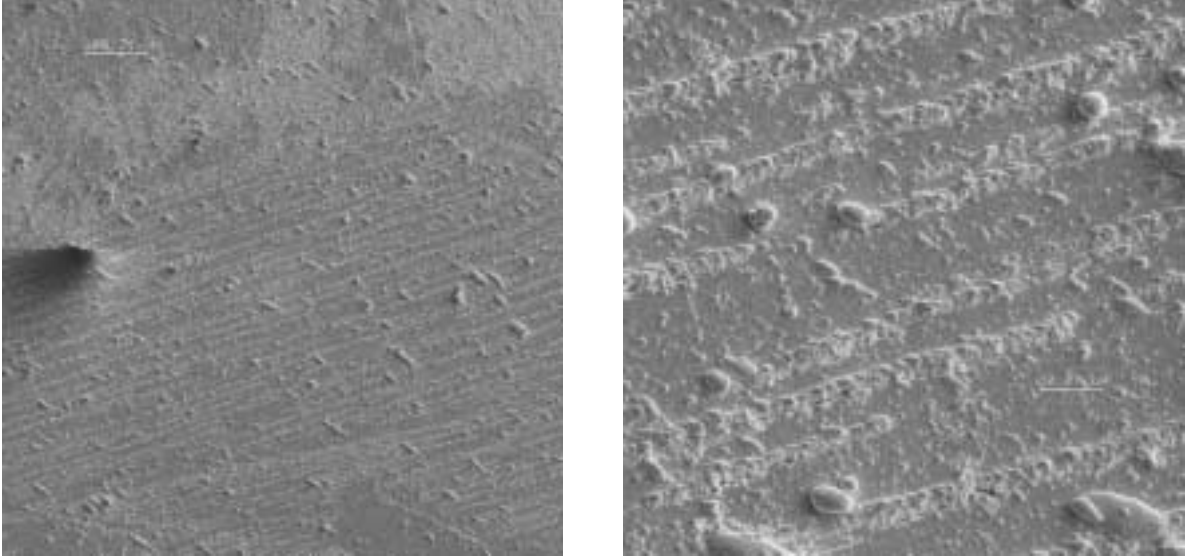
FIG. 19: Fatigue slip bands on a particular crystal grain in the area of maximum temperature rise. The picture on the right is a close-up of these slip bands in which some microcracks are evident at the base of the slip bands. The scale is $100.7\ \mu\text{m}$ on the left and $10.1\ \mu\text{m}$ on the right.

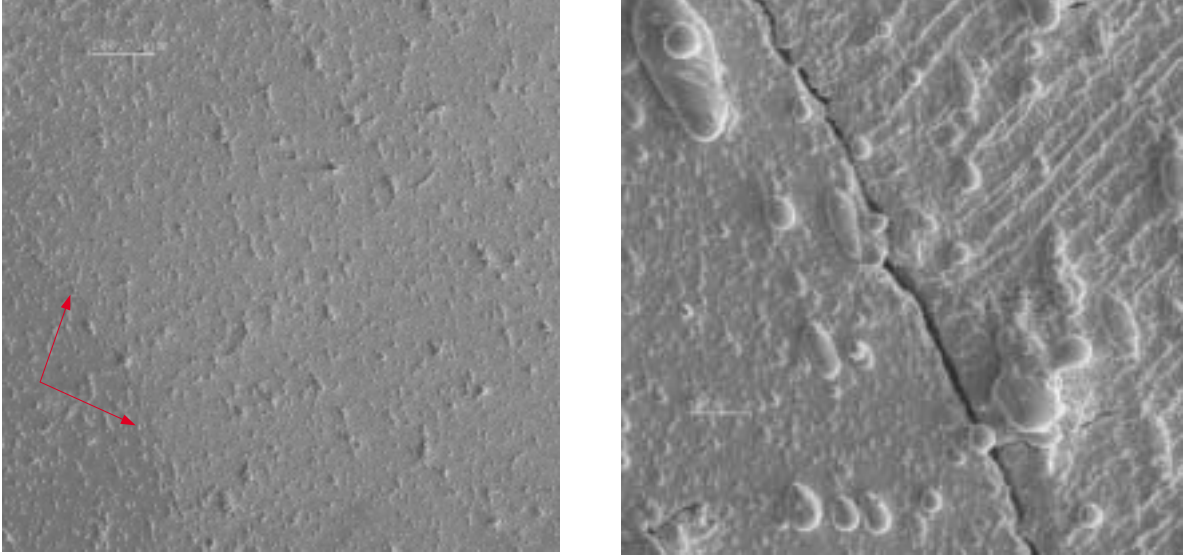
FIG. 20: Grain-boundary cracks in the area of maximum temperature rise. The grain boundary is the transition between the two different textures on the surface shown by the red arrows. The texture on the right-hand side of the picture on the left is due to slip bands. A close-up of one crack is in the right-hand picture where the grain boundary is clear. The length scales are $100.7 \mu\text{m}$ and $10.1 \mu\text{m}$ respectively.

Grain boundaries are another common site for crack nucleations [19, p. 67]. Fig. 20 is an example of cracks along grain boundaries. In the picture on the left, the transition between the two different textures on the surface is shown by the red arrows. The texture on the right-hand side of the picture is due to slip bands. A close-up of the grain-boundary crack is in the right-hand picture. Notice that the striations of the slip bands end at the crack. Grain boundaries act as natural barriers for slip bands, because the neighboring grains usually have incompatible orientations that prevent slip bands propagating across

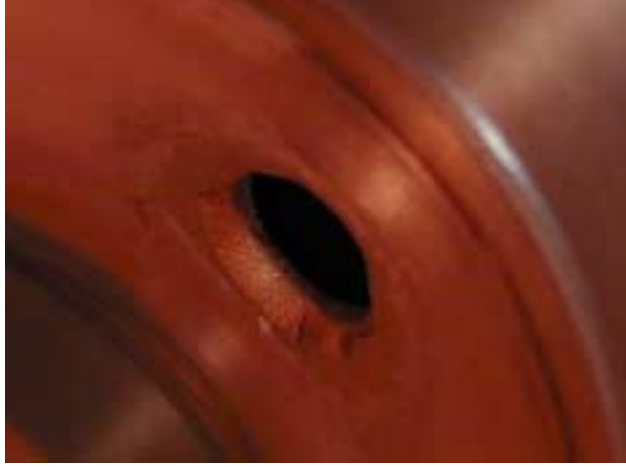
FIG. 22: A picture of the high-power coupling aperture of cavity 1 after the first high-power test. The aperture has been rounded in the direction of the magnetic field. The electric field has caused pitting to occur on either side of the aperture at right angles to the rounding.

Since the damage on the aperture appears to occur in the direction of the surface magnetic

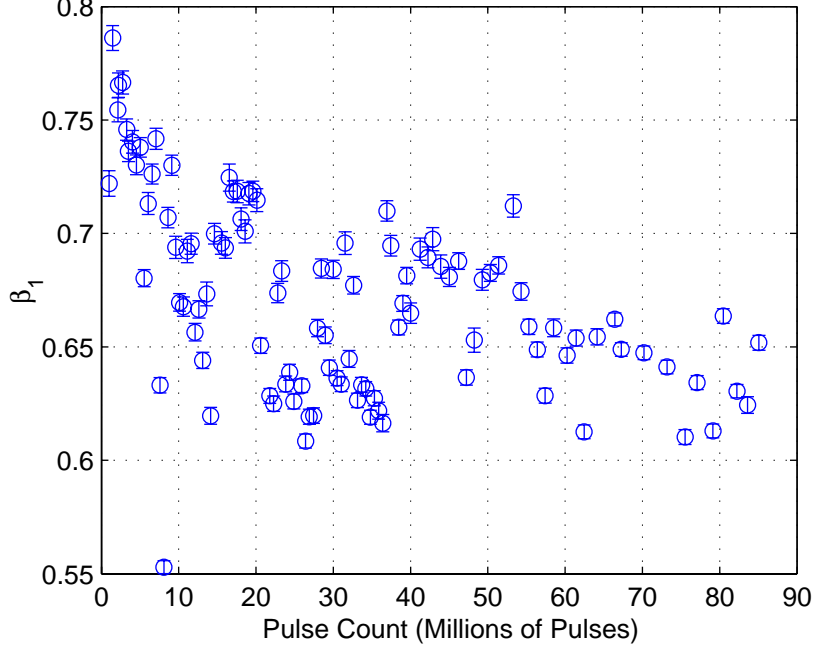
FIG. 23: Measurement of β_1 during the high-power test for the TE₀₁₂ mode.

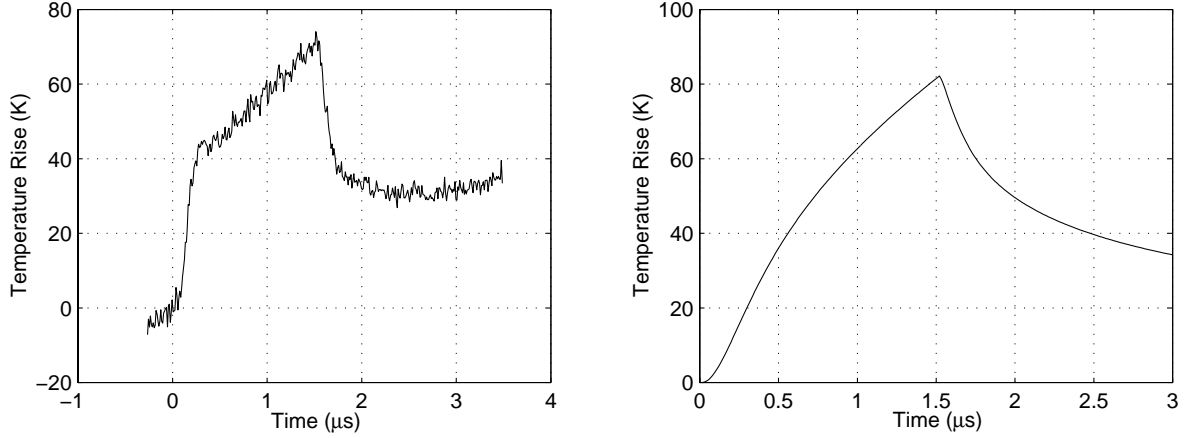
FIG. 24: Measured and theoretical prediction of maximum temperature rise on the endcaps during a high-power pulse. Changes in amplitude and phase of the reflected TE_{012} power are assumed to be caused by temperature rise alone in this measurement. There is discussion of this assumption in the text. The theoretical prediction is based on a 7.3 MW power input. The RF pulse is initiated at time $0 \mu s$.

1. The rapid rise and fall times when the X-band power is turned on and off. They are comparable to the cavity fill-time.

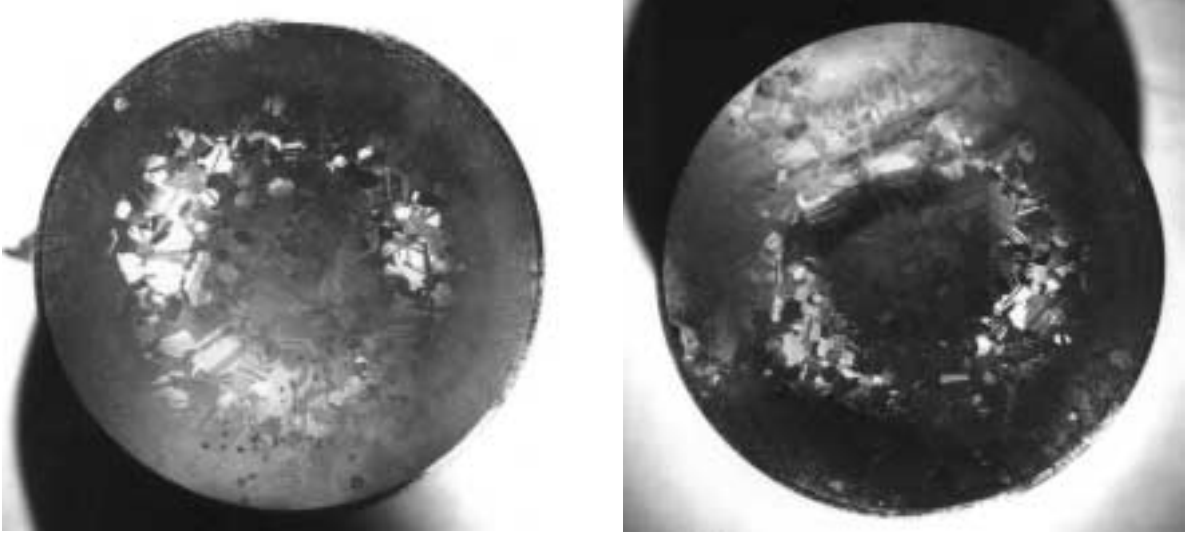
FIG. 25: Surfaces of endcaps 1 (left) and 2 (right) after the second high-power test. The position of the high-power coupling aperture relative to the pictures is the top of endcap 1 and top-left of endcap 2.

As with the first high-power test, an obvious visual change in the grains of both endcaps is shown in Fig. 25. The width of these regions is between 7 and 8 mm. There is also tarnish

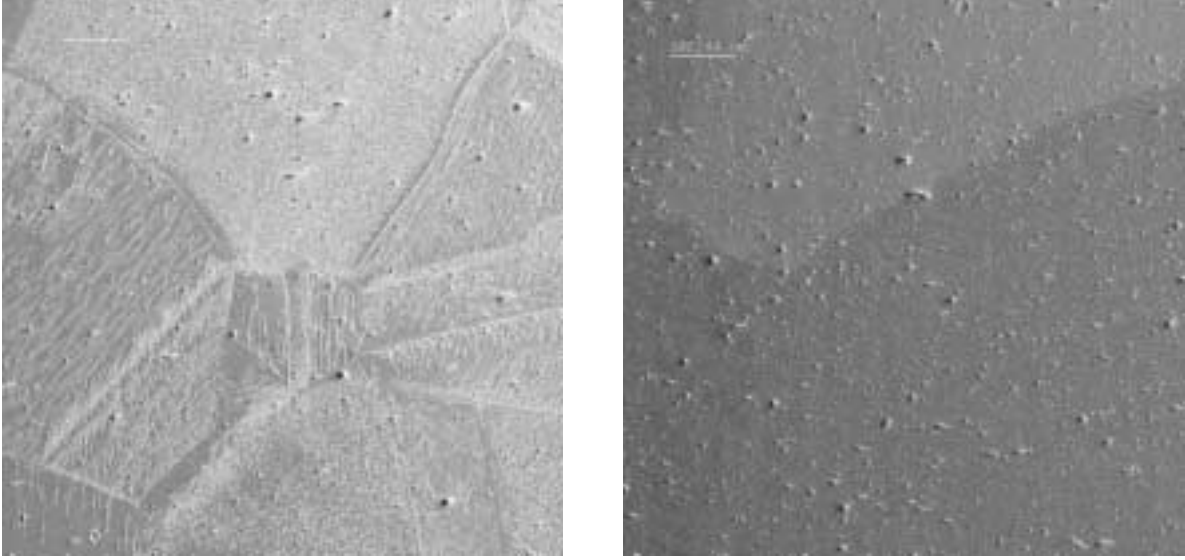
FIG. 26: A comparison between a region in the area of maximum temperature rise (left) and the center of the endcap in which the temperature rise is close to zero (right). The length scale is $100.7 \mu\text{m}$.

As a point of comparison, the picture on the left of Fig. 26 shows a region in the area of maximum temperature rise with a multitude of fatigue slip bands including grains with multiple slip. Multiple slips can occur when the crystal axes of the grain are such that the applied shear stress is greater than a critical value on more than one slip system [21, p. 29]. On the right is a region near the center of the endcap in which the pulsed temperature

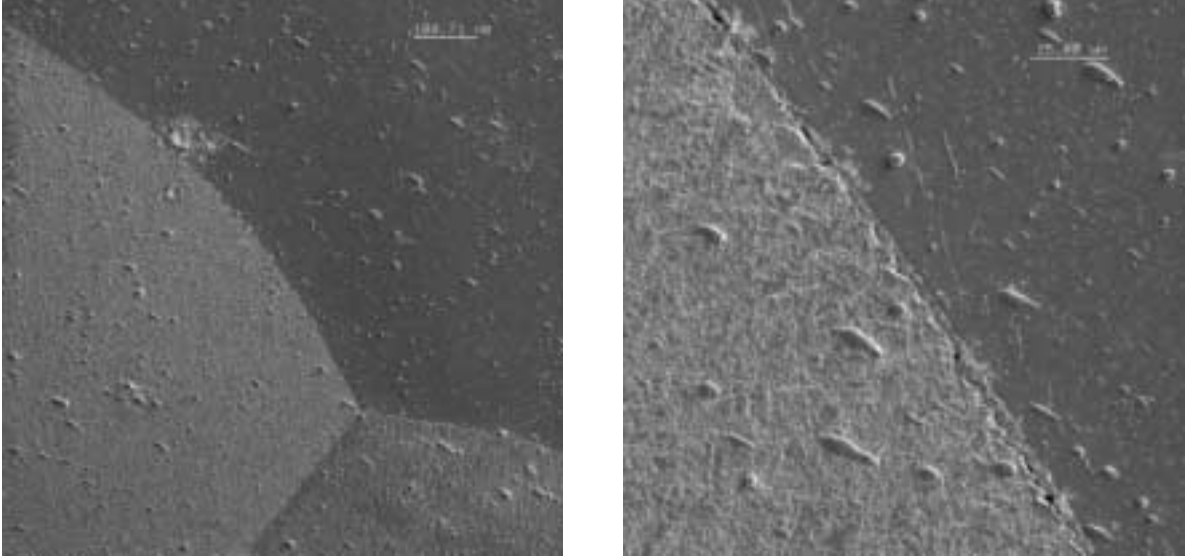
FIG. 27: Grain-boundary cracks in the area of maximum temperature rise. The grain boundary is the transition where the whitening due to slip bands stop. A close-up of one crack is on the right where the grain boundary is clear. The length scales are $100.7 \mu\text{m}$ and $25.0 \mu\text{m}$ respectively.

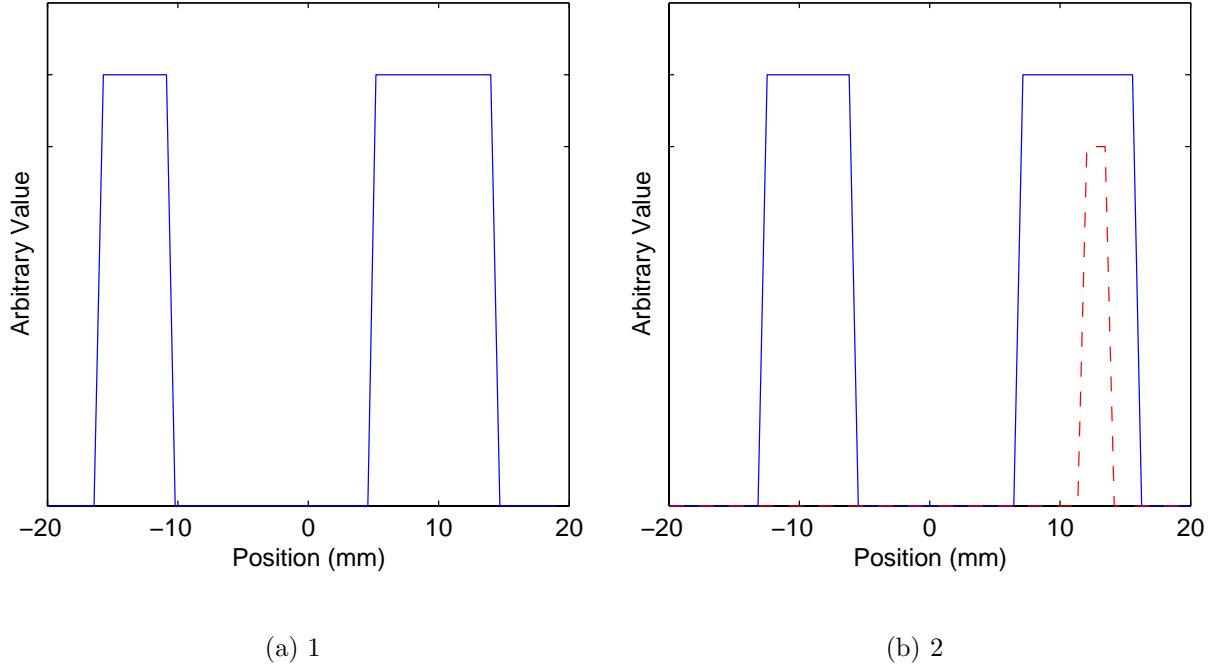
FIG. 28: Random scans along diameters of each endcap. The solid line corresponds to regions of surface roughening and the dotted line is for regions that contain cracks on the surface. The centers of the endcaps are at position 0 mm.

The plots show that surface roughening and slip bands occur around the area of maximum temperature rise at the radius 10.6 mm . The offset that occurs in the plot for endcap 1 is due to an offset of 2 mm of the scanned diameter from the center of the endcap. The center of the endcap was approximated at the time the diameters were scanned and determined more precisely afterwards. The small amount of cracks that were found do support the
