COLLECTIVE BEAM INSTABILITIES IN THE TAIWAN LIGHT SOURCE

P.J. Chou[†], SRRC, Hsinchu, Taiwan
A.W. Chao, SLAC, Stanford, CA 94309, USA

Abstract

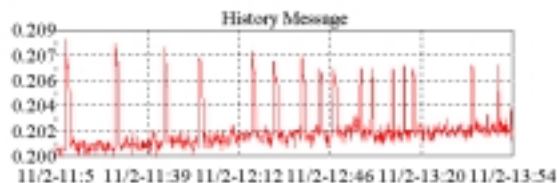
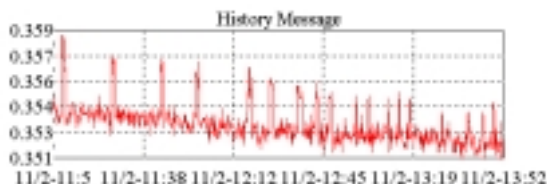
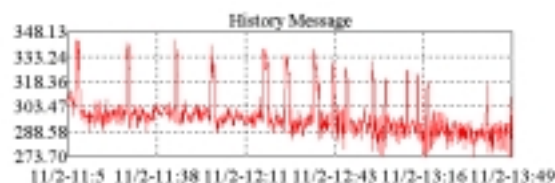
Figure 1: The abrupt distortion of beam orbit and horizontal beam size observed in the same time. The rf voltage modulation was turned on. The vertical scale of beam orbit is in units of mm and the vertical scale of beam size is in μm . The horizontal axis represents the time.

The abrupt change in the closed orbit was correlated to the abrupt change in the horizontal beam size as shown in Fig. 1. This abrupt beam instability caused corresponding abrupt variation in photon intensity for the synchrotron light users. This abrupt beam instability was never observed in low current regime, e.g. for beam current below 130 mA. The onset of this abrupt orbit distortion was neither predictable, nor periodic. The horizontal and vertical orbits shifted by amounts that appeared to be random around the ring. The global orbit feedback system was turned on during this time when orbit shifts took place, and this might have disrupted a natural tendency of orbit shifts with betatron shape. The variation of horizontal beam size is on the order of 30 μm . There was no abrupt change observed in the vertical beam size. The transverse beam size was measured from the profile of synchrotron light emitted from a bending magnet where the dispersion function is nonzero in the horizontal plane.

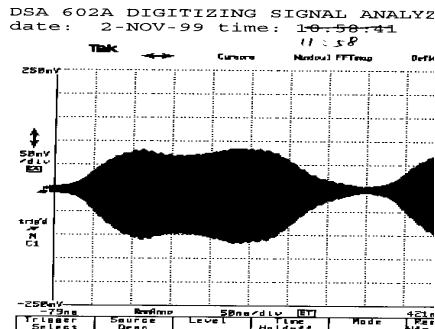
Figure 2: The fill pattern corresponding to the case without the abrupt change in horizontal beam size.

It was noticed that the unpredictable, abrupt change in the horizontal beam size was correlated to the change in longitudinal beam spectrum and the apparent fill pattern of beam current. Figure 2 depicts the fill pattern corresponding to the case without the abrupt change in horizontal beam size. The longitudinal beam spectrum corresponding to the fill pattern in Fig. 2 is shown in Fig. 3. The rf frequency is 500 MHz and the harmonic number is 200 for SRRC storage ring. A closer view of the unstable mode at 587 MHz revealed a strong longitudinal dipole oscillation as shown in Fig. 4.

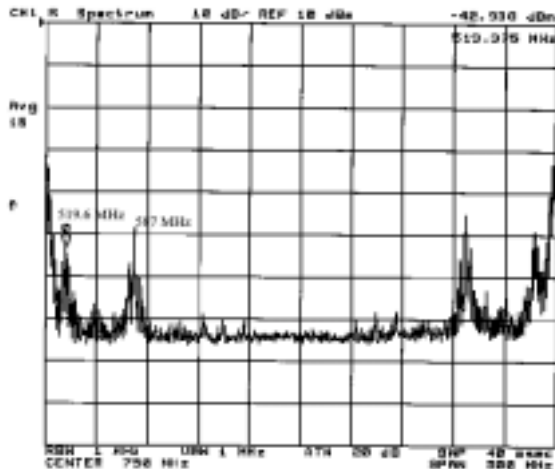
Figure 3: The longitudinal beam spectrum corresponding to the case without the abrupt change in horizontal beam size. Two prominent modes were observed near 520 MHz and 587 MHz. The rf voltage modulation was on. The frequency span is from 500 MHz to 1 GHz.

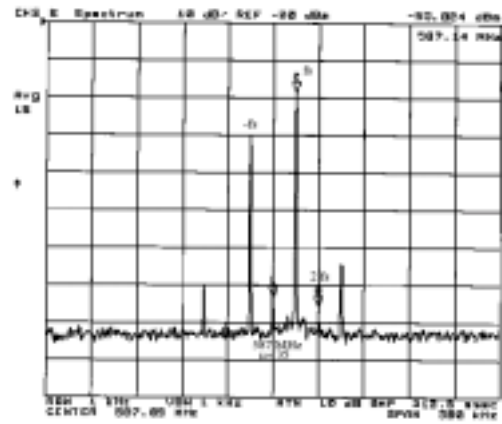
Figure 4: The zoom-in view of unstable mode at 587 MHz. The spectrum is centered at the 235th revolution harmonic. The synchrotron frequency is 25 kHz. 50 kHz/division.

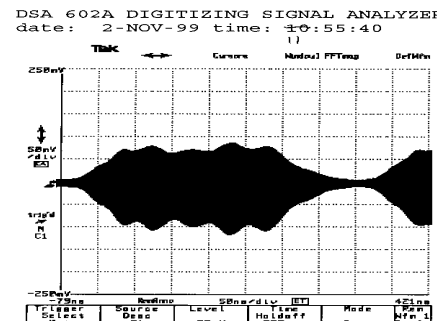
Figure 5: The fill pattern corresponding to the case with the abrupt change in horizontal beam size.

When the abrupt change in horizontal beam size occurred, the apparent fill pattern and the longitudinal beam spectrum switched to different patterns as shown in Figs. 5 and 6 respectively. It was realized that the existence of unstable mode at 587 MHz was related to the abrupt change in horizontal beam size and transverse closed orbit.

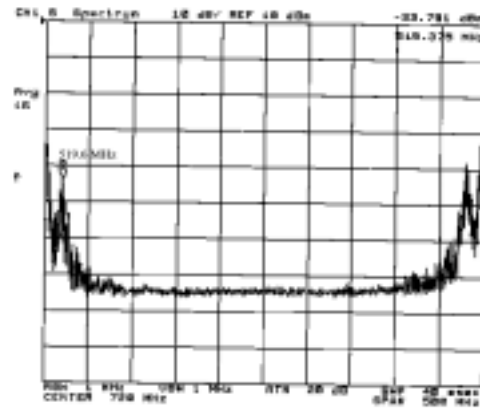
Figure 6: The longitudinal beam spectrum corresponding to the case with the abrupt change in horizontal beam size. The unstable mode near 587 MHz was no longer there. The rf voltage modulation was on. The frequency span is from 500 MHz to 1 GHz.

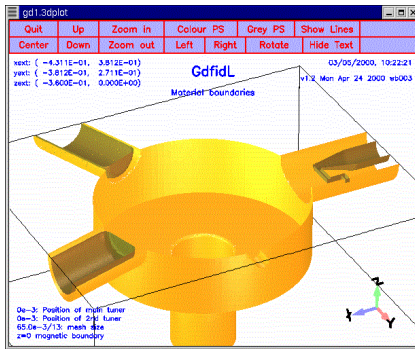
Figure 7: The layout of a Doris cavity in the rf section. The HOM damping antenna was replaced by a tuning plunger.

The layout model of a Doris cavity is shown in Fig. 7. The original design of the Doris cavity was modified. The HOM damping antenna was replaced by a tuning plunger. The longitudinal HOMs for the dual-cavity rf section was calculated by using a 3D rf code GdfidL[3]. Calculated results for a 2D model of rf section are given in Table 1 [4]. Only those modes below the waveguide cutoff were calculated. The growth rate was calculated for the worst case, i.e. on resonance, 200 mA equally-spaced bunch train. The radiation damping rate in the longitudinal direction is $0.176 \times 10^3/\text{sec}$. The disappearance of the unstable mode at 587 MHz in the beam spectrum was related to the abrupt beam instability. This unstable mode corresponds to the longitudinal coupled bunch mode number 37 driven by the HOM at 1590 MHz.

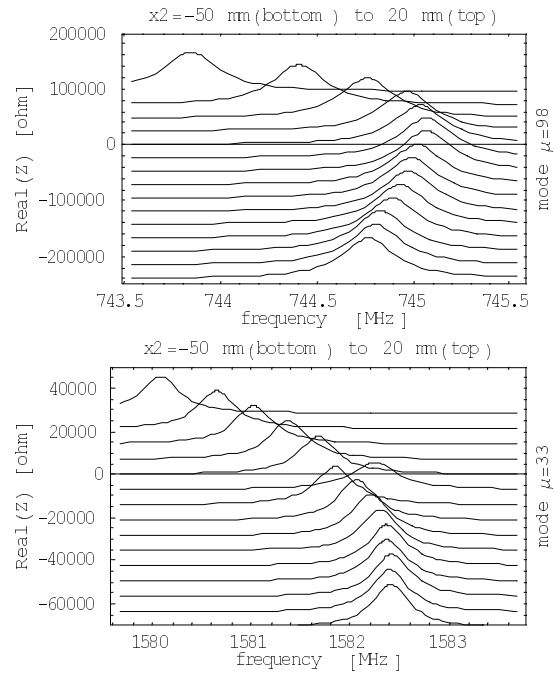
Figure 8: The frequency shift of HOMs vs. position of HOM tuning plunger. The rf plunger was moved at 5 mm per step. The fundamental rf frequency was held fixed by adjusting the first plunger.

We tried to avoid those unstable modes by detuning the frequencies of HOMs. The HOM tuning plunger was moved back and forth in order to find an optimum position while the other plunger was moved to maintain the frequency of accelerating mode. We could not find a setting such that all unstable modes could be avoided. The frequency shift of HOMs vs. position of HOM tuning

plunger was simulated with GdfidL and a 3D model of a single cavity. The simulated results are shown in Fig. 8.

The pattern and the scale of frequency shift for each HOM are not the same as shown in Fig. 8. Therefore, it is impossible to find a setting that all HOMs are avoided. Temperature variation has been used as a control, but was not too effective. The final solution in use for the present operation is to avoid the unstable mode driven by HOM at 1590 MHz with tuning plungers and apply the rf voltage modulation to the beam as well. After the HOM detuning, the abrupt change in the horizontal beam size and transverse orbit is no longer observed in user operation. An upgrade by replacing those two Doris cavities with a superconducting rf cavity developed by Cornell University is currently under way[5]. A longitudinal bunch-by-bunch feedback system is also being developed[6].
