SLAC-PUB-16219

ICFA INSTRUMENTATION BULLETIN

ETCHING OF COPPER COATED MYLAR TUBES WITH CF_4 GAS

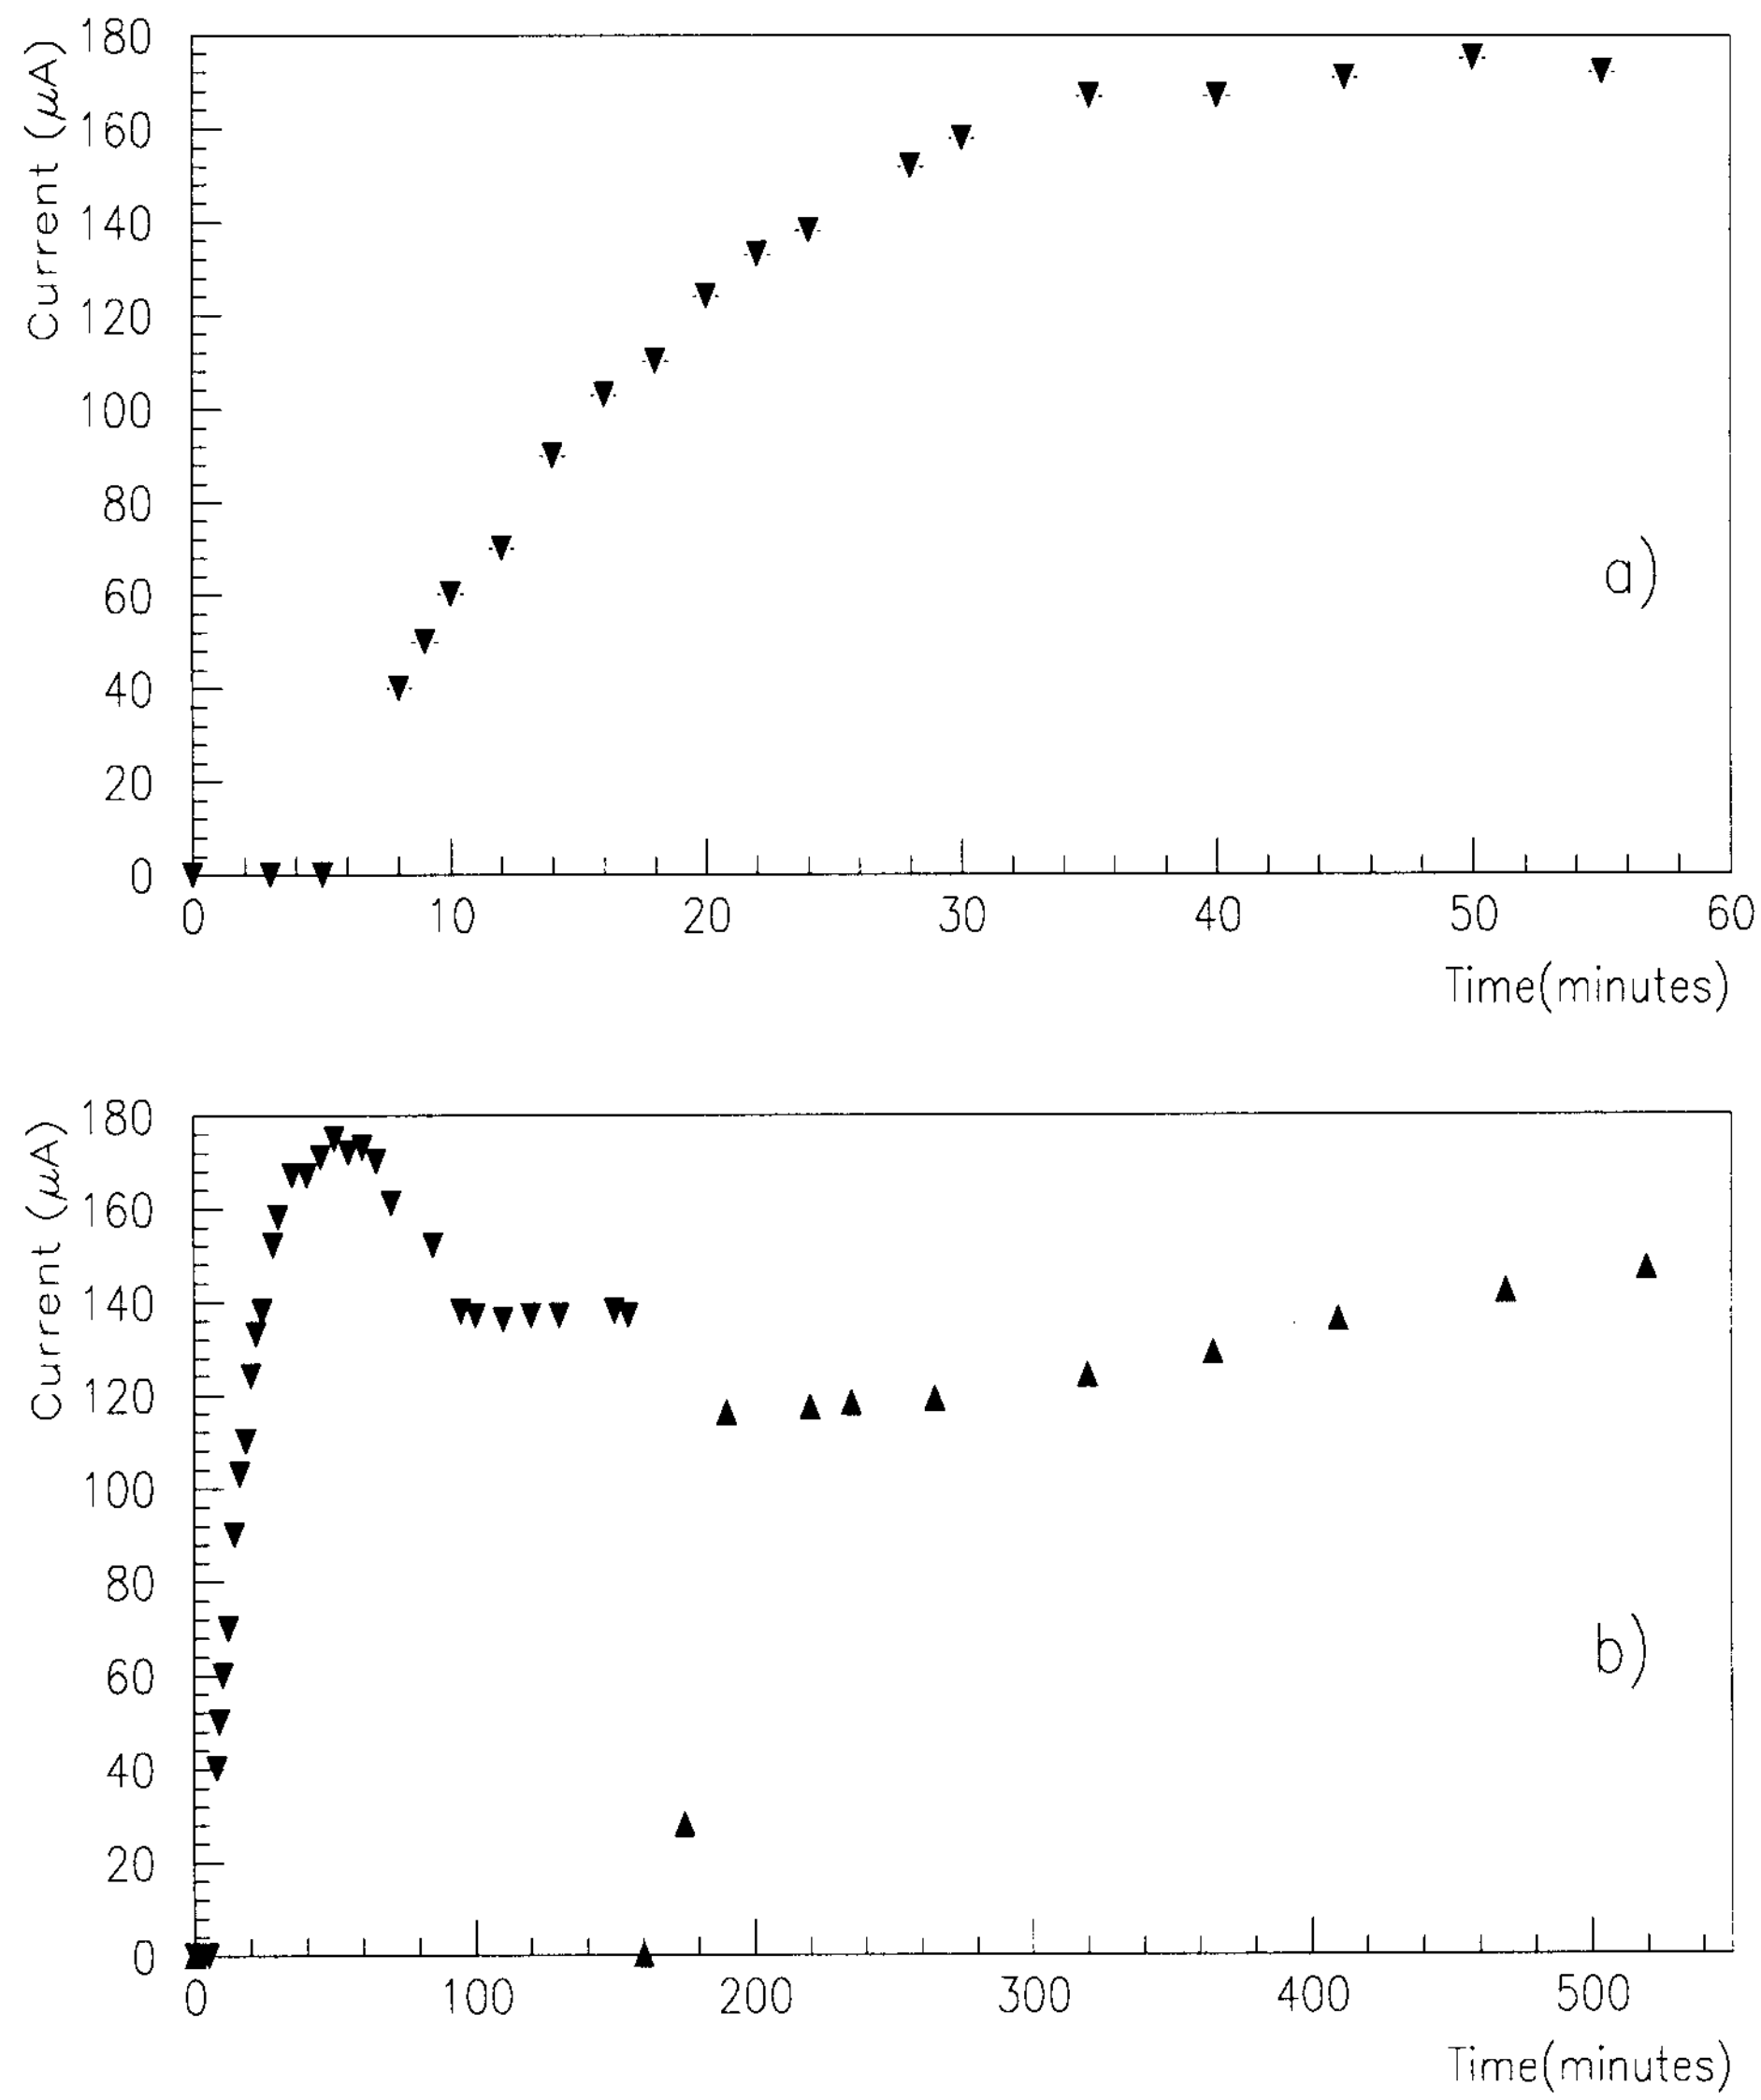
At this point we changed to pure CF_4 operating at the same voltage, namely 2.30 KV. Pure CF_4 began to draw current within a few minutes of turning off the gas flow and after about ten minutes the chamber was drawing ~60 μA; see Figure la. About an hour later, the current reached a maximum of ~180 μA and after about 90 minutes, it leveled off at around 140 μA. The straw

Figure 1: a) Short-term time dependence of current in straw #2 at 2.30 KV in pure CF_4 gas; b) Long-term time dependence; the copper began to thin visibly from the tube wall somewhere between 410-470 minutes on this plot. These data were taken over two days and the second set begins at t=160 minutes.

was turned off, flushed with fresh gas and the measurements started again at t=160 minutes in Figure 1b. About 310 minutes after beginning the second set of measurements, it became visibly apparent that the copper was being removed from the straw surface.

The flourine is then free to react with the copper. As mentioned, a white powder was observed in the straw after the copper was removed and CuF_2 is known to be white in its crystalline form [8].

For other reasons, the seven of eight straw chambers in experiment E871 at BNL were rebuilt for the 1996 run and to avoid problems arising from this effect two precautionary measures were taken: 1) the copper layer was increased from 1000 Å to 2000 Å; 2) all straws were individually pressure checked for leaks before installation. In addition to this, two operational changes were implemented: 1) gas flow rate was increased from 3 volume exchanges per day to 10 per day; 2) chamber voltage was ramped down between beam spills. The final chamber gas used in E871 was CF_4-C_2H_6 (50:50) with an operating voltage of 1950V (measured with an ^{55}Fe source, the gas gain is 8 x 10^4). Due to chamber capacitance, we were unable to ramp more than 100V down in the ~ 2 seconds available between the end of one AGS spill and the beginning of the next. As of this time, there is no indication of copper etching.
