SLAC-PUB-8554
August 2000

Results on an RF Pulsed Heating Experiment at SLAC

D. P. Pritzkau and R. H. Siemann

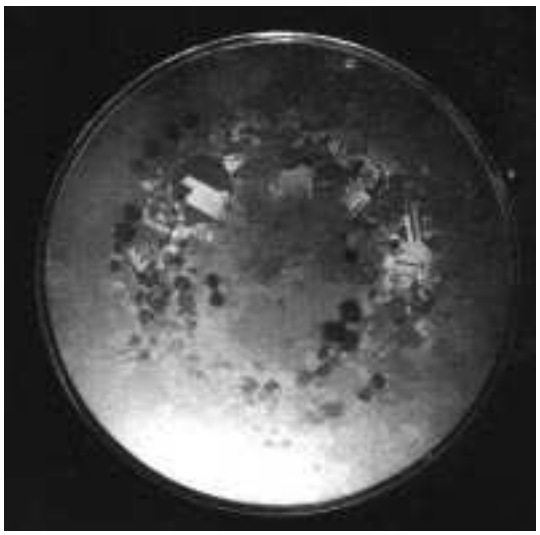
In Figure 1, one can see a visible change in the crystal grains in the region approximately 10.4 mm to 11.0 mm from the center with an average width of approximately 4 mm to 5 mm. From GdifdL [8] simulations, the fields in the region closer to the coupling iris is 5% higher than the fields diametrically opposite of this region. This simulation would then explain why there is more damage in the region closer to the aperture, since the region farther away has a temperature rise approximately 10% lower.

Figure 1: One of the copper endcaps. The other endcaps are similar in appearance.

density of the copper globules increases closer to the plane of the coupling irises. One may also see dark circles along the area of maximum magnetic field. Since they seem to occur in pairs and the magnetic field in this area is radial, we believe these patches are due to multipacting. However, it is not yet understood why this occurs since the electric field in this region is zero.

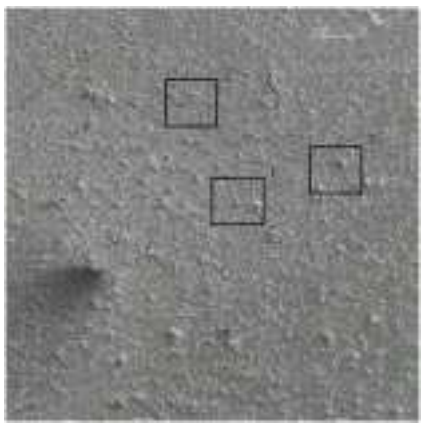
The endcaps were examined with a scanning electron microscope using secondary emission and a 5 keV electron beam. Figure 2 shows a region where maximum damage is expected. Note that this endcap pictured is different from the one shown in Figure 1; however, all four endcaps are similar in appearance. The little bumps along the surface are the copper globules sputtered from breakdown at the coupling iris. More importantly, one can easily see the numerous cracks that have occured on the surface. For comparison, a region at the center where the temperature rise is close to zero is shown in Figure 3. This picture was taken at the same magnification. There are no cracks in this region. The copper globules are also noticeable here. Because of the sputtering, we cannot isolate the unloaded Q degradation shown in Table 1 due to sputtering from that due to the presence of the cracks.

Each endcap was scanned along a random diameter. The scans show that cracks are only evident in the region of visible grains in Figure 1 where maximum damage is expected. Higher magnification images of the regions of cracks were

Figure 2: Region (0.9 mm $\times$ 0.9 mm) where maximum damage is expected. The scale in the upper right-hand corner is 100.7 μm. Figure 4 has higher magnification images of the indicated regions.

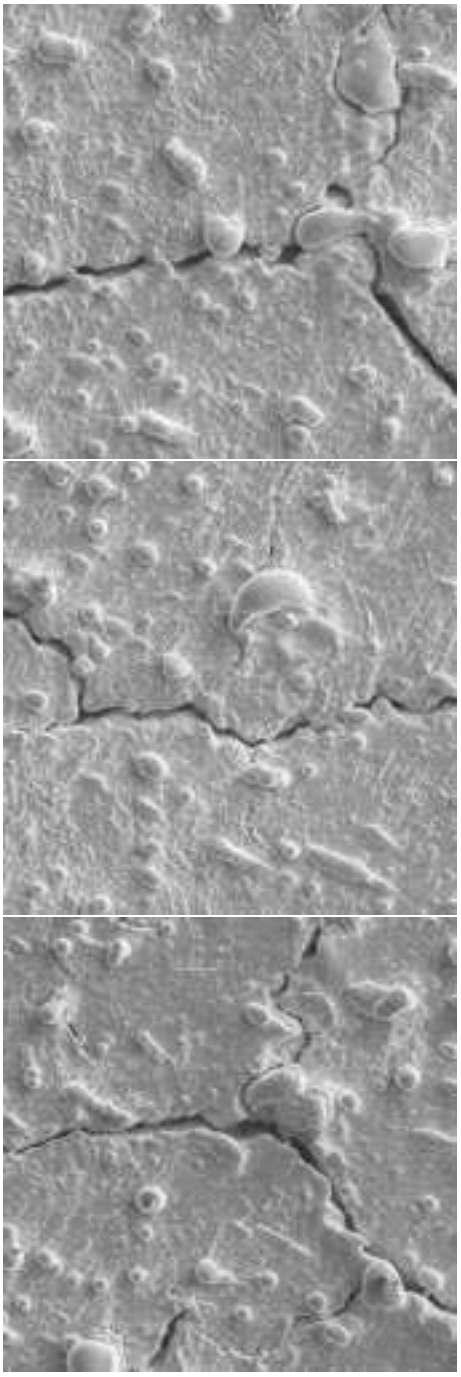
taken. For the endcap shown in Figure 2, the average location of all higher-magnification images of cracks is approximately 10.4 mm from the center with a standard deviation of 1.3 mm. Close-up shots of a few of these cracks are shown in Figure 4.

Figure 4: Regions 1–3 from Figure 2. The scale shown in each image is 10.0 μm.

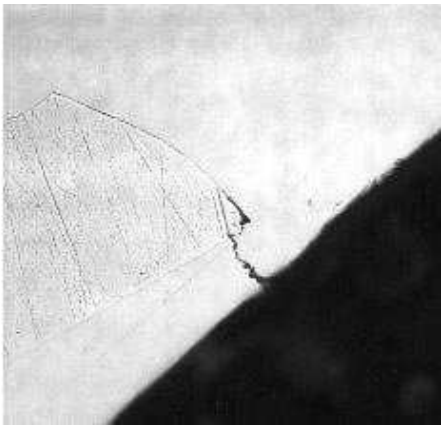
An internal cross-section of the endcap shown in Figure 1 was completed. Not as many cracks were evident in the cross-section, but they did occur in the region of maximum temperature rise. One interesting crack is shown in Figure 5. It begins at the surface and propagates down to an internal grain boundary. Afterwards, the crack propagates along the grain boundary.

Figure 5: A cross-section of the endcap shown in Figure 1 showing an internal crack in the region of maximum temperature rise. The crack extends 24 μm into the surface before touching the grain boundary.
