LARGE COMPONENT DEFORMATION STUDIES USING VIDEOGRAMMETRY

*John A. Greenwood, LS
Alignment & Metrology Group, Fermilab, Batavia, IL 60510*

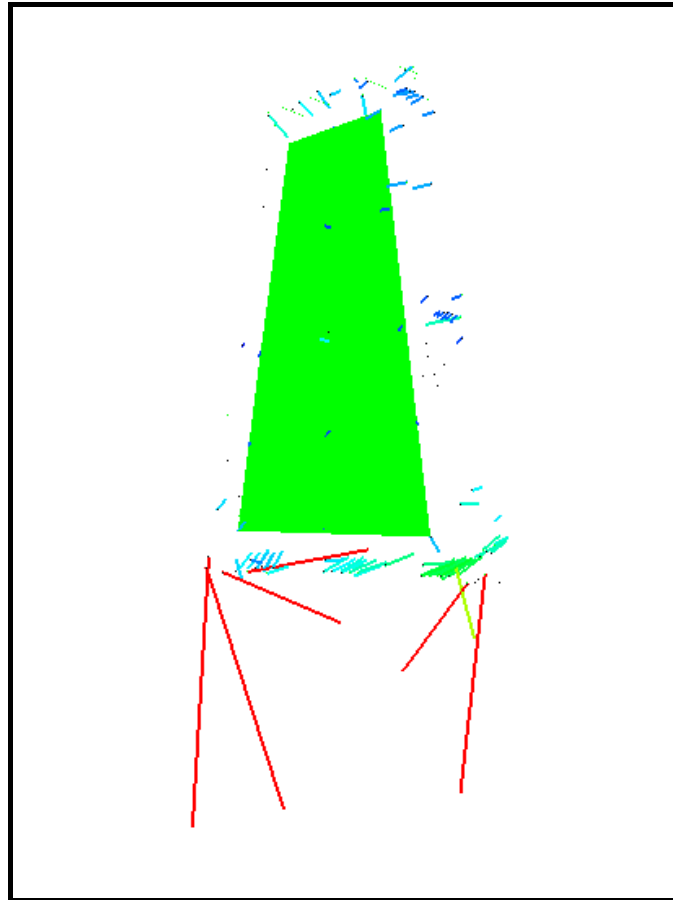
Figure 9 - 6 o'clock epoch

In Figure 8, the chamber was suspended using the near lifting point seen in Figure 3, and the lifting point seen at the center of the small end in Figure 4. Interestingly, this is the first evidence of the inelastic distortion mentioned above. In Figure 9, the chamber was suspended by the single lifting point at the small end.

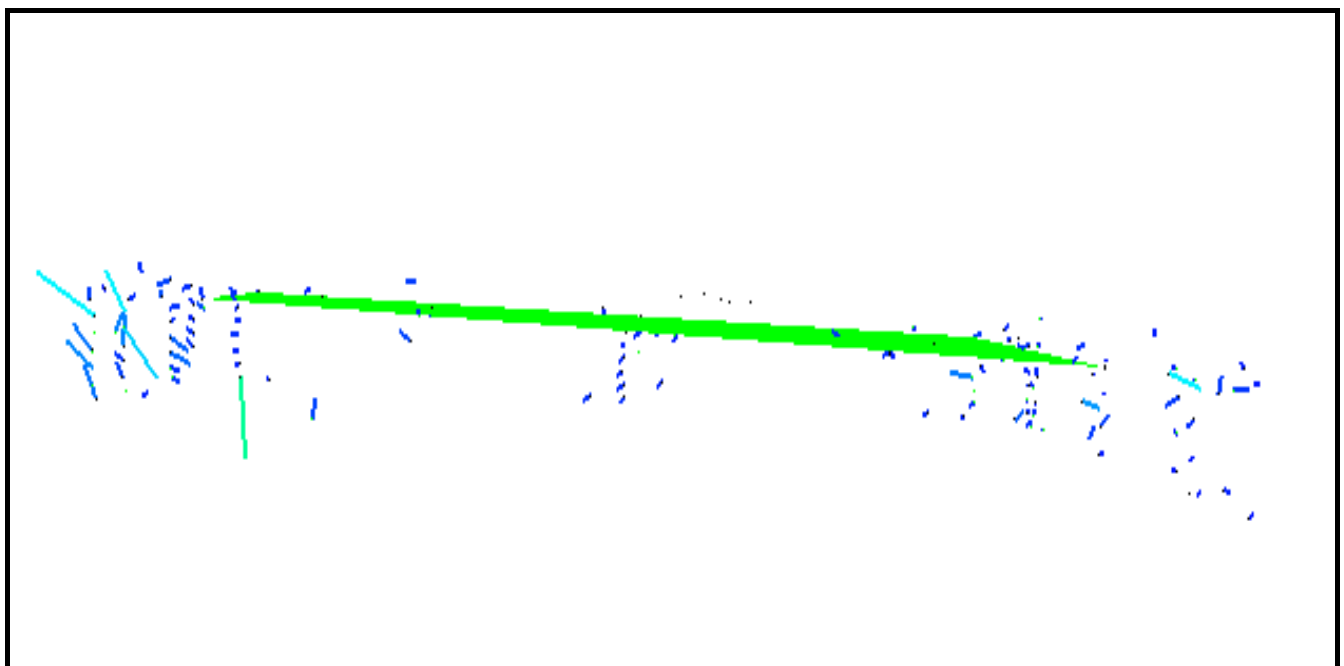
Figure 14 - Post run 1 - Post run 2 delta

The post run measurements, Figures 12 and 13, were made on a surface table at the second facility. The work area was quite cramped, which gave a slightly poorer Plan Quality Factor. The Plan Quality Factor is a measure of the appropriateness of the number of exposure and the position and orientation of the camera stations. The effects of this can be seen in Figure 14, when compared to Figure 6. The distortion at the lifting point at the large end is still apparent, as is the likelihood that the small end external framework has not been replaced in the same location.
