SLAC-PUB-12050
August 2006

RF Breakdown Studies in Tungsten and Copper Structures

Presented at the 12th Advanced Accelerator Concepts Workshop
Lake Geneva, Wisconsin
July 10-15, 2006

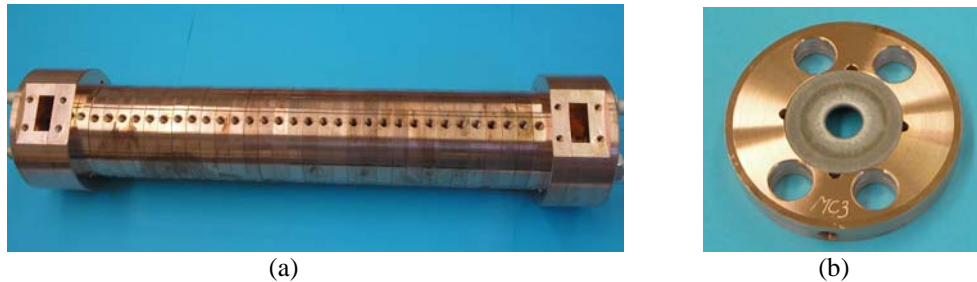
molybdenum and tungsten irises were rf tested at NLCTA. A photograph of the 11.424 GHz, tungsten iris structure without the input and output waveguides attached is shown in Fig. 2a, and one of the copper cells with the tungsten iris insert is shown in Fig. 2b. This structure was fabricated at CERN and the tungsten iris inserts were machined and polished by an outside company. In contrast with the 30 GHz structures, the experimental results at X-band were not encouraging for either a molybdenum [3] or tungsten [4] iris structure. In particular, after several months of rf processing the tungsten iris structure, there was no significant improvement beyond that achieved during the first few weeks. The structure was gassy and required reprocessing when coming back on in power after brief shutdowns. It also required reprocessing when changing back to previously processed pulse lengths. The maximum gradient achieved with 200 ns long pulses was 63 MV/m with a breakdown rate of 10-20 per hour during 60 Hz operation. A prototype NLC copper structure being processed in parallel performed significantly better, achieving 100 MV/m with 250 ns duration pulses and less than 10 breakdowns per hour.

FIGURE 2. A CERN fabricated (a) 30-cm X-Band accelerator using (b) cells with tungsten iris inserts (iris diameter ~ 1 cm).

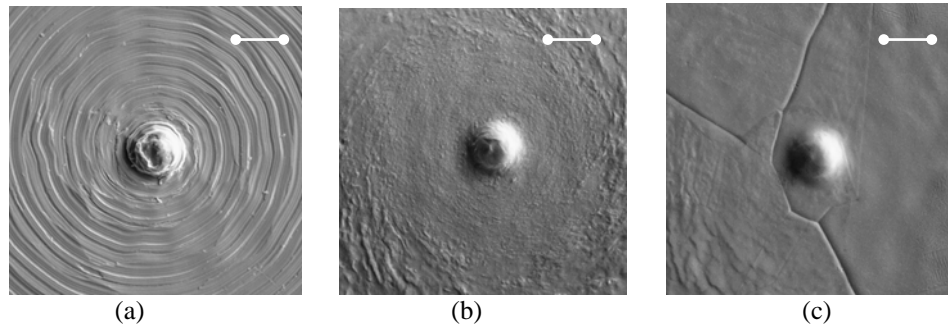
FIGURE 6. Typical copper surface topography at various stages of fabrication: (a) after machining, (b) after chemical etch, and (c) after heat cycling. All SEM images were taken at 1000x magnification (scale bar =10 μm).

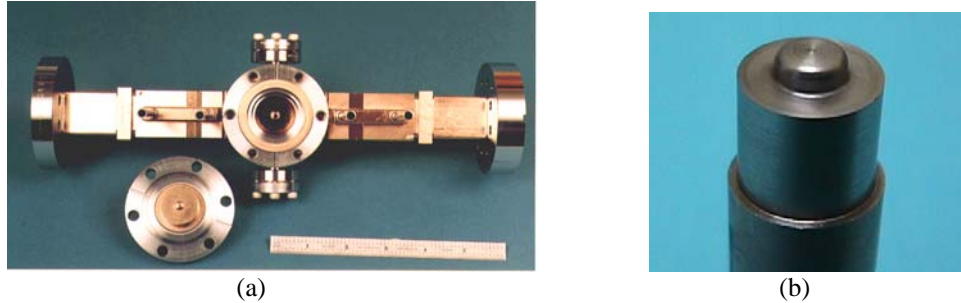
fed directly by a SLAC 50-MW X-band klystron. The cavity has two removable field enhanced noses that enables analysis of the high gradient surface areas before and after rf testing. The cavity noses are replaceable, making this an ideal setup for rf testing different materials. Tungsten rods with the same nose profile as the cavity noses are currently being used to optimize the polishing parameters (Fig 12b) in preparation for fabricating the cavity noses.

FIGURE 12. Cavity with two removable noses (a) to be used to study high gradient properties of tungsten. Polishing techniques are being finalized with (b) tungsten rods having the same cavity nose profile.

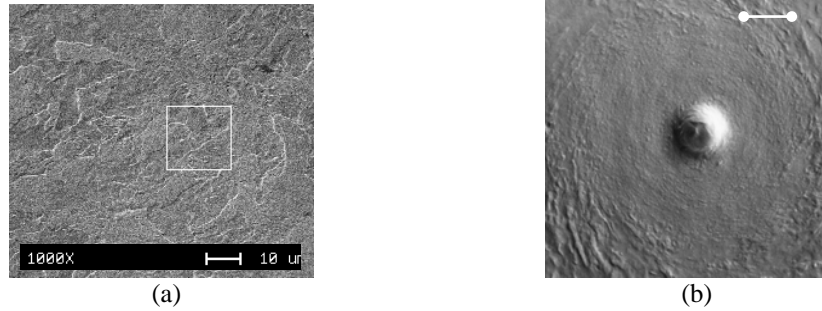
A combination of hand polishing and electropolishing has thus far provided the best tungsten surface finish. An example of two tungsten rods that were hand polished and then electropolished is shown in Fig. 11. The electropolishing was done with both a 2 V (Fig. 11a) and 4 V (Fig. 11b) source, while the remaining parameters (e.g. time and temperature) were kept the same. The tungsten rod that was electropolished at 4 V has a smoother surface compared to the electropolished sample at 2 V. However, the surface has a large number of etch pits. Further experiments are being conducted to determine the optimum parameters.

FIGURE 13. Tungsten rod after (a) hand polishing and electropolishing compared to a (b) typical chemically etched copper surface (scale bar = 10 μm).
