SLAC-PUB-1095
(ACC)
August 1972

BRAZING WITH COPPER AND COPPER-BASE ALLOYS*

G. P. Fritzke

Stanford Linear Accelerator Center
Stanford University, Stanford, California 94305

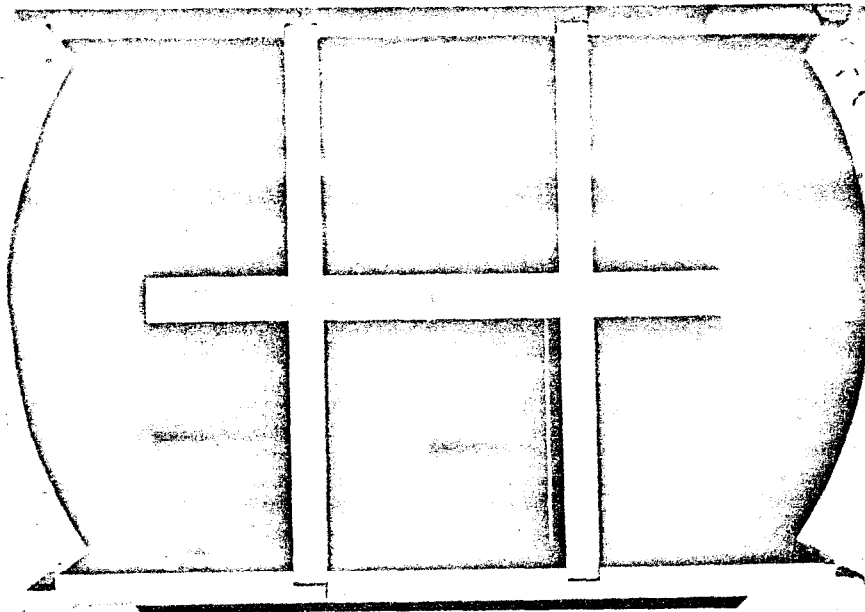
FIG. 11--Cross section through stainless steel target.

As shown in Figure 11, the short sides of the stainless steel target were set into milled slots cut into the inside surfaces of the longer top and bottom pieces. Tack welds were used to jig the plates. Copious quantities of copper powder were spread along the joint with a brazing cement. The part was inserted into an Inconel retort which was purged with nitrogen and hydrogen and lowered into a large furnace at a temperature of 1100°C. Every joint cracked, as shown in Figure 12. Metallographically, the joint area showed numerous copper-filled cracks similar to Figure 13.
