BEHAVIOR OF THE FIRST SUIT OF SCOTCHLITE IN THE 40" SLAC HYDROGEN
BUBBLE CHAMBER

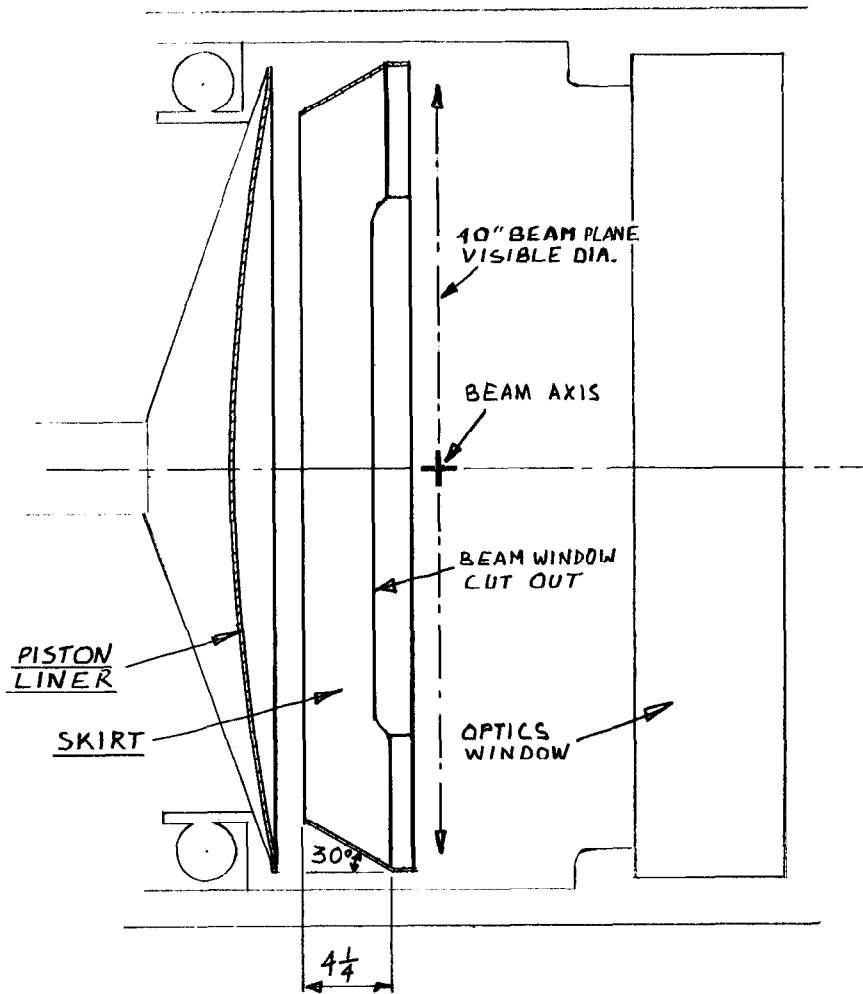
FIG. 1.
RETRODIRECTOR MOUNTING IN THE 40" H.B.C.

The retrodirector components shown in Figures 1 and 2 have been referred to as the piston liner and the skirt. Description of their construction follows.

The piston liner was clamped in place on the piston with a total of twenty-four #10-24 screws holding the two clamping half rings. It was these rings which became loose during the run and forced its termination.

- (c) The remaining skirt segments will be mounted to chamber walls with suitable brackets. (This is a temporary reduction of the skirt size.)
- (d) The piston liner will no longer be truncated. It will be reduced slightly in diameter and bent sufficiently to allow entrance into the chamber through the window opening. The liner will be held in place by a one-piece steel clamp ring equipped with indium sealing wires (see Fig. 8). The ring will also be distorted to allow entry into the chamber. Bolts holding the ring will be tack welded to prevent loosening.
