Open Reliability Issues (Vacuum, Magnets & PS)

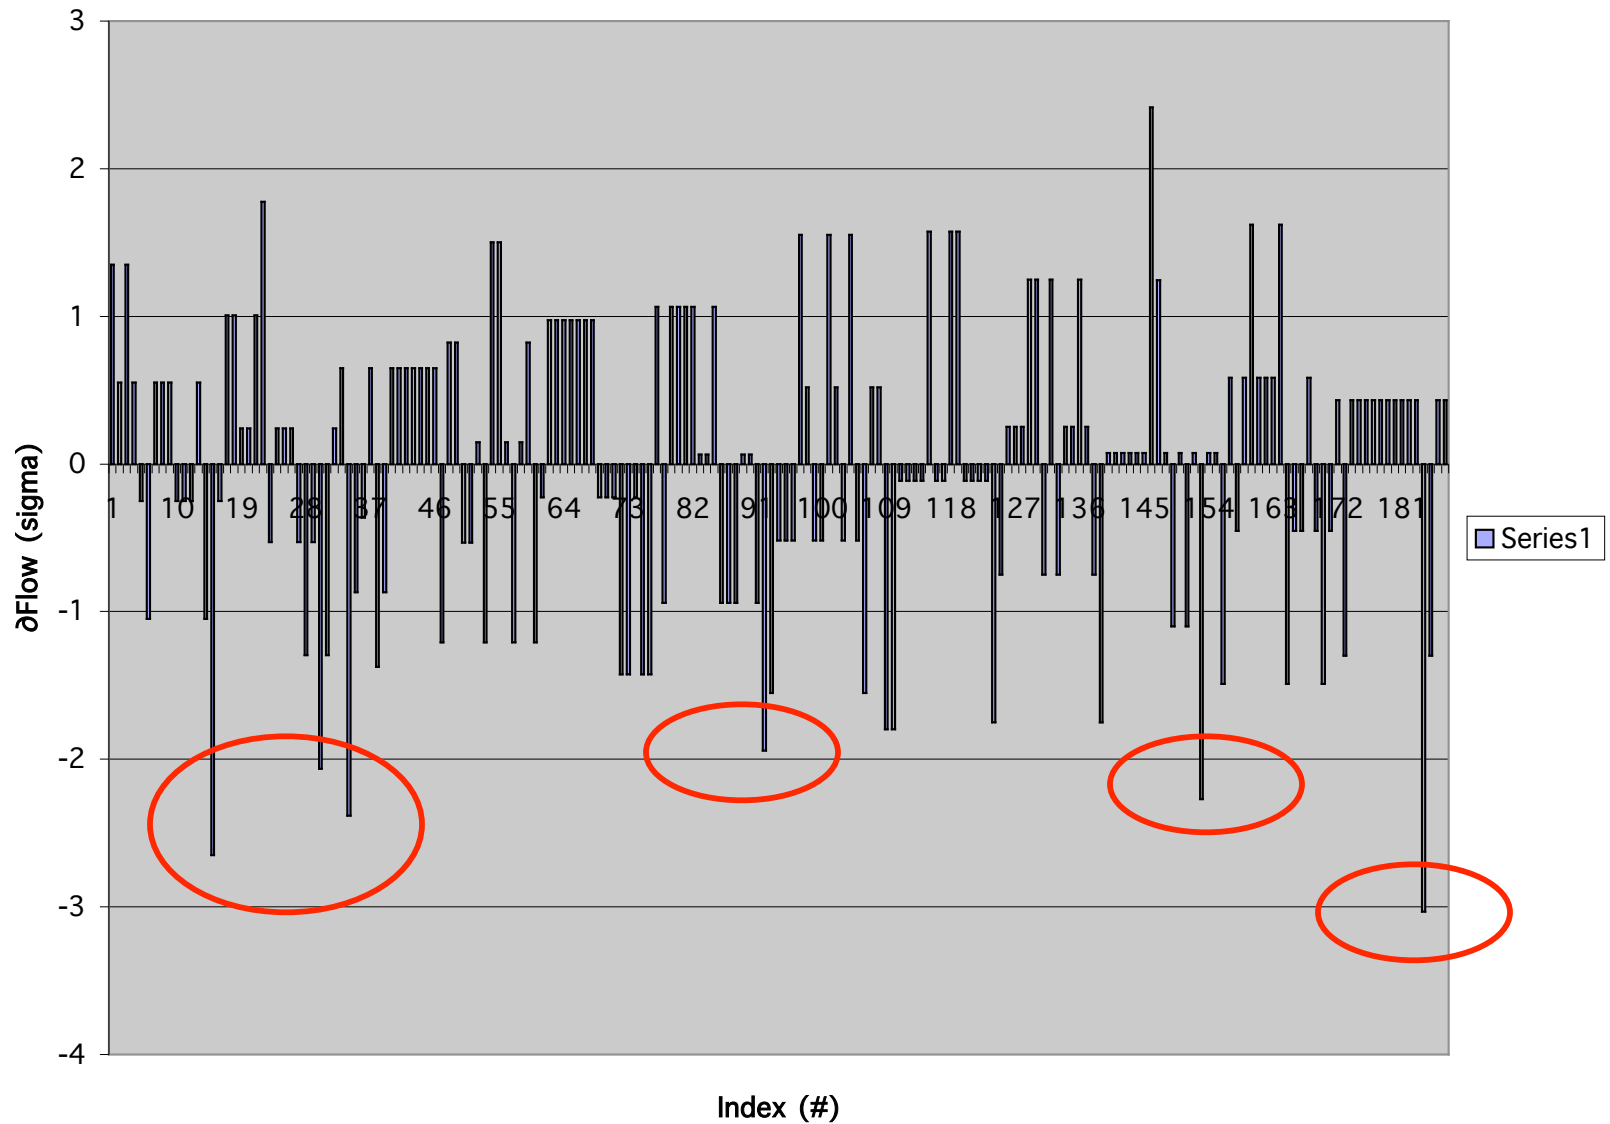
HER Dipole Flow Rates

“0” is
5...6 gpm
depending
on half-
arc.

“ σ ” is the
spread in
the half-
arc the
chamber
is in
(0.2...0.3
gpm typ.).
