TWO-MILE ACCELERATOR PROJECT

Quarterly Status Report
1 October 1967 to 1 January 1968
June 1968

Technical Report
Prepared Under
Contract AT(04-3)-400 and
Contract AT(04-3)-515
for the USAEC
San Francisco Operations Office

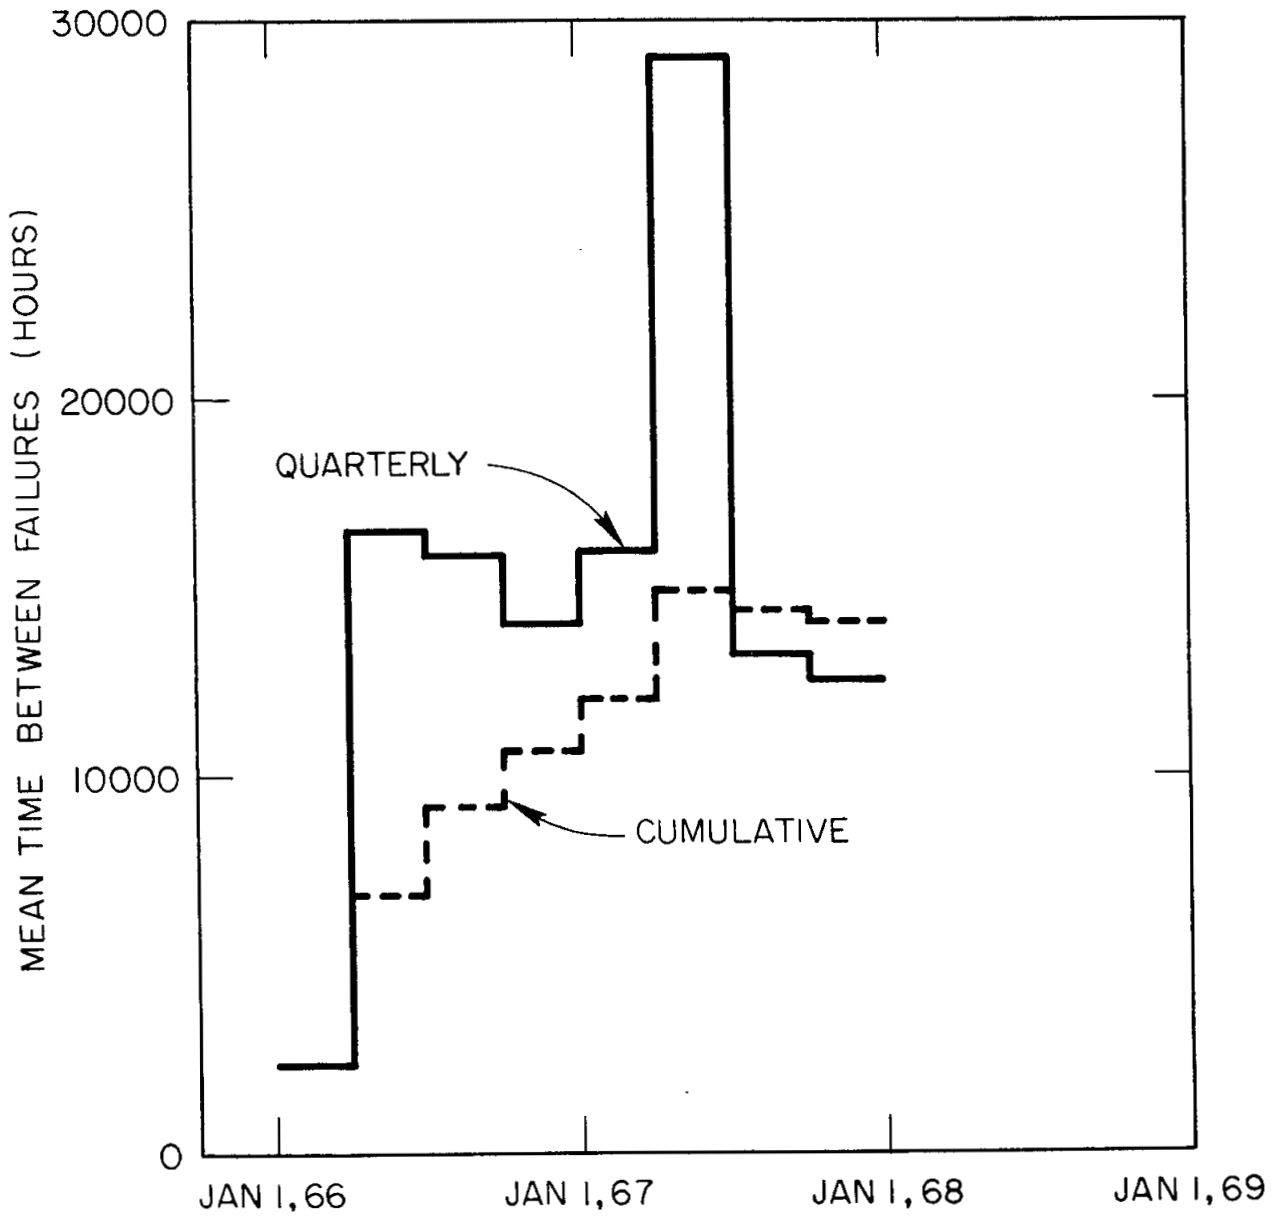
1046A6

FIG. 9--MEAN TIME BETWEEN FAILURES, EXCLUDING SPERRY TUBES

Figure 8 gives the mean time between failures (MTBF: number of operating hours per quarter divided by the number of failures per quarter), the mean operating tube age, and the mean age at failure for the past two years including all tubes. The MTBF, excluding all Sperry tubes from the statistics, is shown in Fig. 9. This also includes the cumulative MTBFs. Since there is only one Sperry tube left in operation to date, we feel that the exclusion of the Sperry data from the statistics makes the trend more realistic.

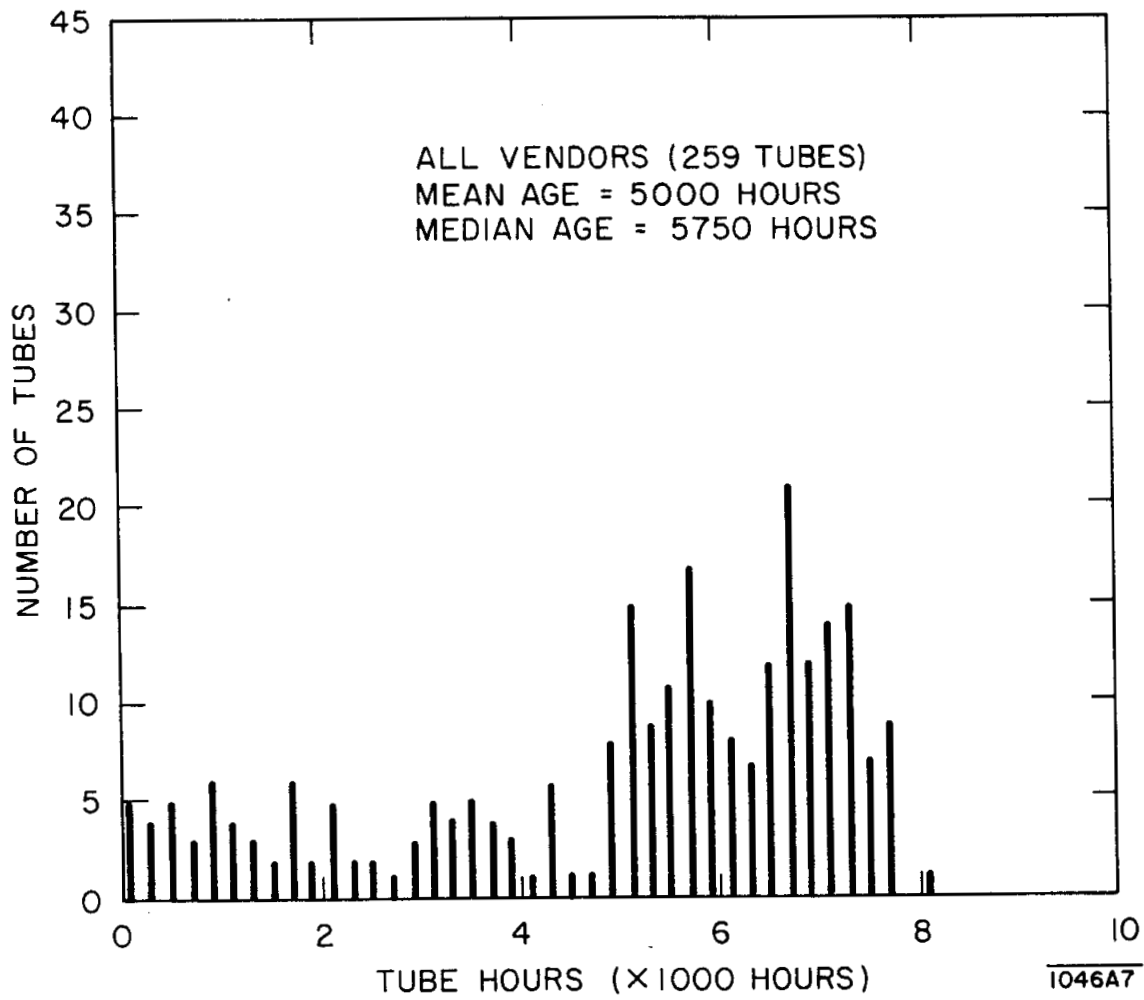
FIG. 10--KLYSTRON AGE DISTRIBUTION (ALL VENDORS) IN 200-HOUR INCREMENTS

Figure 10 gives the klystron tube age distribution on January 1, 1968, and indicates a mean age of 5000 hours and a median age of 5750 hours.
