NEW JOINING TECHNIQUE FOR WATER-COOLED COPPER MAGNET COILS*

(Paper to be presented at the Second International Conference on Magnet Technology, Oxford, England, July 11-14, 1967)

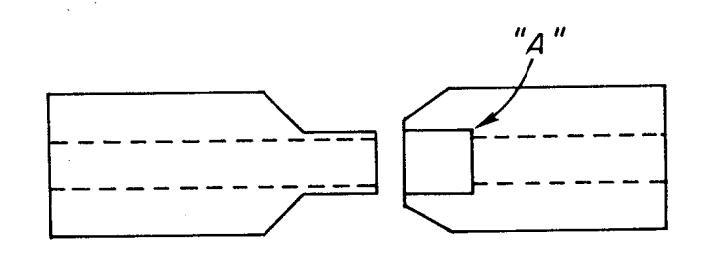
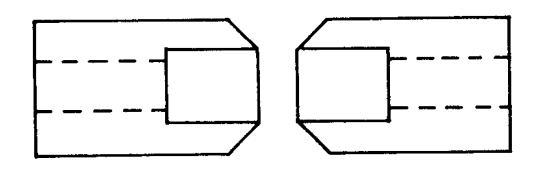
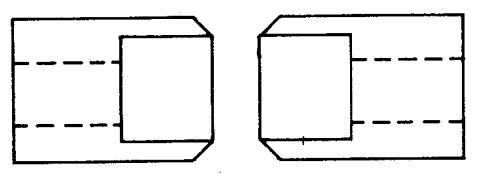
JOINT 1 - INTEGRAL BUTT

JOINT 2 - STRAIGHT BUTT

JOINT 3 - THIN COPPER SLEEVE

"A" - ORIGIN OF FAILURES IN TENSILE TESTS

JOINT 4 - THICK COPPER SLEEVE

JOINT 5 - THIN STAINLESS SLEEVE

JOINT 6 - THICK STAINLESS SLEEVE

All weld tests were performed on water-cooled copper conductor with an outside dimension of 3/4-inch (19 mm) square and a 7/16-inch (11 mm) diameter center hole. Figure 1 shows the joint designs used. The design ideas are:

No. 1 Self aligning with integral sleeve to control weld "drop-through."

- No. 2 Simplified butt joint for machining ease.
- No. 3 Simplified butt joint for machining ease (both sides identical)

using self aligning copper sleeve.

No. 4 As No. 3 above, but using thicker copper sleeve to minimize welding time.

No. 5 Same as No. 3, but using thin type 304 stainless steel alignment sleeve.

No. 6 Same as No. 4 above, but using thick type 304 stainless steel sleeve.

It was observed that all fractures occurred at point "A" (see joint 1, Fig. 1), except joint No. 2 which had no sleeve. All welded test specimens failed inside the 2-inch gage length centered about the weld. The unwelded comparison specimens failed outside of the gage length but the gage elongation is included for information.
