HIGH POWER MODEL FABRICATION OF BIPERIODIC L-SUPPORT DISK-AND-WASHER STRUCTURE

H. Ao *, Y. Iwashita, T. Shirai and A. Noda,
Accelerator Laboratory, NSRF, ICR, Kyoto Univ.,
M. Inoue, Research Reactor Institute, Kyoto Univ.,
T. Kawakita, K. Ohkubo and K. Nakanishi, Mitsubishi Heavy Industries, Ltd.

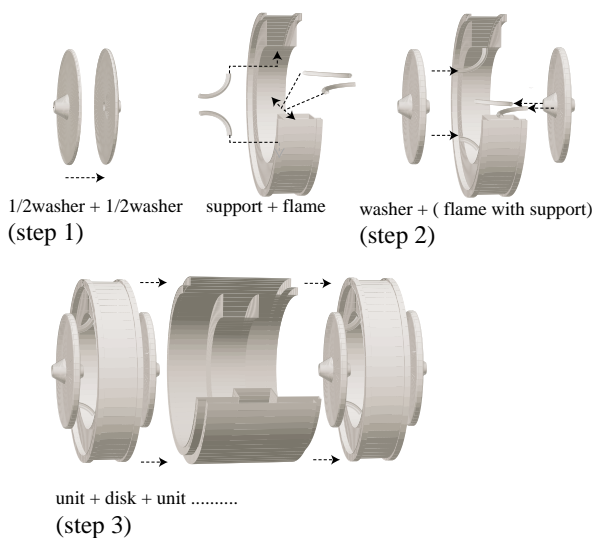
Figure 1: Fabrication steps of the biperiodic L-support DAW

The DAW structure is fabricated by three brazing steps.(See fig.1)

The wall loss on the metal surface requires water paths in the washer and support. Cooling water enters from one side of the supports and goes out from another side. Two rough processed half washers were brazed together (step1), and then it was machined to the final dimensions.

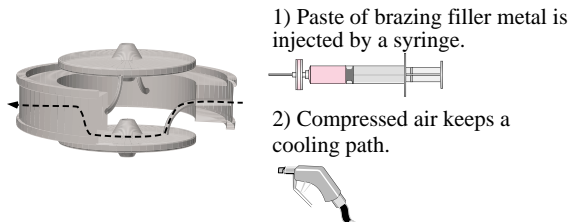
Figure 2: Repairing a vacuum leak by paste of brazing filler metal.

Leak repairing The five leak units were tested for repair, and the four of them were successful at the stage of step2. The way of repairing was as follows. After paste mixed with a brazing metal powder was injected into a cooling path, these units were heated up again. Because the paste metal must not fill up the cooling path, viscosity of the paste was adjusted by additional acetone, and compressed air was blown after inserting the paste. The repaired washer was set at lower side in a heat up process for the brazing metal not to flow out.

Although three units had no vacuum leak after an entire brazing (step3), one unit caused a small vacuum leak again. The leak rate was 5.0×10^{-9} [torr/l/s]. Because the brazing metal for the repair has melting temperature at the middle between step2 and step3, the margin of the melting temperature was ensured. Endurance of the repaired area, however, seems not enough.

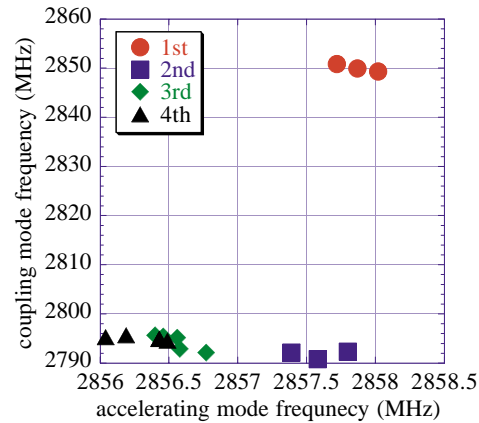
Figure 3: Single unit measurements of frequencies.

Frequency The accelerating and coupling mode frequencies were measured at step2. Figure 3 shows the measurement results as a scatter diagram.

The frequency errors are small within the same model generations. It means that the fabrication process keeps good reproducibility. It is important to examine the dependence of the frequency on the number of units for the design of a multi-cell-DAW. Many aluminum models were used to optimize dimensions[3]. Figure 4 shows the frequency convergence up to 12 units of the optimized test model.

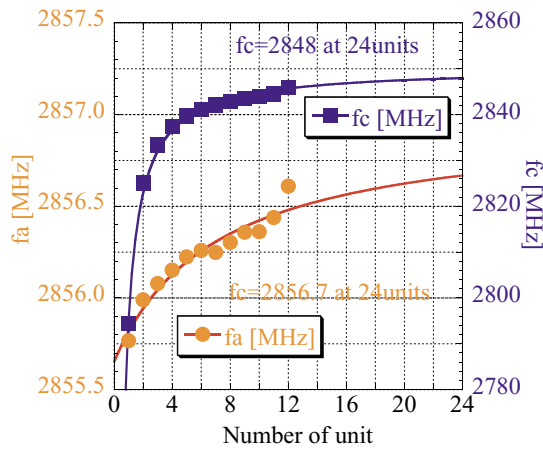
Figure 4: Unit number dependence on the accelerating and coupling mode frequencies.

The tolerance of the accelerating mode frequency is about 1 MHz at this stage. Because the squeeze method can raise the accelerating mode frequency up to about 1.5 MHz. The coupling mode frequency is about 10 MHz lower than the operating frequency 2857 MHz from this result. This 10 MHz error is considered as tolerable, because the DAW has a large coupling constant, and thus the mode separation is about 30 MHz.

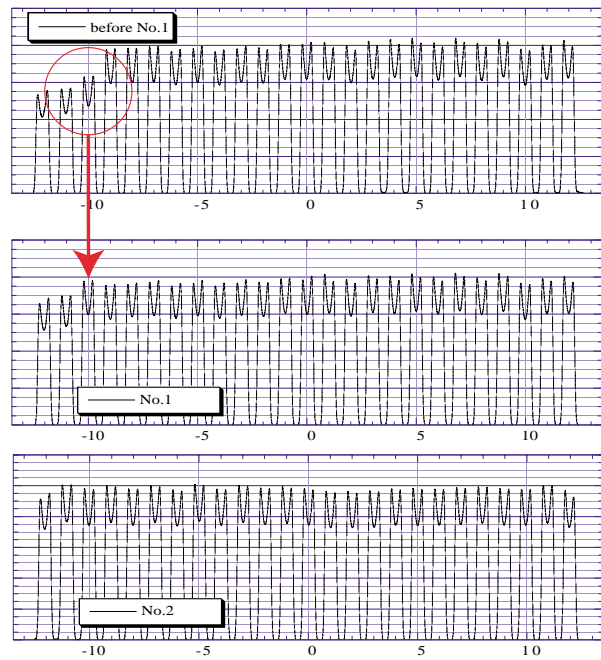
Figure 5: Correction of the electric field distribution and the final distributions of No.1 and No.2 accelerating tubes.

In the DAW, the flatness of the electric field distribution can be corrected without changing the frequencies. Figure 5 shows the example of the field correction. The field distribution was checked before whole brazing (step3) assembled temporarily. A coordinate measuring machine measured the washer positions, and then they were corrected by hand. The final field distribution is also shown in Fig. 5.
