DETECTION OF INSTRUMENTAL DRIFTS IN THE PEP II LER BPM SYSTEM.*

W. Wittmer[†], A.S. Fisher, D.J. Martin, J.J. Sebek,
SLAC, 2575 Sand Hill Road, Menlo Park, CA 94025, USA

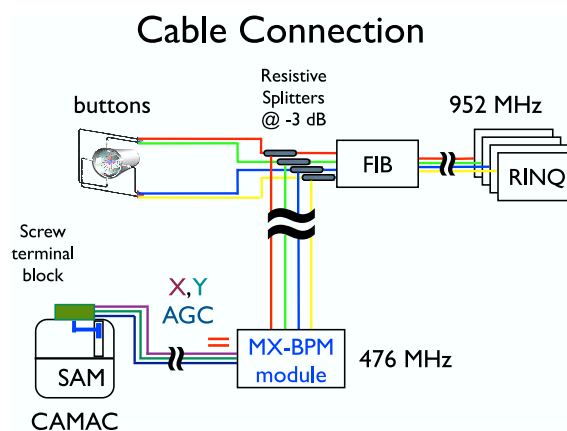
Figure 1: Test setup used in LER of PEP II. The upper path describes the original PEP II BPM installation. Before the the FIB the signal is split and half of the signal is brought to the BERGOZ module. The position analog output is digitized by the SAM and included in the SCP as Analog SStatuS (ASTS) channel.

To eliminate all possible error sources hidden in the existing BPM system the signal coming from the four beam pickups had to be split before the Filter Isolation Box (FIB). This was done by installing resistive splitters. To

be able to adjust the setup during operations and to not expose the electronics to radiation it was decided to have the BERGOZ module installed in one of the surface support buildings. Consequently, we were restricted to choosing BPMs with their standard electronics (RINQ modules) in such buildings. In addition the FIB, which is installed in the tunnel a few feet away from the pickups, had to be brought up to these buildings. A schematic of the test installation is shown in fig.1.

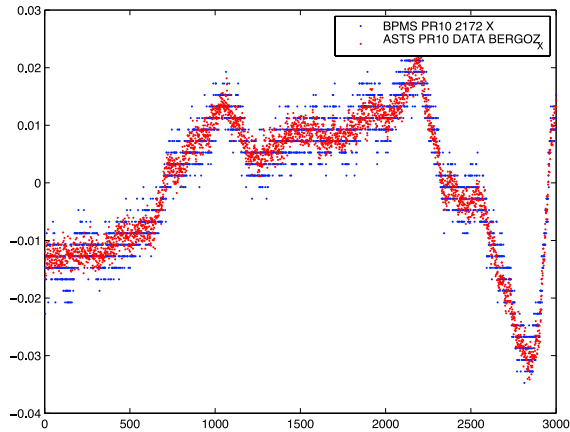
Figure 2: Correlation plot data comparing the position horizontal position reading from the BERGOZ module to the PEP II unit. The BERGOZ unit is scaled and offset corrected, since it was set for SPEAR. The blue trace shows the PEP and the red the BERGOZ unit.

The first phase of the test was to ensure, that the BERGOZ unit was working properly in the PEP II environment. This is important as a light source such as SPEAR typically has smaller orbit deviations, usually less than one millimeter, from the design orbit than does LER, where differences of up to 20 millimeter are measured. Therefore a location was chosen where the standard position reading showed no problems. Fig. 2 compares simultaneous BPM readings using the RINQ and BERGOZ modules. The two position readings tracked closely. After this test, the setup

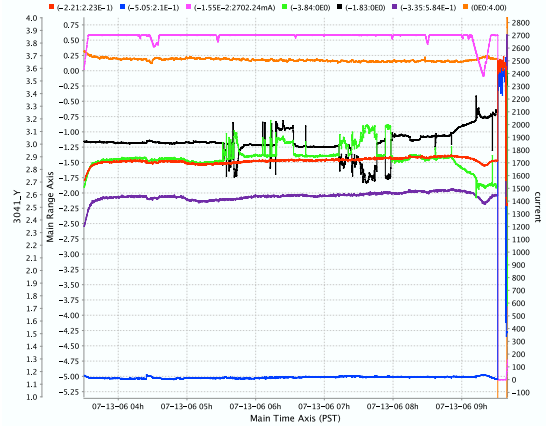
Figure 3: EPICS channel archive data showing the position readings of two PEP and the BERGOZ unit during one fill. The magenta trace indicates the LER beam current which is stable at 2.8 Ampere during most of the fill. The unit 3042 (x green, y black) shows jumps and beam motion. Neither is exhibited by either the BERGOZ unit (x-red, y-blue), which shares the position signal from the same pickups, or by the neighboring unit 3041 (x-purple,y-orange).

was moved to a location with a known bad position reading. Since the position jumps occur at random, the correlation plot tool was not suitable for this test. Instead the EPICS channel archive data were analyzed. Every BPM and selected ASTS channels are archived at rates between one and ten seconds. The disadvantage is that these data are taken asynchronously and the comparison is only possible on a long time scale. These are also raw data, which means the BERGOZ positions are not scaled and offset corrected. Fig.3 displays horizontal and vertical position readings of two neighboring RINGQS and the BERGOZ unit. The second PEP unit, separated only by a main dipole from the unit of interest, is used as reference to determine if the beam is moving. Unit 3041 shows jumps that are

which was undetected until these measurements. At the end of this fill, the horizontal and vertical position readings of unit 4032 start to slowly drift while the other units show no orbit change. When first observed, it was unclear what was happening. Either the BERGOZ unit could not track real beam motion or the PEP unit was drifting. The second PEP unit confirmed that the bad unit not only jumped but drifted. This is particularly bad since, as contrary to the jumping, it is not possible to determine if a BPM is drifting only from its position reading. A detailed analysis of the data showed no pattern of this behavior. Neither period, start time, or maximum change in position reading showed dependence on other parameters like beam current, beam motion, etc. These results triggered a closer analysis of the hardware, which showed that a batch of FIBs had bad solder joints. These were not detected using standard test procedures. During the last downtime an effort was begun to find and repair all these FIBs.

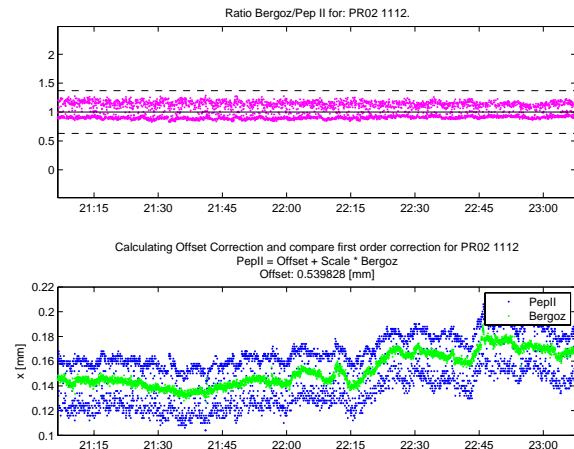
Figure 4: Correlation plot results for the units installed in location PR02 1112 in the LER for the horizontal plane. The upper plot shows the ratio of the BERGOZ position measurement to the PEP. The lower shows the actual position readings with the BERGOZ units (green trace) with offset corrected. The PEP unit's (blue trace) position readings depicts a two state behavior which is unphysical.

During this analysis, another failure mode of the existing BPM system has emerged. As shown in Fig. 4, which depicts the PEP position reading in blue and the BERGOZ in green, the PEP unit has a two state position reading with an average difference of $400 \mu m$. The BERGOZ unit is centered between them due to the algorithm calculating the offset. The correct interpretation is that the correct position is shown by the upper part of the blue trace while the lower is a bad reading. This indicates that jumps can occur more frequently than expected.
