# Additives That Prevent Or Reverse Cathode Aging In Drift Chambers With Helium-Isobutane Gas<sup>\*</sup>

## Abstract

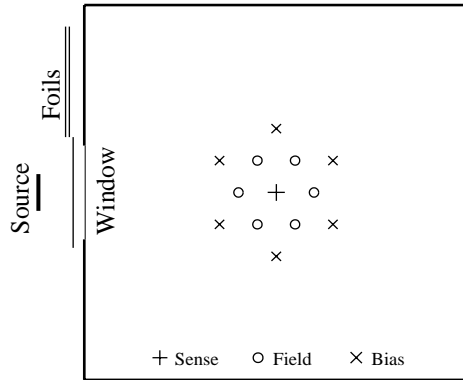
A small test chamber was built having one hexagonal BaBar-like cell as shown in Fig. 1. The sense wire (20 $\mu\text{m}$  gold coated tungsten-rhenium) is surrounded by six field wires (120 $\mu\text{m}$  gold coated aluminum) at 1 cm wire spacing. The six outer bias wires at 1300 volts together with 2050 volts on the

Figure 1. The test chamber. A single drift cell is enclosed in a square aluminum tube 10.2 cm per side, and 30.5 cm long.

sense wire provide a 19.2 KV/cm field on the field

(cathode) wires and 239 KV/cm on the sense (anode) wire.

A 100 mCi  $\text{Fe}^{55}$  source and attenuation foils provide any desired wire current up to 30 nA/cm. The source could be closed with a 6 mm thick aluminum shutter. A thin Mylar window restricted the ionisation to the middle 22 cm of the sense wire length. The maximum current at mid-length is calculated to be (total wire current) / 13 (nA/cm).

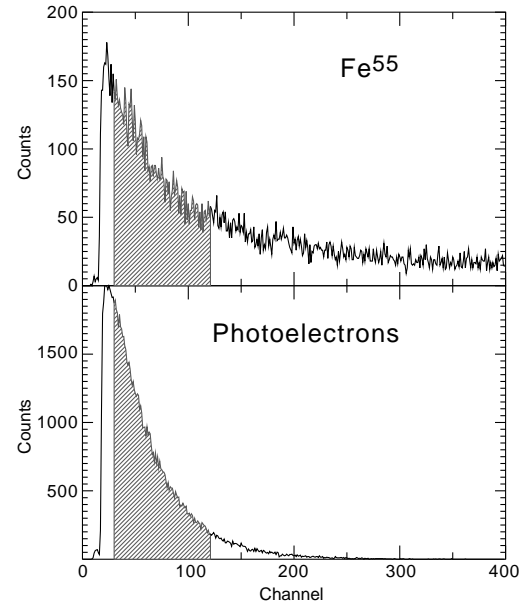
Figure 2. Pulse height spectrum for small pulses from  $\text{Fe}^{55}$  and from single photoelectrons. The shaded channels are used to count single electron avalanches. The  $\text{Fe}^{55}$  peak is off scale at channel 5500.

$\text{Fe}^{55}$  at a low source level, while the bottom plot shows the spectrum when incandescent light is allowed into the chamber. The latter spectrum is from photoelectrons off the cathode wires, and establishes the shaded channels (30-120) to be used for counting single electron avalanches. The small pulses from  $\text{Fe}^{55}$  are due to conversion locations grazing the boundary of the cell with only a single (few) electron(s) reaching the anode.

A Pico ammeter (Keithly 487) and a multi-channel analyzer (Perkin Elmer/Ortec 142PC, 570, and TRUMP PCI-8K) measured the cathode current and anode pulse spectrum respectively. The 8K-channel range in the analyzer could accommodate both the  $\text{Fe}^{55}$  peak at channel 5500 and the signal from one-electron avalanches at channel ~32. The analyzer did not record pulse heights below channel 20. The top plot in Fig. 2 shows the small pulse spectrum from

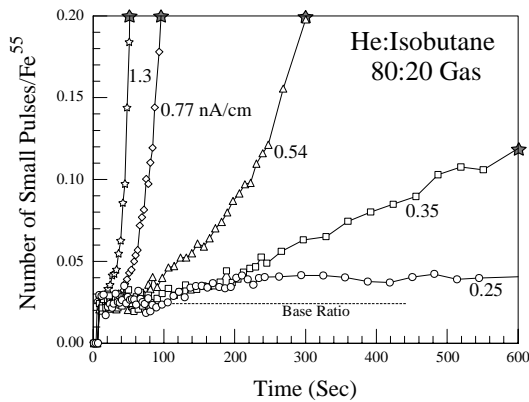
Figure 3. Transient behavior of small pulses in the (80:20) gas after opening the source shutter, for various levels of wire current. A star at a boundary indicates that breakdown occurred outside of the plot area.

the transient behavior of small pulses for wire currents from 0.25 to 1.3 nA/cm in the Helium:Isobutane (80:20) gas with no additives.

When the source is first opened, the small pulse ratio starts at the same 0.025 base value for all current levels. At the highest current (1.3 nA/cm) the ratio grows rapidly until the chamber breaks down after 60 seconds. At lower currents the break down takes longer to develop. At 0.25 nA/cm the chamber does not breakdown although there is an elevation in the number of small pulses.

In order to better understand the onset of the Malter currents, the transient behavior of small pulses was measured in response to a step in chamber ionisation. This was done by closing the source shutter for at least 5 minutes and then opening the shutter while recording pulse spectra every few seconds. The ratio of small pulse counts to peak counts was then plotted versus time. Such plots were recorded for various chamber currents. Fig. 3 shows

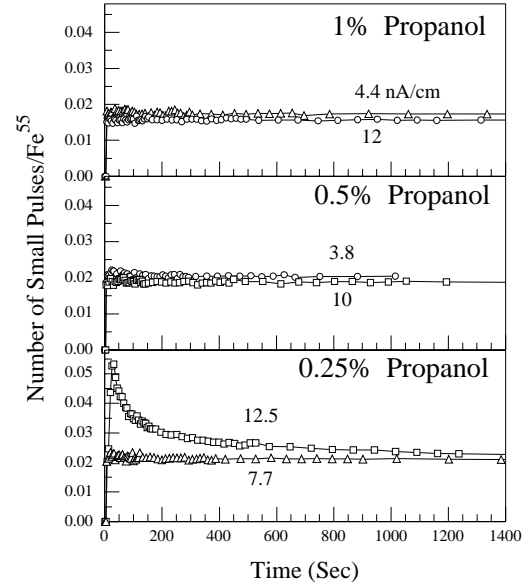
Some additives allowed chamber operation beyond wire currents of 10 nA/cm. The transient behavior with 2-Propanol,  $\text{CH}_3\text{CHOHCH}_3$ , is shown in Fig. 4. At concentrations of 1% and 0.5% there is no small pulse activity for wire currents of 10 nA/cm or more, while at 0.25% there is an initial increase at 12.5 nA/cm and then a gradual decline. The declining

Figure 4. Transient behavior of small pulses with an alcohol additive 2-Propanol. Concentrations above 0.5% show no small pulse activity.

A strange behavior already seen in Fig. 4 bottom is the rise and fall of the small pulse activity after the shutter is opened. This was seen for all gases with or without additives, for currents slightly below the break down threshold. Fig. 7 shows this effect for the Helium:Isobutane (80:20) gas.

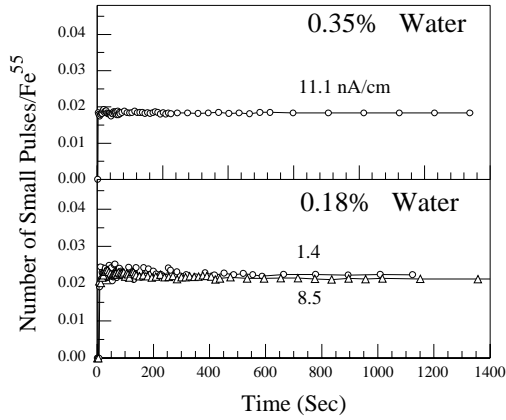
The transient behavior for a water additive is shown in Fig. 5. There is no visible small pulse activity with 0.35% or 0.18% water.

Figure 5. The small pulse transient behavior with a 0.35% or 0.18% water additive shows no increase in small pulses.

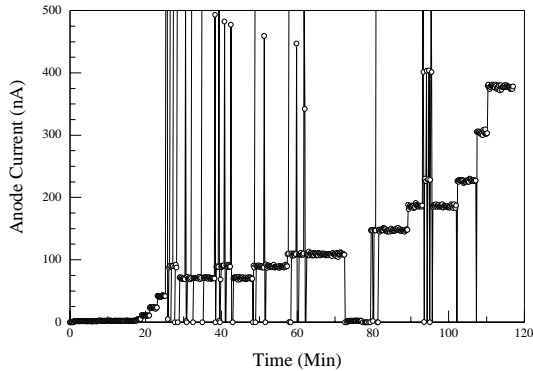
The final two additives tried in this study,  $\text{O}_2$  and  $\text{CO}_2$ , behaved differently. Whereas the previous additives allowed immediate operation at higher chamber currents, these did not. With  $\text{O}_2$  or  $\text{CO}_2$  it was necessary to increase the ionisation slowly. If brought on too quickly, the chamber would ignite in Malter mode, but after repeated attempts would become stable. Fig. 6 shows the anode current with 0.05% oxygen. After 2 hours of training the maximum  $\text{Fe}^{55}$  source was reached, at an anode current of 375 nA (29 nA/cm wire current).

Figure 6. The anode current during a curing cycle with 0.05%  $\text{O}_2$  is shown. The spikes are chamber trips, but after repeated attempts the chamber reaches a stable state at each current level up to the maximum  $\text{Fe}^{55}$  source level.

But more importantly, when the  $\text{O}_2$  was removed from the chamber gas, the chamber could still operate at the maximum 29 nA/cm wire current. The  $\text{O}_2$  additive was able to cure a damaged chamber. This measurement was repeated several times (by damaging the chamber at high source levels and elevated high voltage, followed by a cure cycle) with the same result.

The fact that the chamber could not operate immediately at high currents with oxygen but had to be slowly trained is indicative that the oxygen reacts with and removes ingredients on the wires over a period of time. It requires both oxygen and a high chamber current to cure the chamber. Most likely, the ionic current passing through the high electric field near the wire surface heats up the local gas, which allows reaction of oxygen with the carbon based deposits (polymers) on the wire surface. The  $\text{CO}$ ,  $\text{CO}_2$ , etc. combustion products are removed from the chamber by the flowing gas.

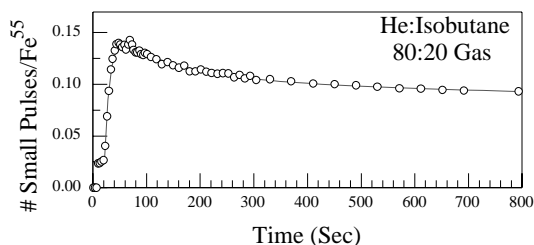
Figure 7. Small pulse activity at ionisation levels just below the break down threshold shows a rise and then a fall from a step increase in  $\text{Fe}^{55}$  ionisation.

The increase in small pulses is readily explained by the Malter theory, in which an insulating deposit on the cathode collects the incoming positive ions and charges up to a point where the resulting high electric field draws off electrons from the insulator. As the charge and the electric field build up with time, the rate of emission of electrons also increases as observed, until Malter break down occurs or the charge build up is balanced by ohmic current flow through the insulator.

But the sudden reduction in small pulses after a build up period means that some other mechanism turns on which suppresses emission of electrons from the insulator. A likely candidate is heat. The positive ions gain energy when traversing the 19 KV/cm electric field at the cathode, and this energy is dissipated as heat in the collisions with the gas near the insulator or the insulating surface itself. As the insulator heats up, its effective resistance may fall. The charge build-up would then discharge more rapidly and the emission of electrons would decrease as observed.

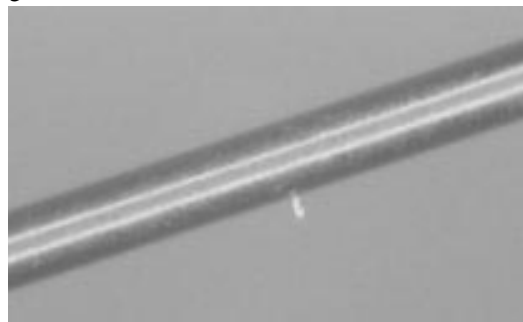
After the test chamber was maximally damaged, the chamber was opened and the wires were viewed with a microscope. A few whiskers were found on both the anode and cathode wires. An example of a

long whisker on a cathode wire is shown in Fig. 8. The whisker is white in color. Another cathode whisker (not shown) was of approximately equal size but was black in color.

Figure 8. Picture of a whisker on a 120  $\mu\text{m}$  cathode wire after the chamber was purposely damaged by running at the maximum source strength and an elevated high voltage.

The chamber was then operated with 0.05% oxygen and run until cured to the maximum source strength. Pictures were again taken of the same regions on the cathode wires. The white whisker was gone while the black one was still there as before.

This suggests that the white whisker was a damaging element. It contributed to chamber break down and was removed by the oxygen cure. On the other hand, the black whisker did not cause break down at the highest ionisation level. However, this was a recent observation and there was no time to repeat it before the aging workshop. The white whisker could have fallen off the wire while transporting the chamber to the microscope room. This work will be repeated.
